# Preliminary Information

PIP5498B SES Lamp P050D P0300 Setting On A Cold Start And/Or a Run Rough Warm with No codes

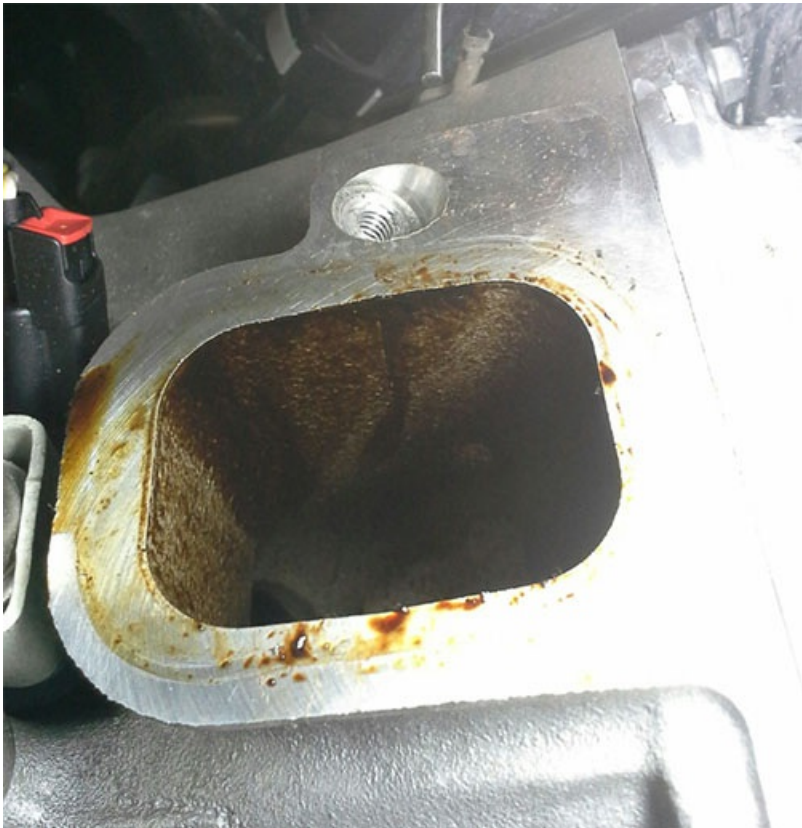
At times it may be necessary to remove the head for inspection.  
If the head casting line is the concern the intake port will be wet with a coolant oil mix.  
This could be the cause of a running rough warm concern with or without codes.  
The location of where the coolant is running down in the port will also look washed down.

If this is found the cylinder head will need to be replaced.

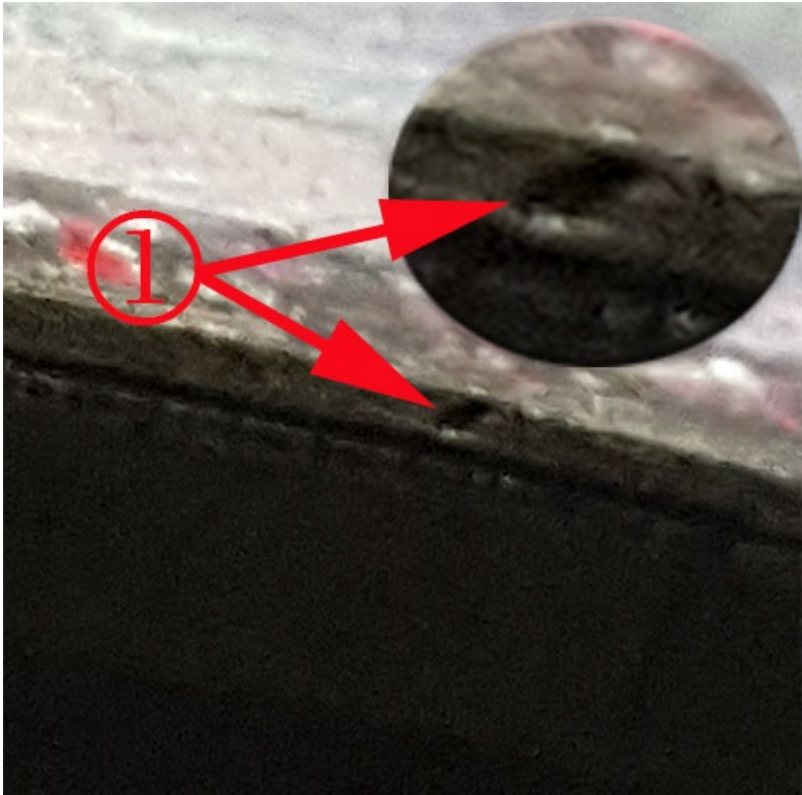
For coolant entry at the liner to deck face casting of the cylinder bore.

It is hard to see the actual source (pin hole) but it usually streams down the liner so that you can see it with a borescope.(Sometimes) The top of the piston will be steam cleaned.  
Do not confuse residual fuel on the piston crown / surface as coolant. Some fuel residue may be present and can be mistaken as coolant (reason for the cooling system Dye to be added). Use black light to confirm the liquid is coolant. If this concern is present, do not replace the cylinder head because that will not repair this concern. Call PQC per the latest version of [16-NA-338](#), if required, reference this PI and replace the engine.  
Small surface pock marks or pitting appearance on the deck surface is normal and engines should not be replaced for such appearance as they do not connect to coolant passages and cause a leak path that generate engine misfires. During engine warranty analysis studies, engines are being replaced for small pitting in the deck face as described above, when the subject cylinder / piston is saturated with fuel and not coolant
