# Preliminary Information

PIP5335A SES Lamp With Camshaft Position Codes P0340 and/or P0341

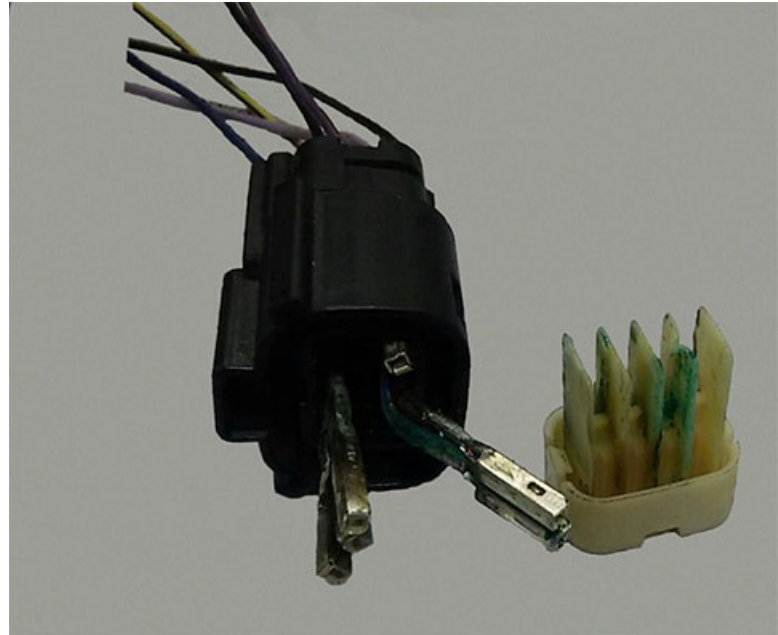
A vehicle may be setting DTC's P0340 and P0341 at times

If normal SI Diagnostics does not isolate the concern, inspect for corrosion in connector X154 located on the front cover next to the vacuum pump.  
See the illustration below

If this condition is encountered repair as needed.
