# Preliminary Information

PIP3423N DTC P0016 P0017 P0018 P0019 P0008 P0009

## Condition / Concern

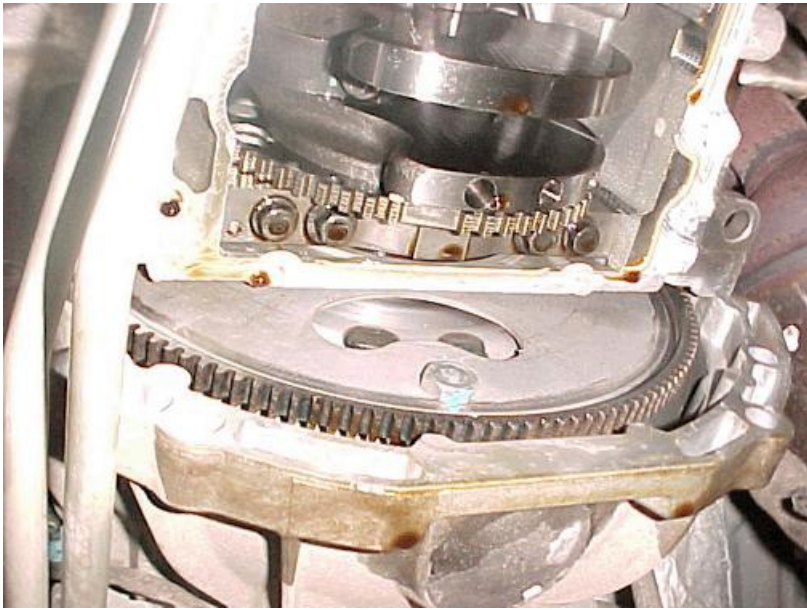
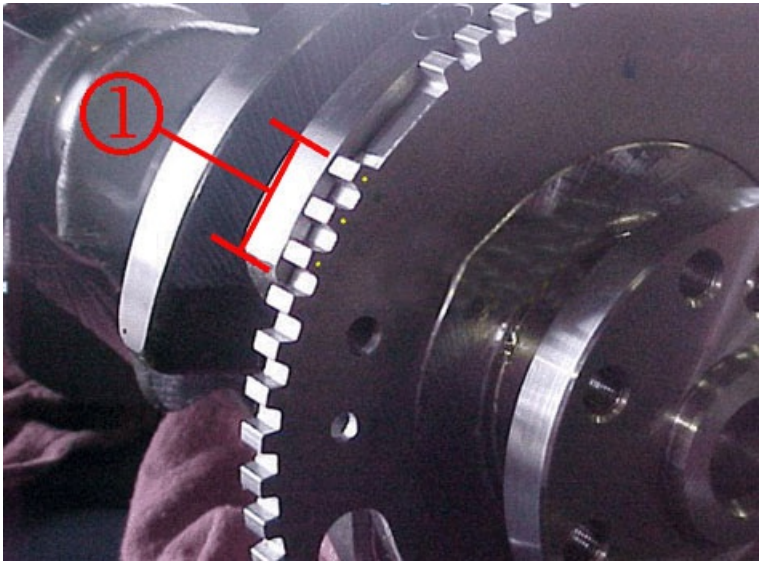
1= The actual measurement of a good Reluctor wheel.

25 to 26 mm This measurement is from the end of the machined surface of the crankshaft throw to the edge of the open space in the reluctor. (approximately 3 1/2 teeth)

The reluctor for the crankshaft sensor pressed onto the rear of the crankshaft may have moved.  
Refer to attached photographs for exact location.  
(It is possible on some applications to view this with a bore scope through the crank sensor hole without removing the oil pan)  
If the reluctor has moved then replace crankshaft.

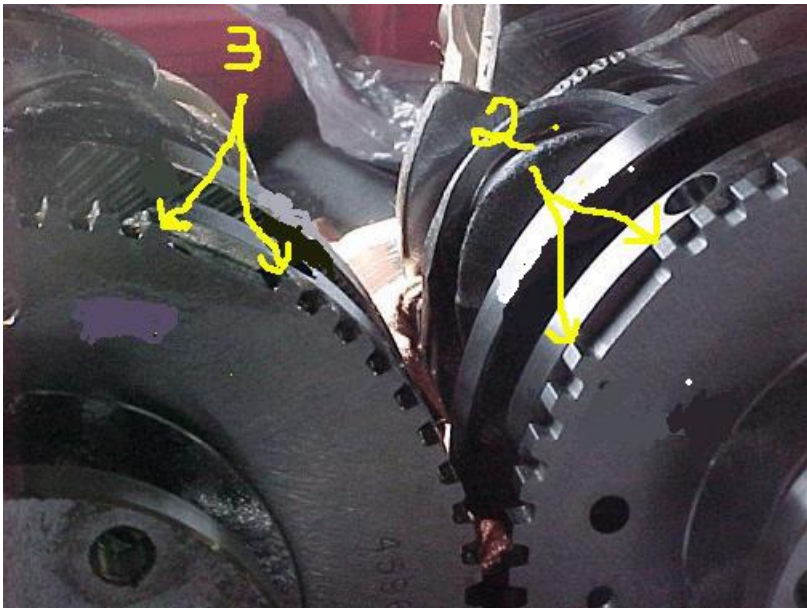
2 and 3 = Show a good reluctor next to a bad reluctor.

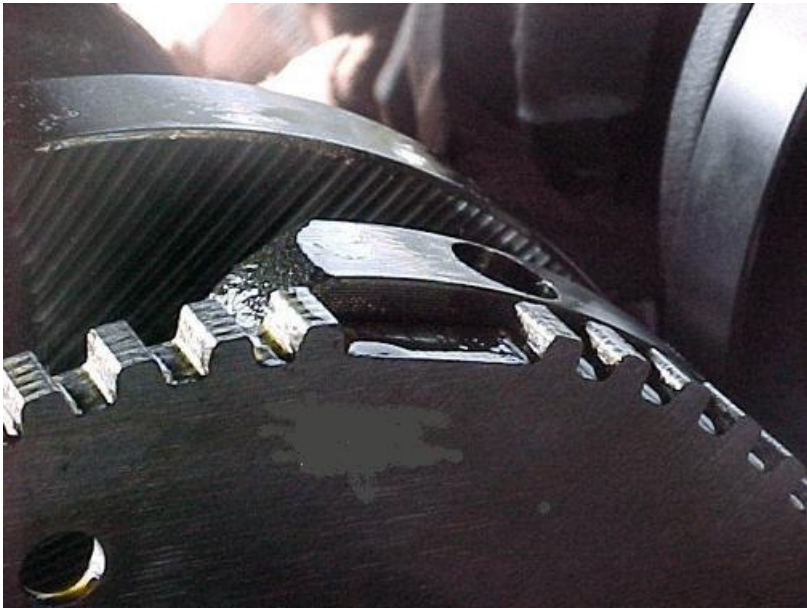
Crankshaft with bad reluctor wheel.

**NOTE:** The distance can be offset either clockwise or counter clockwise. Both will result in these codes.
