# Preliminary Information

## PIP4959F Cold Start Misfires

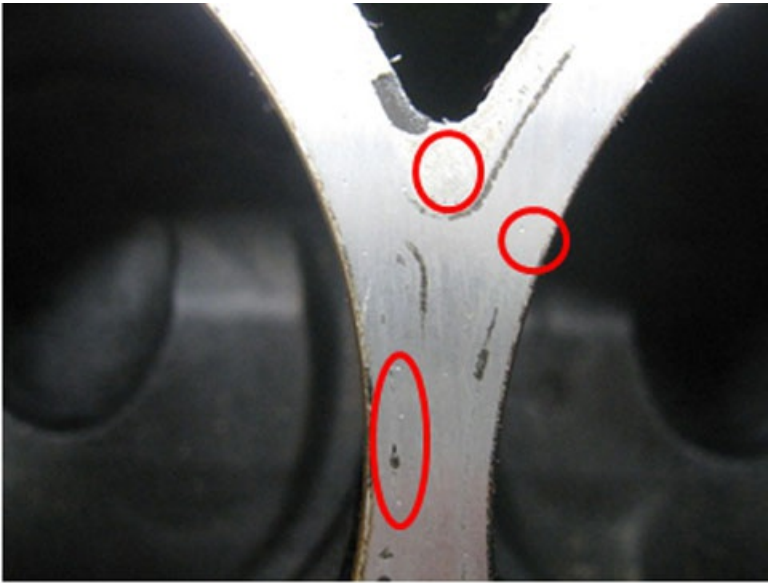
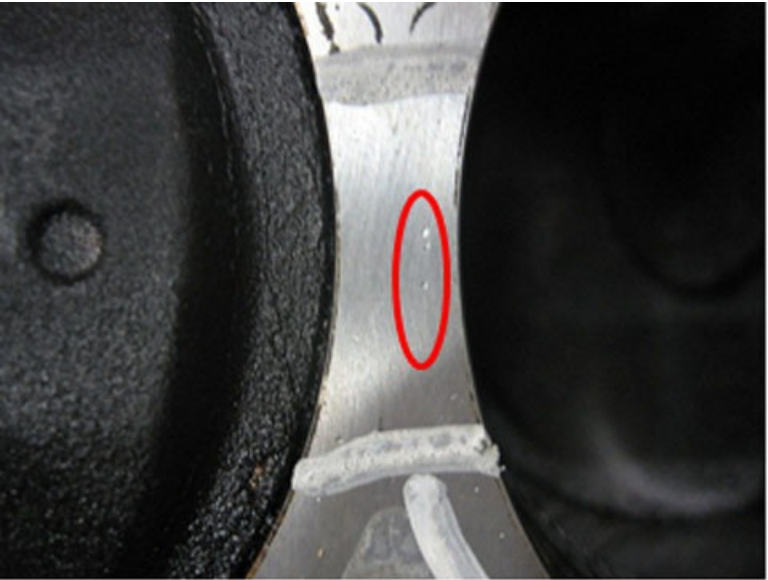
See pictures below for examples of deck pitting and actual porosity with leak path.

Small surface pock marks or pitting appearance on the deck surface is normal and engines should not be replaced for such appearance as they do not connect to coolant passages and cause a leak path that generate engine misfires.

During engine warranty analysis studies, engines are being replaced for small pitting in the deck face as described above, when the subject cylinder / piston is saturated with fuel and not coolant.

Engine replaced for subject pitting conditions will be returned to the dealership as non defective.

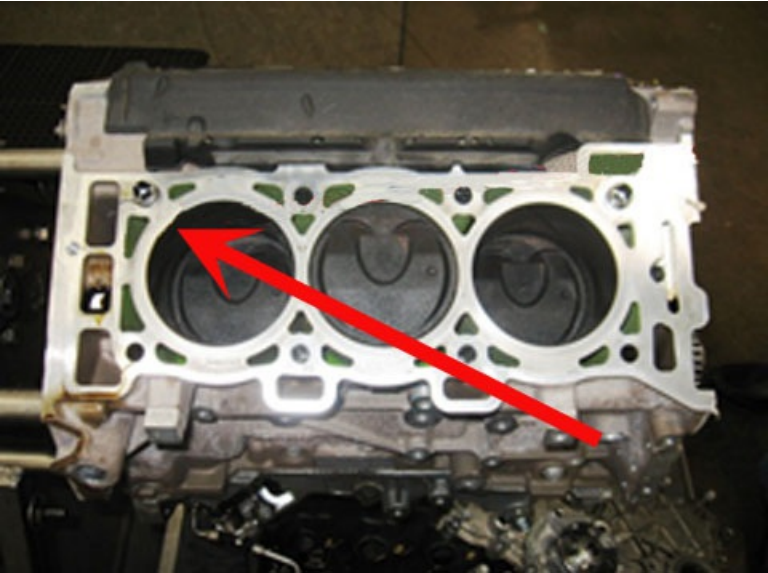
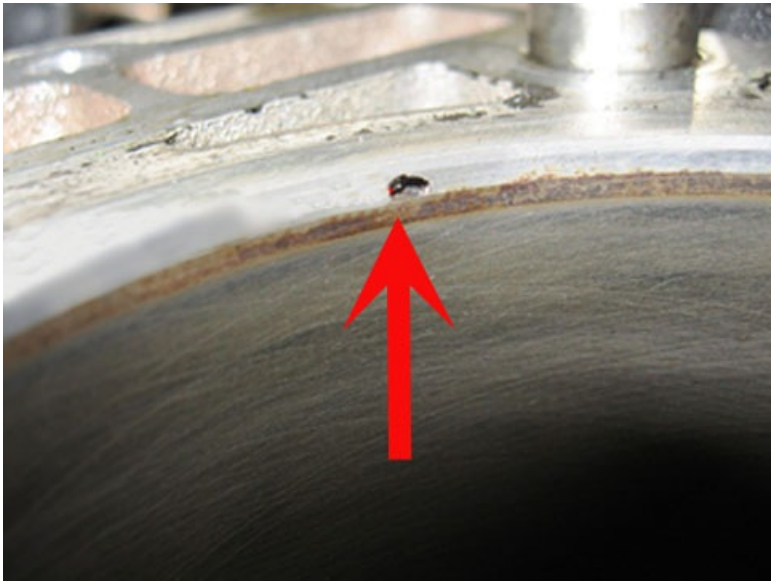
Location: # 5 at the 10:00 o’clock position.

The photo above is an example of what true porosity is.

Cylinder deck face to cylinder liner interface location can cause a leak path into the cylinder for rapid large counts of misfires when cold.

Such Porosity is rare, therefore technicians should inspect the subject cylinder and look for a break in the carbon ring.

Usually if porosity is present there will be a break in the carbon ring.

Coolant present in a cylinder cleans the area of entry and can be found by wiping the carbon ring dry with a clean soft towel, exposing the leak path. Only if true porosity is found would engine replacement become necessary.

Call PQC per the latest version of [16-NA-338](#), if required, reference this PI and replace the engine, ONLY in cases where porosity has been found to be the cause.
