# Preliminary Information

PIP5468C Check Engine Light On with Leaks in the Charge Air Cooler System.

Models

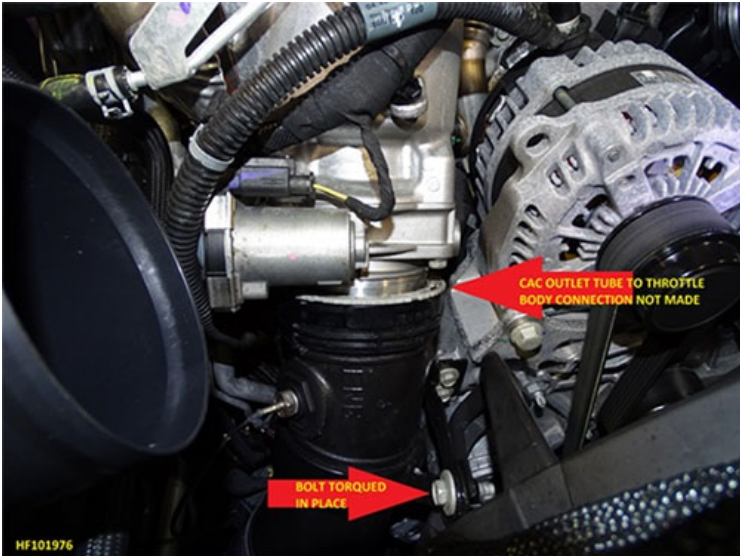
Check for non-secured connection of the charged air cooler pipe at the intake air flow valve (throttle body).  
Check for proper alignment of the charged air cooler pipe bracket and bolt hole.

If any combination of DTCs DTCs P0101, P0299, P0712, P11CC, P11DC, P20EE, P2002, P2463, P2627, P2A00, P2459, P22B6, P200C, P200E, P0263, P0266, P0269, P0272, P0275, P0278, P0281 and/or P0284 are set; check for loose charge air cooler ductwork at the turbocharger outlet pipe, the charge air cooler inlet pipe, the charge air cooler outlet pipe and the connection at the intake air flow valve (throttle body). Please note that a static visual inspection may not reveal that the connection is not adequate and that it is most likely to occur during engine roll or brake torque. It is highly recommended to test for leaks in the charge air cooler system by using the procedure found in Service Information Document ID: 4282009 (Charge Air Cooler Diagnosis) Please perform a Diesel Particulate Filter (DPF) Regeneration Enable after repairs are made. Refer to Service Information Document ID: 2445614.
