## Technical Service Bulletin

| GROUP<br><b>CAMPAIGN</b> | NUMBER<br><b>18-01-017</b> |
| DATE<br><b>APRIL, 2018</b> | MODEL<br><b>ACCENT (HC)</b> |

**SUBJECT:** HC ACCENT SPARK PLUG REPLACEMENT  
(SERVICE CAMPAIGN T2X)

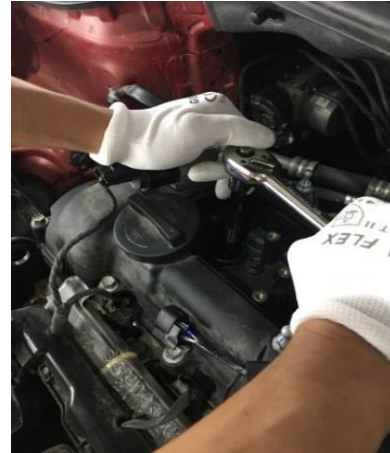
5. Remove each of the 4 spark plugs using a 16mm spark plug socket on a 3/8" ratchet and extension.

**Perform the below spark plug inspection of each plug as it is removed and identify any cylinders that have damaged plugs.**

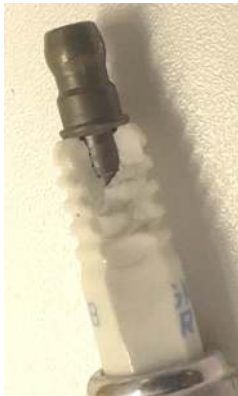
| Plug Ceramic Condition | Example | Repair Action |
|---|---|---|
| <b>Damaged with fragment(s) detached from the plug.</b> | | <b>DO NOT START ENGINE. Contact Techline for further repair advice.</b> Identify affected cylinder(s) and take photo of the damaged plug condition to provide Techline to view severity of the plug condition and repair.<br><b>Note:</b> Fragment(s) may have fallen into the engine port(s) and may require special procedure to prevent engine damage. |

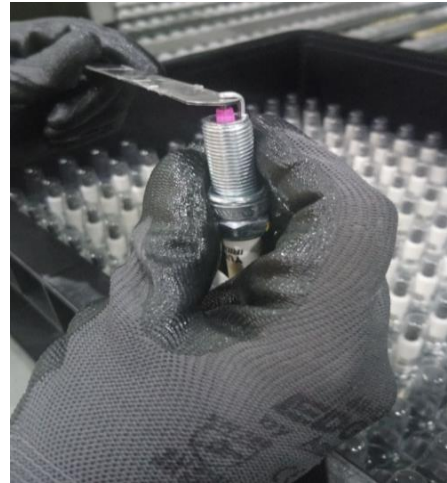
Inspect the electrode gap of all 4 new spark plugs using a gap gauge. Adjust as required to meet specifications.

Electrode Gap spec:  
0.9 - 1.0 mm  
(0.0354 – 0.0394 in)

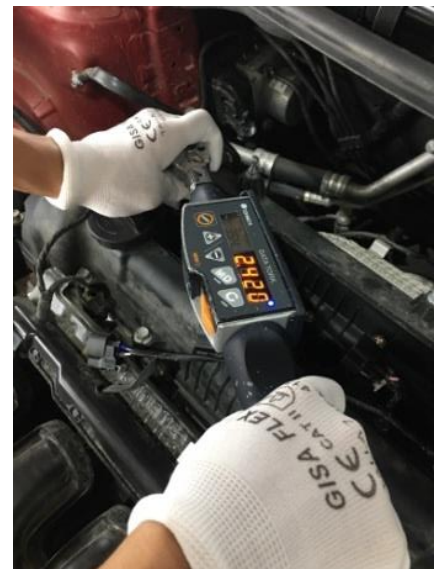
8. Tighten all 4 spark plugs with a torque wrench to specifications.

**14.7 ~ 24.5 N.m**  
**(1.5 ~ 2.5 kgf.m, 10.9 ~ 18.0 lb-ft)**
