# Technical Service Bulletin

## 01 MIL on, DTC P243600 and/or P243700 stored in ECM

01 18 56 2049142/2 March 2, 2018. Supersedes Technical Service Bulletin Group 01 number 17-40 dated October 23, 2017 for reasons listed below.

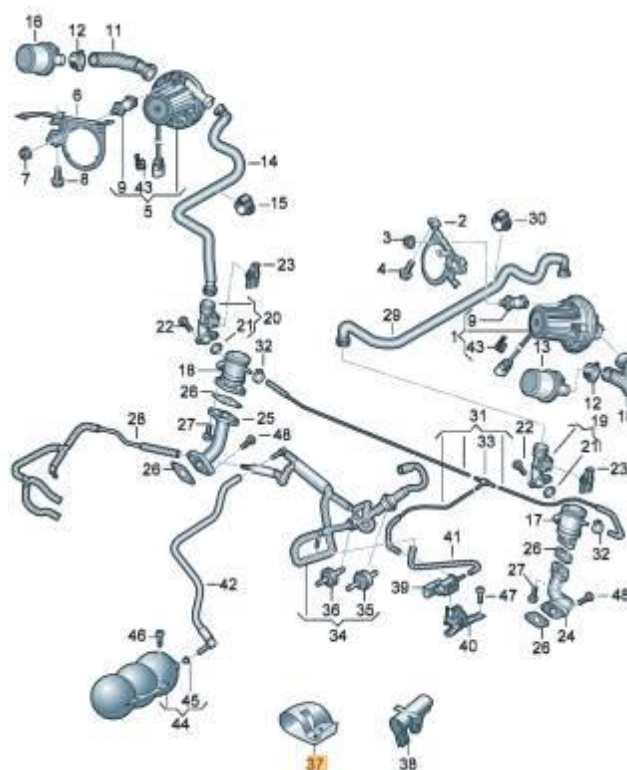
According to the Guided Fault Finding, the differential pressure sensor Bank 2 (G610) has to be replaced.

**Figure 1.** Replace the sender.

1. Replace the Differential pressure sensor Bank 2 (G610) according to the Repair Manual, *Engine >> 24 Multiport fuel injection >> air filter housing, removing and installing >> 26 Exhaust System>Secondary Air System >> Combination valve, removing and installing >> Secondary air injection sensor G609/G610, removing and installing.*

2. Then add the insulation (Figure 1, number 37) on the pressure sensor Bank 2.

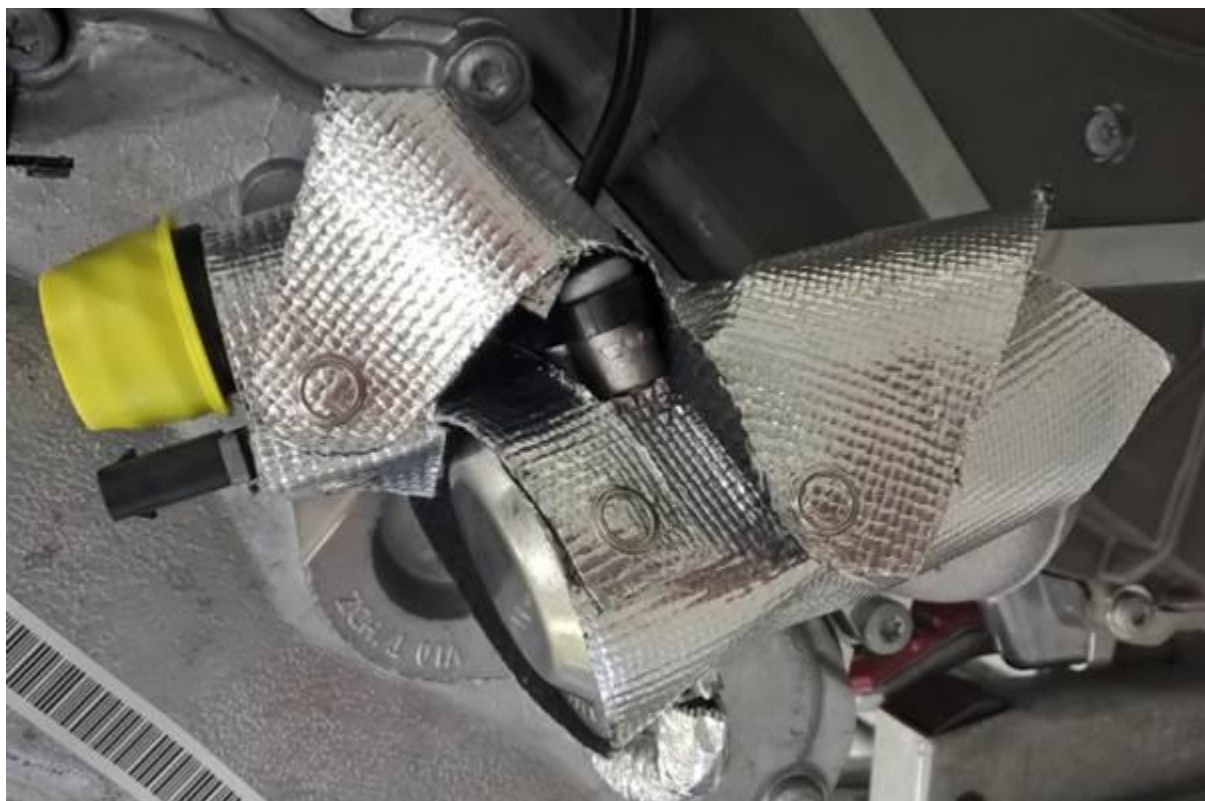
**Figure 2.** Insulation on Bank 2 pressure sensor after installation.

At the end of the repair the pressure sensor and the combination valve should have the insulation on both banks (Figure 2).
