## SERVICE BULLETIN

**APPLICABILITY:** 2014-15MY XV Crosstrek Hybrid Electric Vehicle (HEV) **NUMBER:** 16-94-15R

**SUBJECT:** Diagnosis and Repair of DTCs P172A and P0B0B

**DATE:** 07/30/15

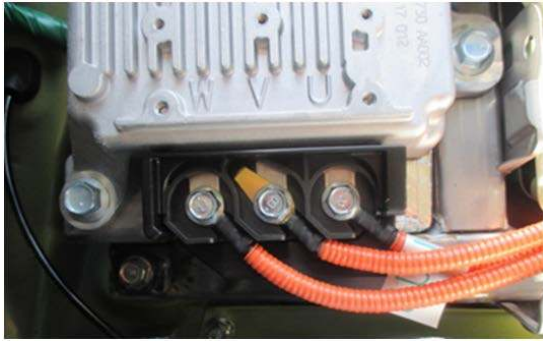
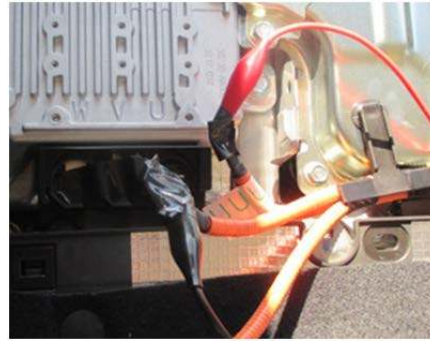
- Remove the rear cargo area floor mat and the sub-trunk (storage tray).
- Remove the orange HEV Service Disconnect plug and put it in your pocket.
- Remove the TORX screws and necessary trim clips securing the aluminum battery cover.
- **ONE AT A TIME**, remove the 3 bolts securing the orange "W", "V", and "U" cables to the electric oil pump inverter. As each cable is removed, cover each terminal end with one piece of electrical tape to insulate it. Connect the RED (+) test lead from the DVOM to the "U" cable end and BLACK (-) lead to the "V" cable end as shown. Confirm the "W" cable end is wrapped with insulating tape.

**IF THE DVOM SHOWS 0.5V OR MORE:** the o-ring and drive motor are damaged. The drive motor / case assembly must be replaced. Remove the CVT assembly following the procedure in the applicable Service Manual.

**IF THE DVOM SHOWS LESS THAN 0.5V:** the root cause of the DTC is elsewhere. Continue with the DTC diagnostic procedure in the applicable Service Manual.
