**NUMBER:** 25-002-14

**GROUP:** Emissions Control

Malfunction Indicator Lamp Illumination Due To Oxygen Sensor

2010 - 2012 (DJ) Ram Pick Up (2500)

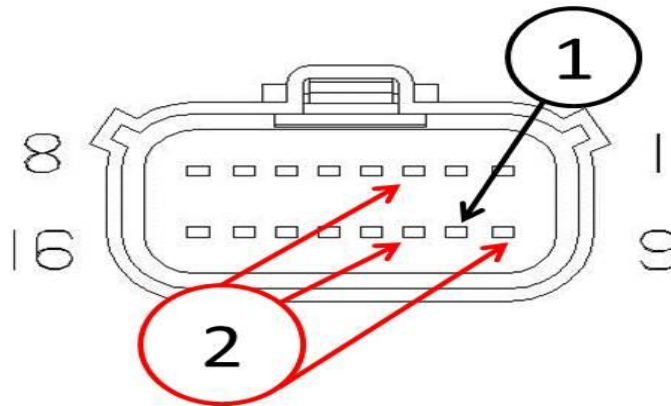
**Fig. 1 FOUR WIRES FROM TRUCK MUST BE TRANSFERED TO OVERLAY HARNESS**

1 - Terminal 10 - Always a Gold Plated Terminal

2 - Terminals 3, 9 and 11- Must be Inspected on Model Year 2011 For Gold Plating

**NOTE: In the following steps, four of the terminals will be removed from the original Oxygen Sensor Module connector and installed in the 68250763AA overlay harness Oxygen Sensor Module connector. Of those four terminals, some MY11 trucks were built with tin terminals and should have been gold plating. Three of the four terminals, (if required, determined below) will need to be replaced with the gold plated terminals supplied in the 68250763AA kit.**

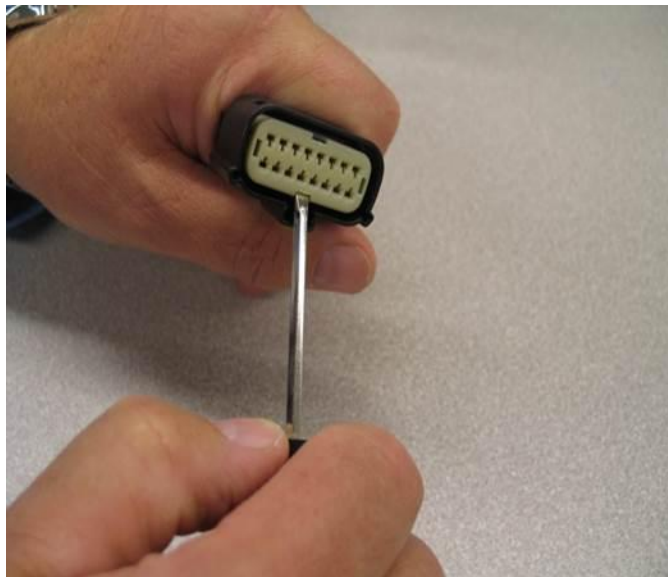
**Fig. 2 LIFT TPA 5MM**

- 
14. To release the terminals from the original Oxygen Sensor Module connector; use a narrow blade, flat screwdriver (3 mm wide max), and pry the white TPA (white cover seen when looking in connector). Notice the travel of white TPA is only .2" (5 mm) or until a "click" is heard. This is the release point of the TPA. The TPA is a device that locks the release finger so that when seated, terminal will not and cannot be disengaged, (Fig. 2) and (Fig. 3). Do not extend the TPA past .2" (5 mm) or the TPA may be damaged.

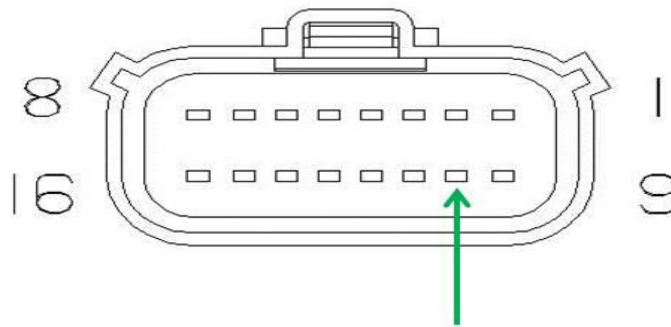
**NOTE: Terminal #10 is ALWAYS gold plated and is not required to be changed ON ANY APPLICATION. Inspect terminal #10 to see what the gold terminals look like for a reference when inspecting terminals #3, 9 & 11 in the following steps.**

***Fig. 4 TERMINAL 10 IS A GOLD TERMINAL***

Remove Terminal 10

15. Starting with terminal #10 ([Fig. 4](#)), push the wire into the connector from the back, and while keeping the tool or drill at 90° angle to the face of the TPA, push the tool or drill in until it releases the lock finger in the connector as shown in ([Fig. 5](#)). At this point the wire should pull out the back. As the terminal is removed; note the orientation of the terminal in the connector for ease of installation later.

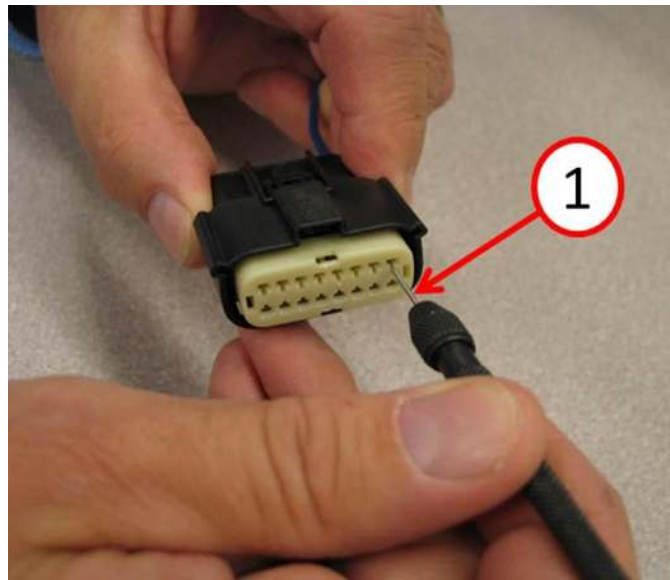
***Fig. 5 INSERT TOOL IN SERVICE PORT ADJACENT TO THE TERMINAL TO BE REPLACED***

1 - 1MM Drill Bit Used as Service Tool
