**NUMBER:** 18-028-14 REV. D

Flash: MIL Illumination - Diagnostic and System Improvements

2014 (DS) Ram Pickup (1500)

**NOTE: This bulletin applies to vehicles equipped with a 3.0L diesel engine (sales code EXF).**

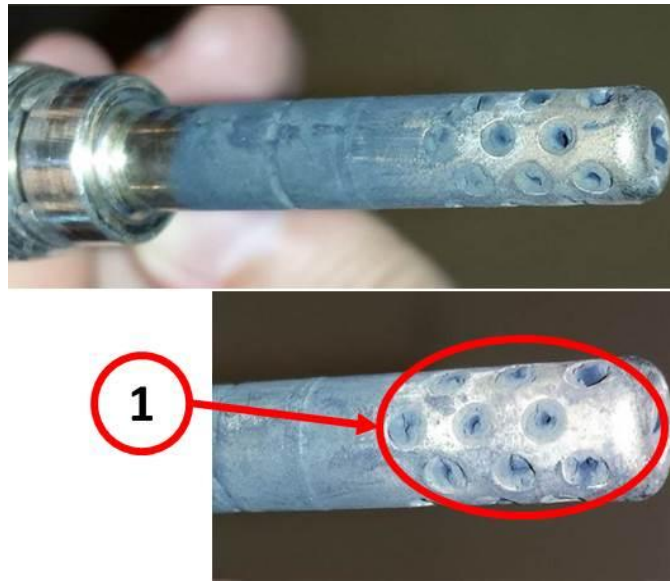
**Fig. 1 EGT Sensor Bank 1 Sensor 2**

10. Replace the O2 sensor. Refer to detailed repair procedures available in DealerCONNECT> TechCONNECT> Service Info Section 14 - Fuel System> Fuel Injection, Diesel> Sensor, Oxygen> Removal/Installation. Proceed to [Step #11](#).
11. Remove the EGT Sensor 1/2 located in the inlet of the Diesel Particulate Filter (DPF)/Diesel Oxidation Catalyst (DOC) assembly. Refer to detailed removal procedures available in DealerCONNECT> TechCONNECT> Service Info Section 11 - Exhaust System> Sensor, Exhaust Temperature> Removal> Exhaust Gas Temperature Sensor 1/2.
12. Inspect the sensor body and probe for any signs of damage or excessive soot. Refer to ([Fig. 1](#)).

1 - Excessive soot blocking sensor ports.

- 
13. Was excessive soot found on the sensor?
    - a. Yes>>> Proceed to [Step #14](#).
    - b. No>>> Proceed to [Step #15](#).
  14. Using shop air set to a maximum of 80 psi, clean all excessive soot from the sensor probe.

15. Using a suitable multi-meter with appropriate test probes, test the resistance between the sensor connector terminals 1 and 2. With the sensor at room temperature, 65-75 °F (18-25 °C), the resistance should measure between 200 and 240 ohms.

16. Is the temperature sensor resistance within specifications?
    - a. Yes>>> Install the original EGT sensor 1/2. Refer to detailed installation procedures available in DealerCONNECT> TechCONNECT> Service Info Section 11 - Exhaust System> Sensor, Exhaust Temperature> Installation> Exhaust Gas Temperature Sensor 1/2.

- b. No>>> Install a new EGT sensor 1/2. Refer to detailed installation procedures available in DealerCONNECT> TechCONNECT> Service Info Section 11 - Exhaust System> Sensor, Exhaust Temperature> Installation> Exhaust Gas Temperature Sensor 1/2.
