## Technical Service Bulletin

| GROUP<br><b>CAMPAIGN</b> | NUMBER<br><b>18-01-017-1</b> |
| DATE<br><b>MAY, 2018</b> | MODEL<br><b>ACCENT (HC)</b> |

**SUBJECT:** HC ACCENT SPARK PLUG REPLACEMENT  
(SERVICE CAMPAIGN T2X)

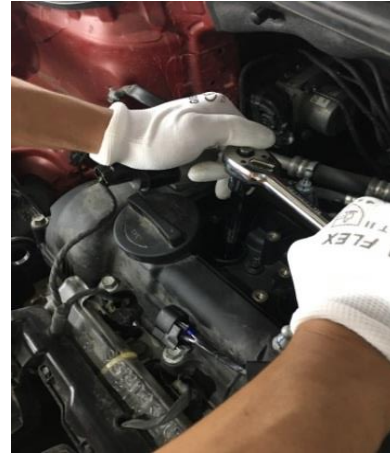
**Perform the below spark plug inspection of each plug as it is removed and identify any cylinders that have damaged plugs.**

5. Remove each of the 4 spark plugs using a 16mm spark plug socket on a 3/8" ratchet and extension.

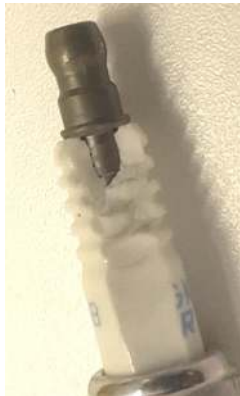
| Plug Ceramic Condition | Example | Repair Action |
|---|---|---|
| <b>Damaged with fragment(s) detached from the plug.</b> | | <b>DO NOT START ENGINE. Contact Techline for further repair advice.</b> Identify affected cylinder(s) and take photo of the damaged plug condition to provide Techline to view severity of the plug condition and repair.<br><b>Note:</b> Fragment(s) may have fallen into the engine port(s) and may require special procedure to prevent engine damage. |
