MODEL  
2017MY  
Niro (DE HEV)

NUMBER  
PS553 (Rev 1, 05/15/2018)

SUBJECT:

HEV WARNING LIGHT AND DTC P1B25/P1B77

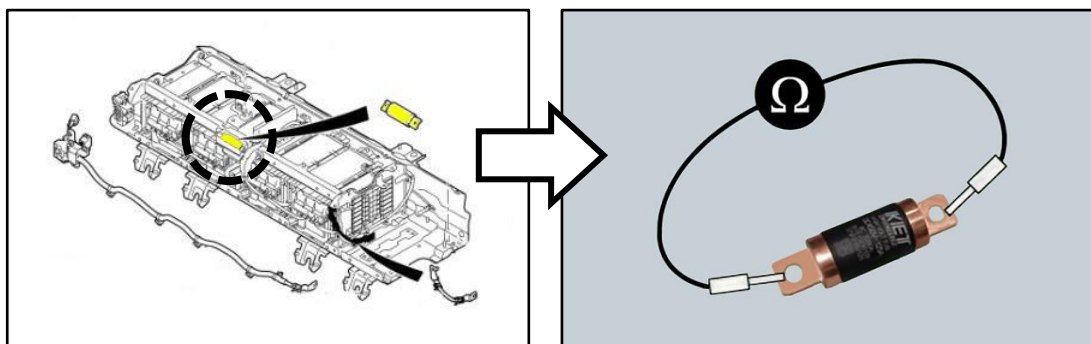
Hi-Voltage Battery Fuse

When addressing a concern related to the Niro HV warning light ON, and KDS detects a primary DTC P1B25 (HV Path Fault) and secondary DTC P1B77 (HV Pre-Charge Fault), then the 125 Amp High Voltage Battery Fuse should be inspected for an intermittent and/or an open condition.

**Measure the resistance while tapping on the fuse (less than  $<1\Omega$  resistance).**

**Specification:**  $1\Omega$  or less ( $68^{\circ}\text{F}$ )

If the measured resistance is not within specification, or the P1B25 DTC is intermittent, replace the 125 Amp main HV battery fuse with the newer 175 Amp main HV battery fuse.  
(Part # 375F2 A8170)
