## SERVICE BULLETIN

**APPLICABILITY:** 2014-2016MY Crosstrek Hybrid (HEV) Models      **NUMBER:** 11-180-18  
**SUBJECT:** DTCs P0A78 and P1C2A- ECM Reprogramming      **DATE:** 05/30/18  
 File Availability

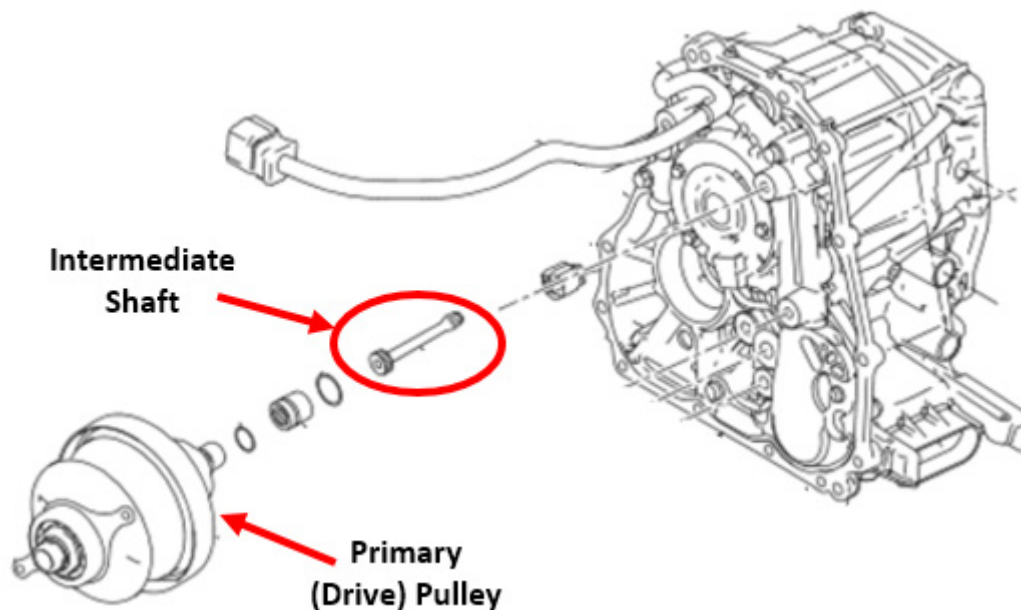
In the event of a Drive Motor and / or Inverter malfunction, DTC P0A78 **AND** P1C2A may set at the same time. This is a RARE occurrence. As a result, the drive motor could be supplied with a higher than specified level of current and damage (twist from over-torque) the CVT's Intermediate Shaft (see below) which is located inside the primary (drive) pulley.

**VERY IMPORTANT:** In the unlikely event DTC P0A78 **AND** P1C2A are detected and set at the same time, follow the diagnostic procedures for BOTH DTCs to determine the fault **BEFORE** proceeding with reprogramming the ECM. In this case, the following 4 components must be replaced together **as a set** following the procedures supplied in the applicable Service Manual.

- Drive Motor Control Module (DMCM)
- Inverter Assembly
- Inverter wiring harness (between the DMCM and the Inverter)
- CVT Intermediate Shaft.
