| MIL ON P314A and/or P0C73, Corrosion Present in A9 Inverter Water Pump Connector | | USA |
| 14-16MY Highlander HV14-2016MY Highlander HV | | |

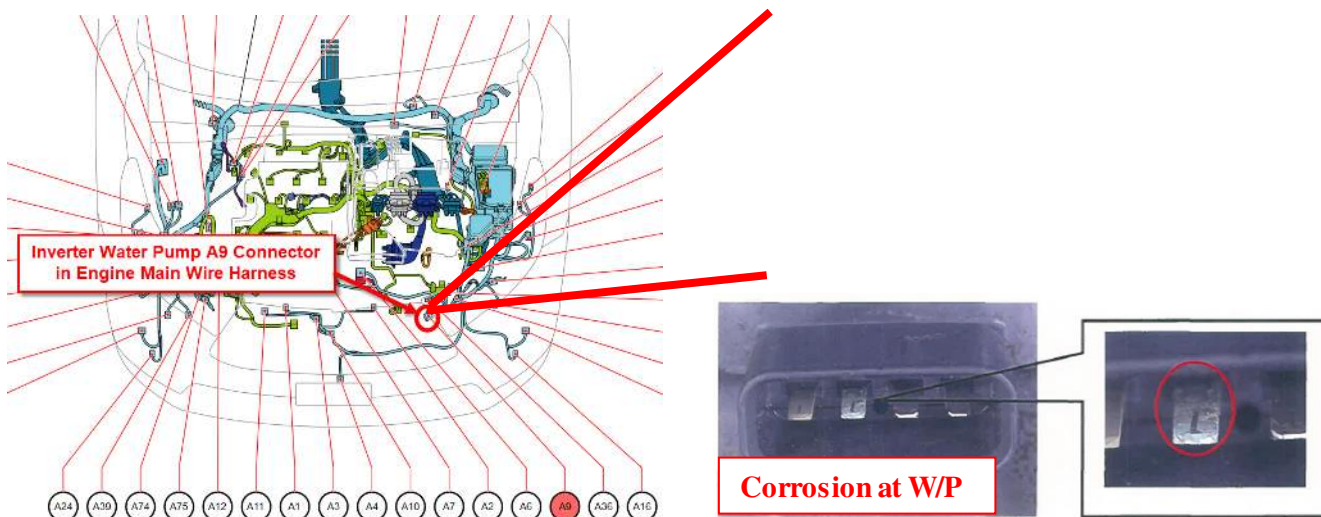
Vehicles may experience a MIL ON condition exhibiting codes P314A and/or P0C73 with evidence of water (corrosion) at the A9 inverter water pump connector. This condition may be caused by vehicles being equipped with an aftermarket windshield assembly with a poorly sealed or damaged deicer harness.

Water can enter in through deicer harness, wick down to the common shared ground junction A72 and then wick from the A72 ground connector to inverter water pump connector.

- 1) Inspect A33 windshield deicer connection-to-engine main wire harness for evidence of corrosion.
- 2) Check if windshield is non-genuine Toyota windshield. Toyota genuine windshields will have a "Toyota" marking on label and a Toyota part number on the deicer harness. The deicer harness and windshield come as an assembled unit.
- 3) Toyota recommends that windshields only be replaced with Toyota genuine parts. Toyota genuine windshields are equipped with seals for prevention of water intrusion to the engine room main wire harness.
- 4) If corrosion is found in the A33 connector and the windshield is a Toyota genuine part, please contact TAS.

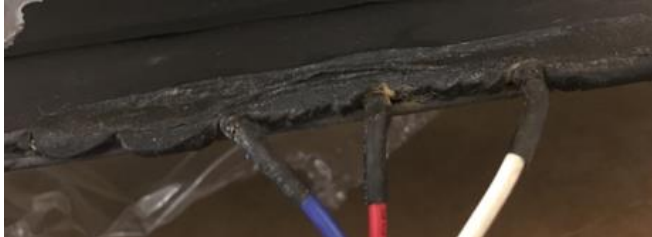
Aftermarket deicer connection at windshield example:

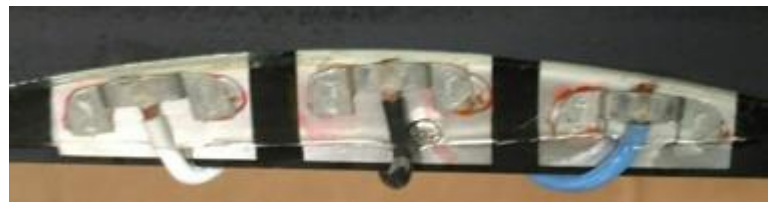
Toyota genuine deicer connection at windshield harness example:
