# Secondary Air Injection System - MIL "ON" DTC P2440, P2442, and/or P2445 (1GR-FE)

## Applicability

| YEAR(S) | MODEL(S) | ADDITIONAL INFORMATION |
|---|---|---|
| 2012 | Tacoma | WMI(s): 3TM, 5TF<br>Body Type(s): Access Cab, Extra Cab<br>Transmission(s): 5AT, 6MT |

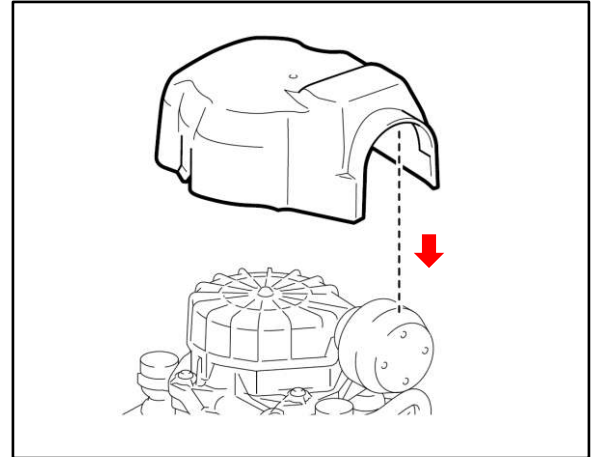
Figure 1.

Air pump cover installation will reduce the possibility of filter damage.

- B. Install the air pump cover.

- (1) Place the air pump cover over the air pump, making sure to follow the contours of the air pump.
- (2) Apply downward pressure until a click is heard.
- (3) Confirm the air pump cover is fully seated.
