# MIL "ON" DTC P2820

**Section** CVT

| YEAR(S) | MODEL(S) | ADDITIONAL INFORMATION |
|---|---|---|
| 2016 | iM | Transmission(s): CVT |

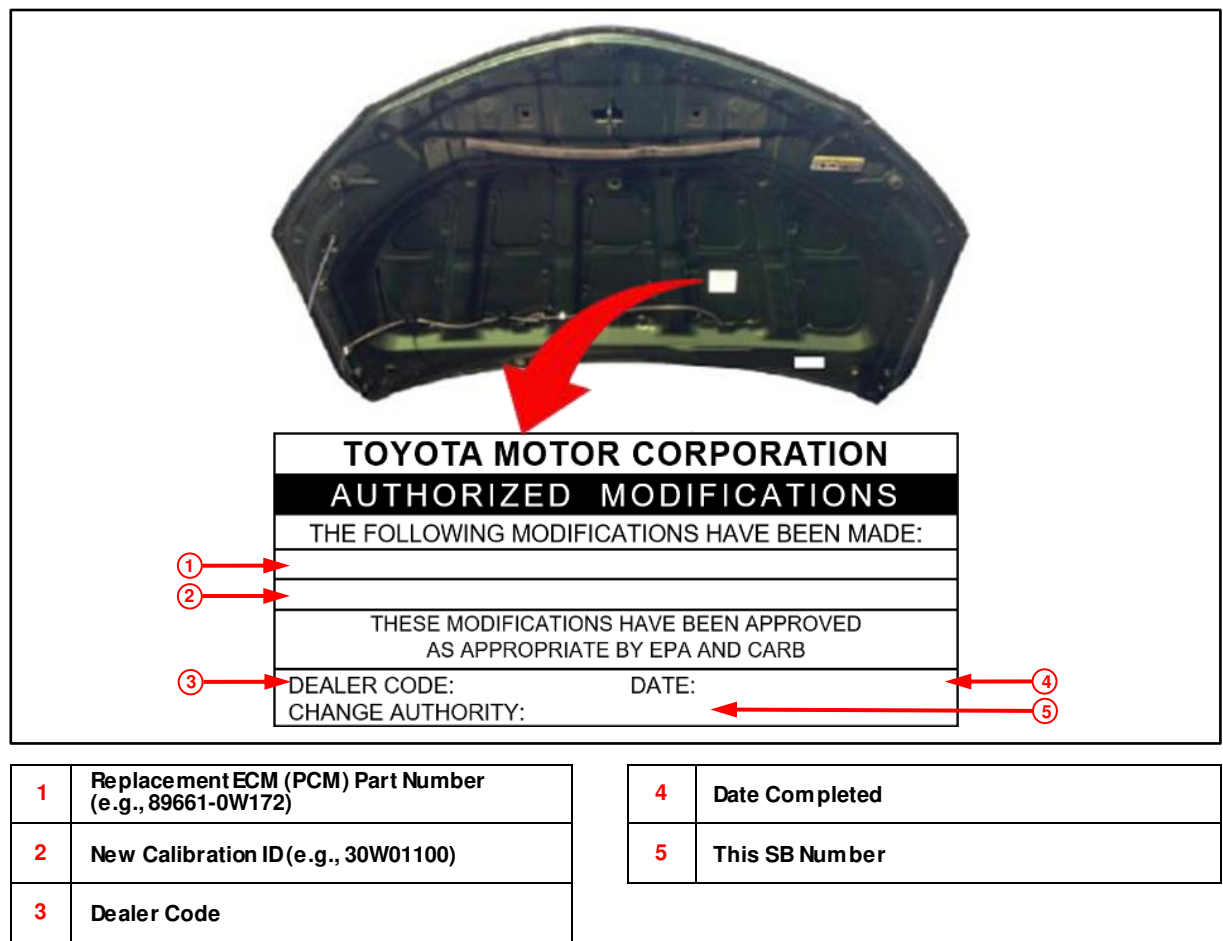
**Figure 1. Location of Authorized Modifications Label for 2016 iM**

4. Check for the Authorized Modifications Label affixed to the vehicle in the location shown below. Confirm if the ECM (PCM) calibration has been updated.

6. Prepare and install the Authorized Modifications Label.
  - A. Using a permanent marker, enter the following information on the label:
    - ECM part number [Refer to the **Parts Information** section for the **NEW PART NUMBER**]
    - Calibration ID(s) [Refer to the **Calibration Information** section for the **NEW CALIBRATION ID**]
    - Dealer Code
    - Repair Date
    - Change Authority [**This bulletin number**]
  - B. Install the Authorized Modifications Label on the vehicle at the location shown in Figure 1. The Authorized Modifications Label is available through the MDC, P/N 00451-00001-LBL.
7. Perform the Techstream ECT Reset Memory Utility.
8. Test drive the vehicle to confirm the repair.
