## Advanced Technical Information

Bulletin #: 1802

### Panamera 4 E-Hybrid (971) Cooling System Fault POC4A00

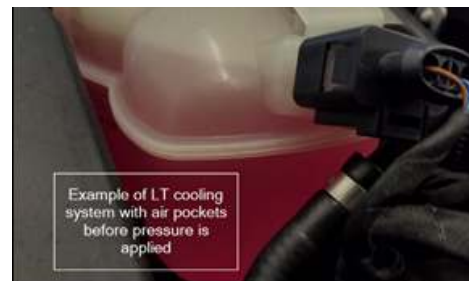
Figure 1

- 1) Check for air in the low temperature cooling system:
  - a) With the ignition off and the system cool, remove the cap of the low temperature cooling system reservoir. Observe and record the coolant level in the reservoir.
  - b) Pressurize the low temperature cooling system to 1.0 Bar using the cooling system pressure tester. Record the approximate amount the coolant level dropped when system is under pressure.
  - c) If there is no air in the system, the coolant level will only drop approximately 4 to 7 mm. (This will vary with factors such as system temperature.)
  - d) If while under pressure, the coolant level drops more than approximately 7 mm, there is likely air in the system and it needs to be bled. (See figures 1 and 2.)
