# Technical Service Bulletin

**CHECK ENGINE LIGHT ON WITH DTC P2610 AND P2507**

**Bulletin No.:** 01-012/18

**Last Issued:** 05/08/2018

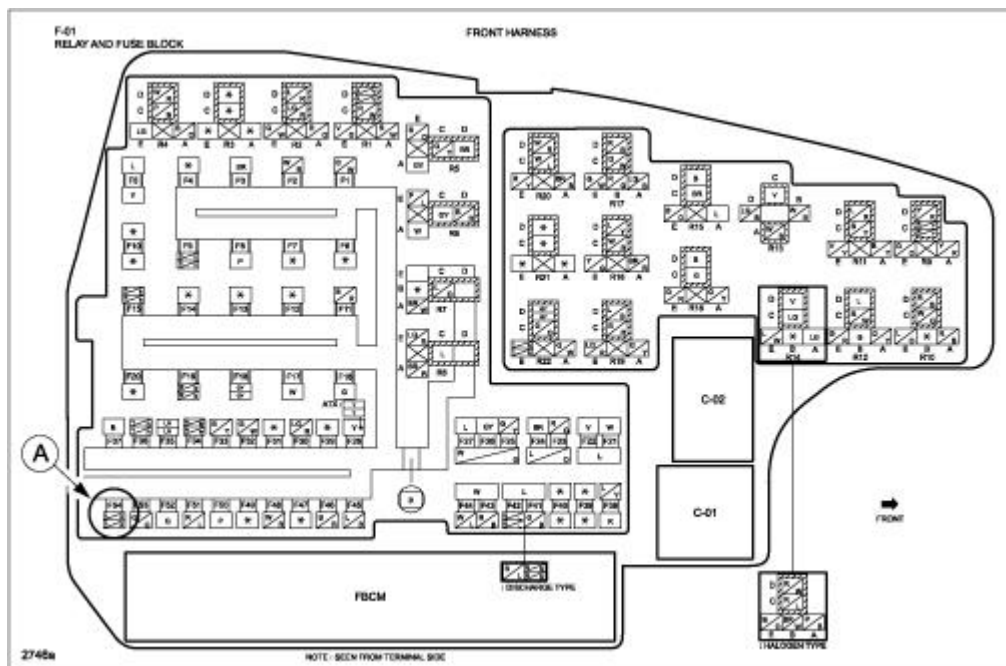
Some vehicles may experience the CHECK ENGINE LIGHT ON with DTC P2610 and P2507 stored in memory after engine start and room fuse 15A (A) removed.

As a past malfunction, the customer will not notice it (no warning light illuminated), but the DTC may be found during a vehicle service. P2507 in this situation is only applicable on 2016 and later models.

This is caused by the engine being started 3 or more times after a short duration of engine off (less than 15 seconds) with the room fuse removed.

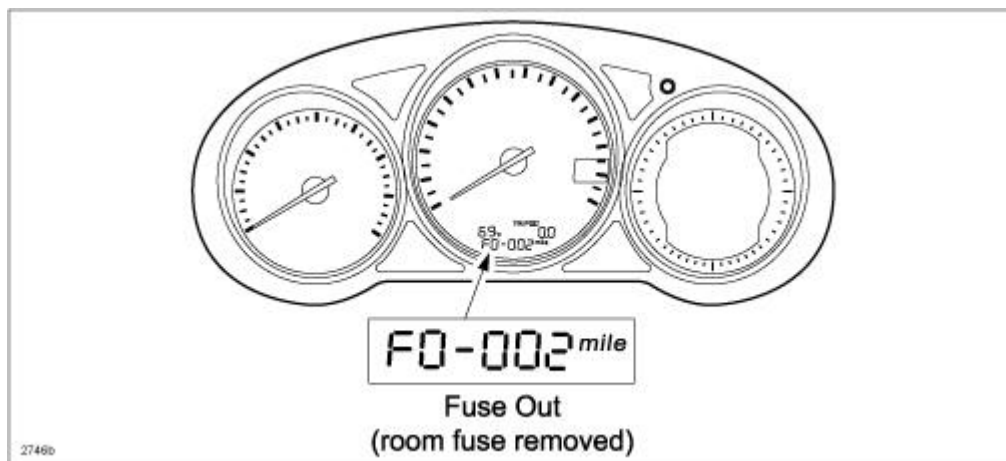
**NOTE:** The odometer will display "F0-002" during transport mode (room fuse 15A removed). Transport mode is canceled when room fuse 15A is installed or the vehicle odometer is more than 12.4mi (20km).
