# Service Alert

**ENGINE OIL DILUTED WITH FUEL CAUSES P0172:00**

**Service Alert No.:** SA-026/18

**APPLICABLE MODEL(S)/VINS**

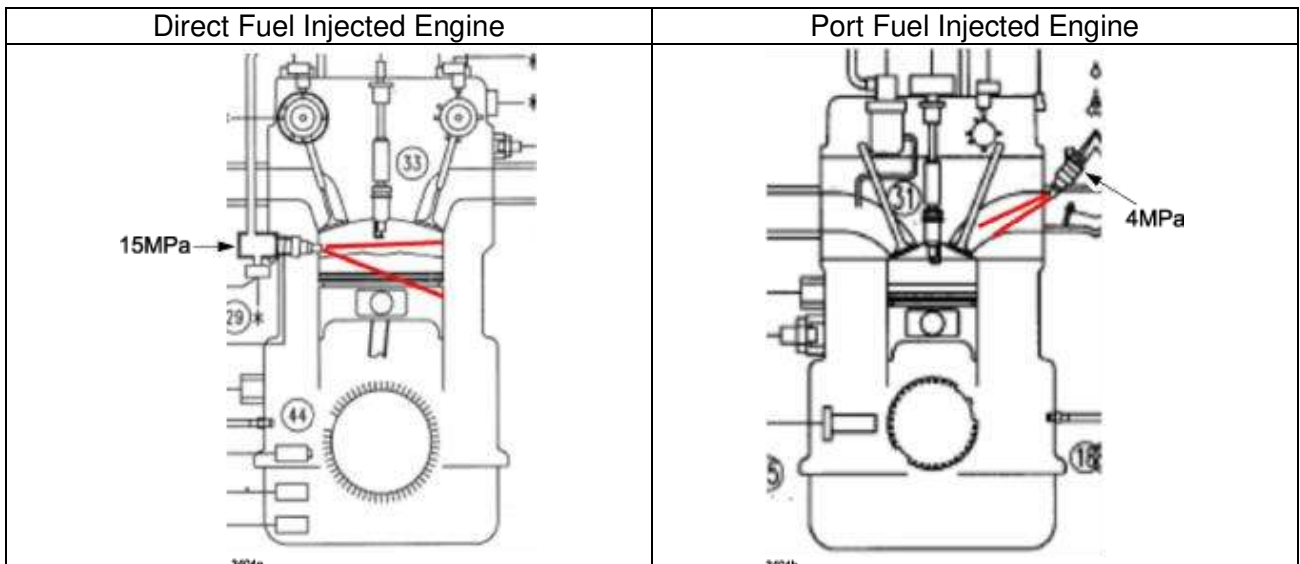
Newer direct fuel injected gasoline engines are designed such that high-pressurized fuel is injected directly into the combustion chamber, which may cause the fuel to adhere to the cylinder wall. The fuel is then scraped by the piston ring and flows down into the crankcase where it mixes with the engine oil, causing the engine oil to become diluted with fuel.

On an older port fuel injected gasoline engine, fuel is injected upstream of the intake valve, so it is unlikely fuel will adhere to the cylinder walls.

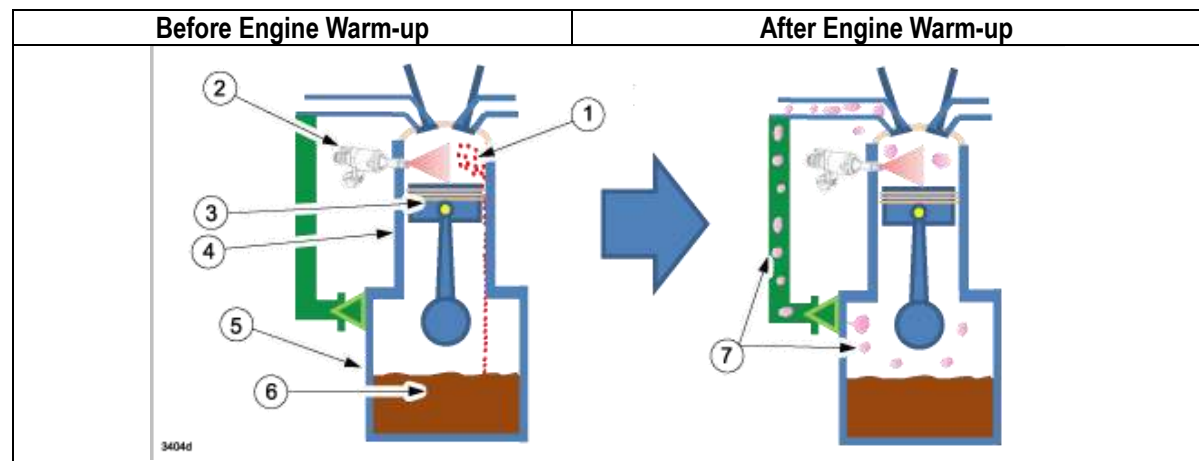
## Normal Engine Operation:

When the engine is not warmed up, fuel (1) from the fuel injector (2) flows down between the piston (3) and cylinder wall (4) and enters in the oil pan (5) mixing with the engine oil (6).

After the engine is warmed up, fuel content (7) in the engine oil evaporates from normal engine operating temperatures and the evaporated fuel is sucked into the combustion chamber and burned off. The amount of fuel injected by the fuel injectors is adjusted according to the amount of fuel evaporated from the engine oil and entering the combustion chamber.

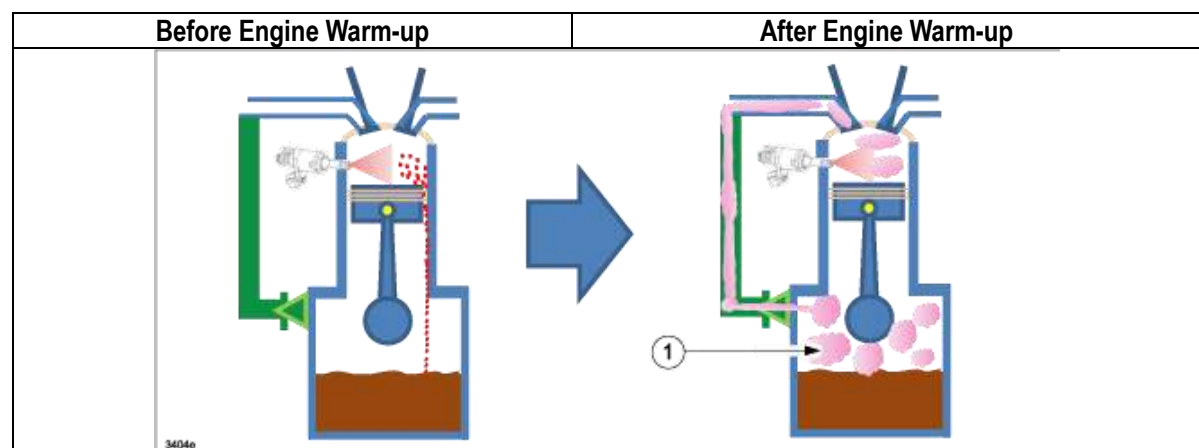
### 2. WHAT CAUSES IT

The vehicle is driven repeatedly where the engine never reaches normal operating temperature, then the vehicle is driven for a longer period of time and reaches normal operating temperature.

After the engine reaches normal operating temperature, a larger amount of fuel content (1) in the engine oil evaporates and is burned off in the combustion chamber and the amount of fuel evaporated exceeds the limit that the fuel injectors can adjust by changing the injection amount. In this case, the system turns on the Check Engine Light.

If a lot of extremely short trips are made where the engine is turned off while the low engine coolant temperature indicator light (Blue) is ON or within 5 minutes after the light turns OFF, the engine oil and filter will need to be changed more frequently. It is recommended to immediately check and replace the engine oil and filter when the Check Engine Light turns on.
