LTB01186NAS1

# TECHNICAL BULLETIN

303-01: Engine

Brake Vacuum Pipe Detached From Intake Manifold

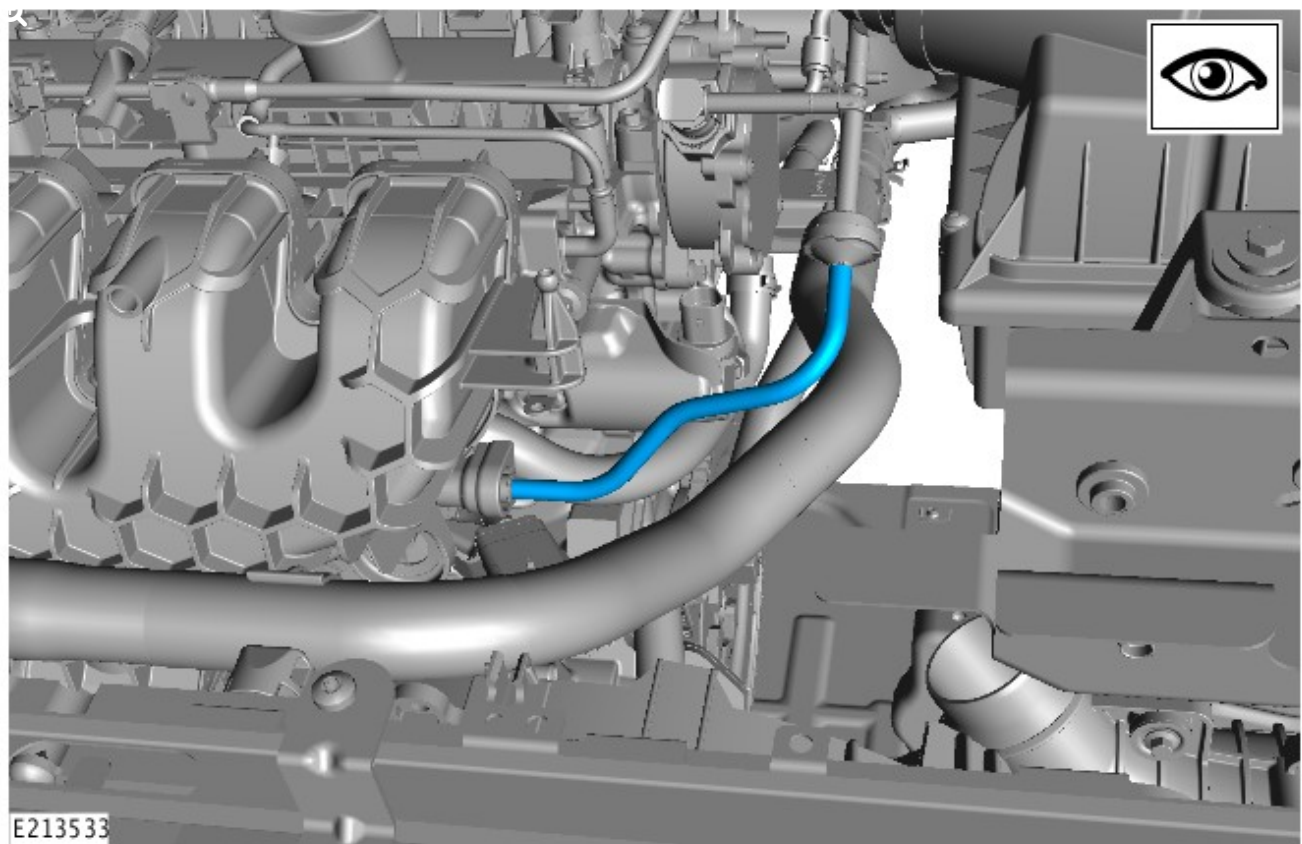
Inspect the brake booster vacuum pipe at the intake manifold.

- If the brake booster vacuum pipe is fully detached, **go to Step 4.**
- If the brake booster vacuum pipe is partially detached, fully detach the vacuum pipe from the intake manifold and then **go to Step 4.**
