# TECHNICAL BULLETIN

303-01: Engine

Intake Camshaft Variable Cam Timing Actuator - Component Failure

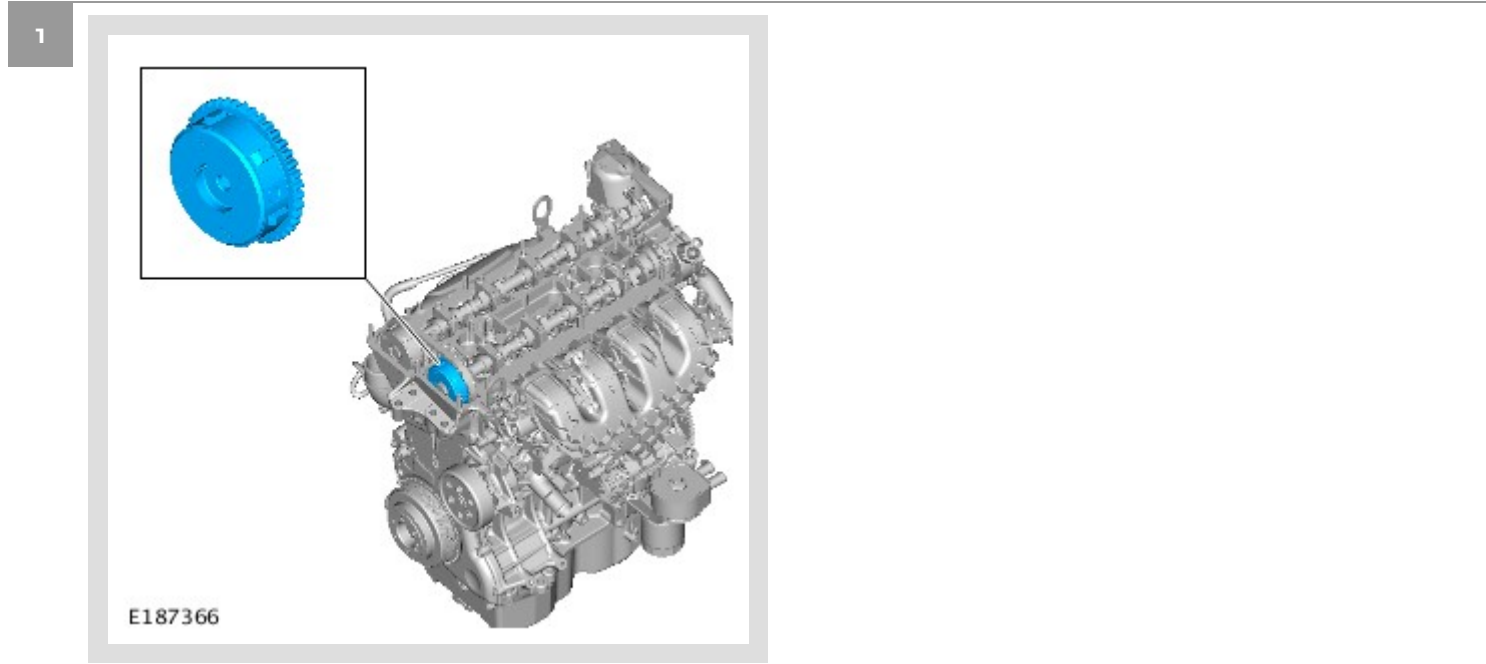
Intake camshaft Variable Camshaft Timing (VCT) actuator location.

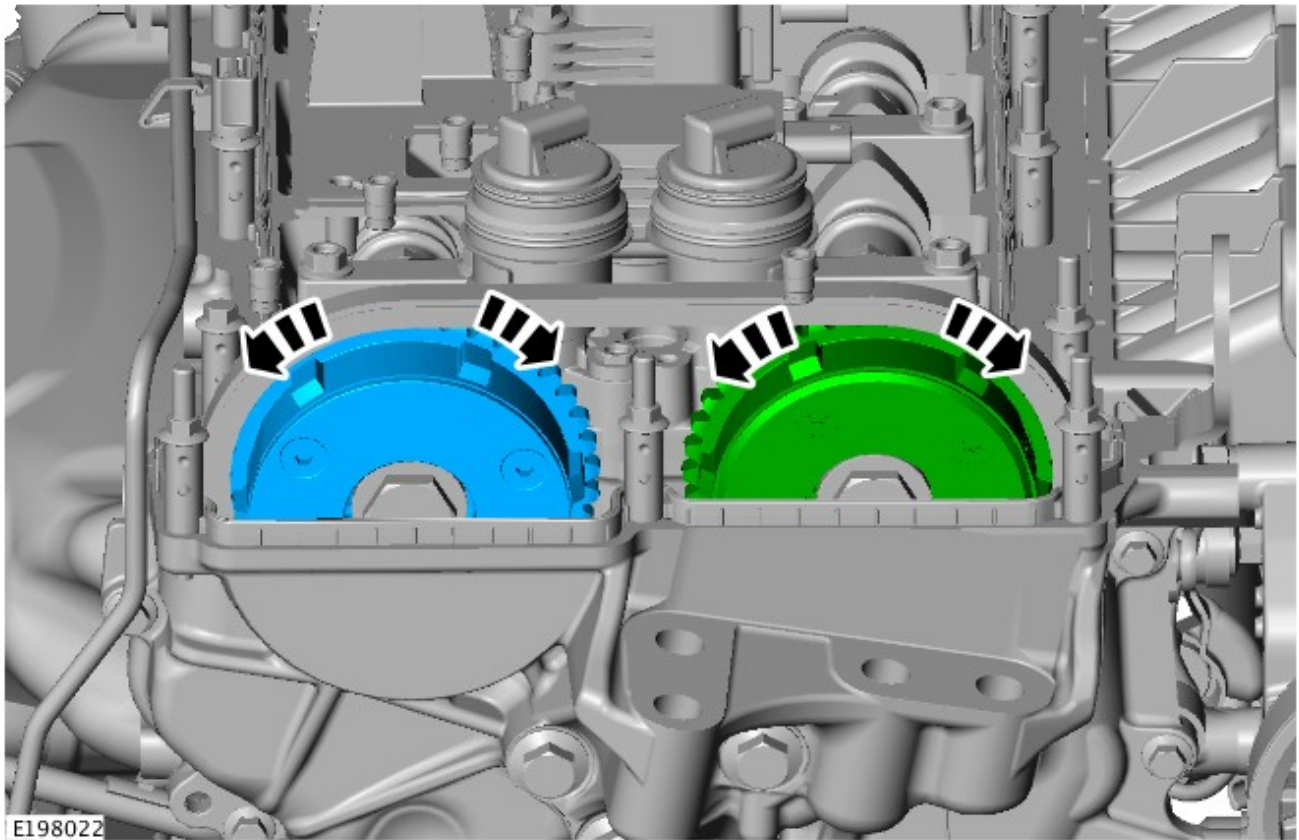
The exhaust camshaft Variable Camshaft Timing (VCT) actuator unit (shown in blue) has restricted movement when turned. The intake camshaft VCT unit (shown in green) has a less restricted movement when turned.

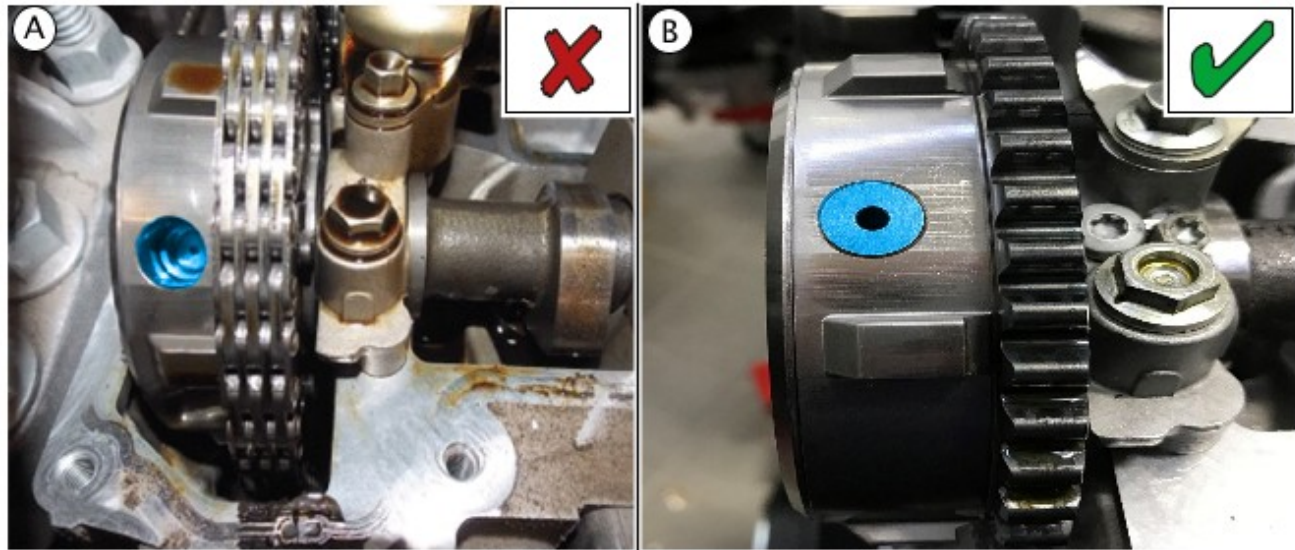
E186694

This may be caused by the 'stopper' in the intake camshaft Variable Cam Timing (VCT) actuator becoming detached, leading to the VCT actuator not functioning.

Inspect the Variable Camshaft Timing (VCT) actuator 'stopper' as shown.

- 1 If the 'stopper' is detached **(A)**, go to Step 4.
- 2 If the VCT actuator is found to be noisy but the 'stopper' is in place **(B)**, go to Step 3.

- 4 Replace the VCT actuator (see Workshop Manual section 303-01: Engine - GTDi 2.0L Petrol - Removal and Installation - Variable Camshaft Timing Actuator).

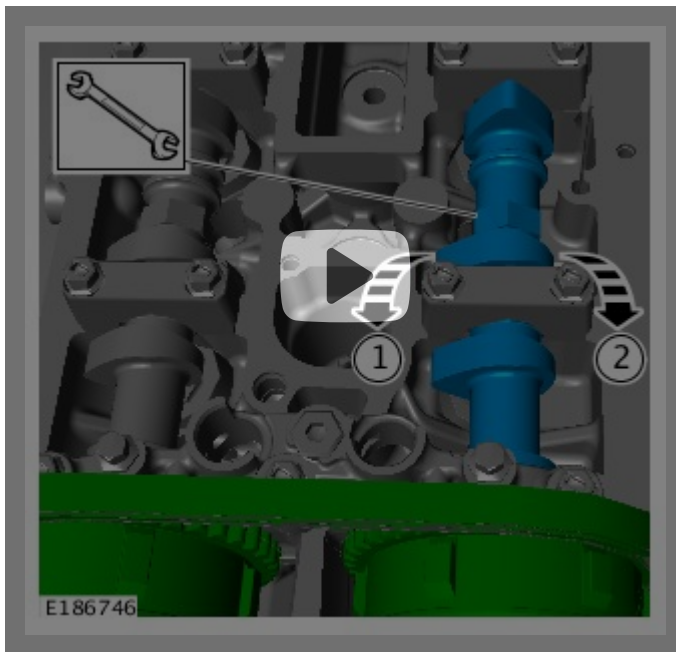
Fully rotate the camshaft anti-clockwise and then attempt to rotate the camshaft clockwise.

- If no clockwise movement is possible without also rotating the engine, do not continue with this Technical Bulletin.
  - Continue to diagnose the customer concern (see TOPIx Workshop Manual section: 303-1 - Engine - GTDi 2.0L Petrol - Diagnosis and Testing).
- If the camshaft rotates freely in both directions, go to Step 4.
