Preliminary Information

PIP5498J SES Lamp P050D P0300 Setting On A Cold Start And/Or a Run Rough Warm with No codes

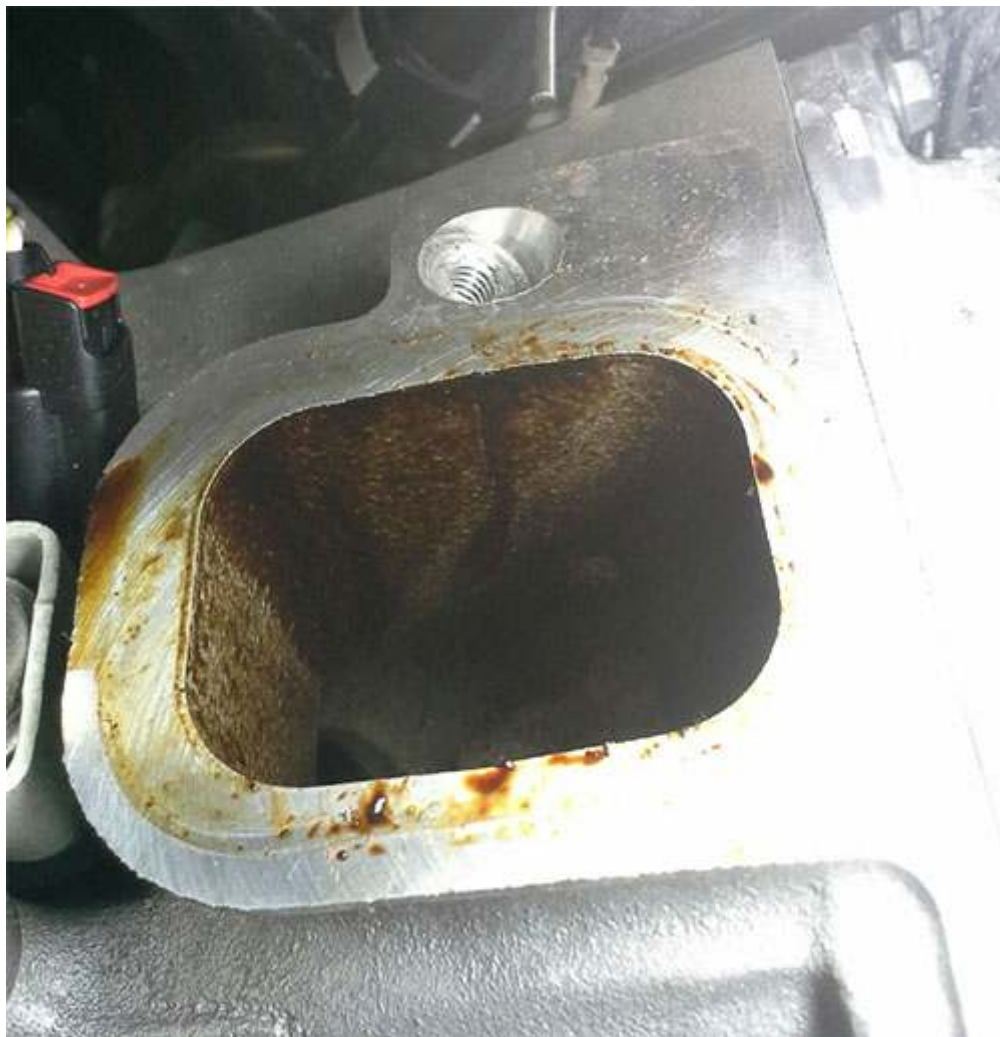
If the head casting line is the concern the intake port will be wet with a coolant oil mix.

This could be the cause of a running rough warm concern with or without codes.

The location of where the coolant is running down in the port will also look washed down.

If this is found the cylinder head will need to be replaced.
