# Preliminary Information

## PIP5498K SES Lamp P050D P0300 Setting On A Cold Start And/Or a Run Rough Warm with No codes

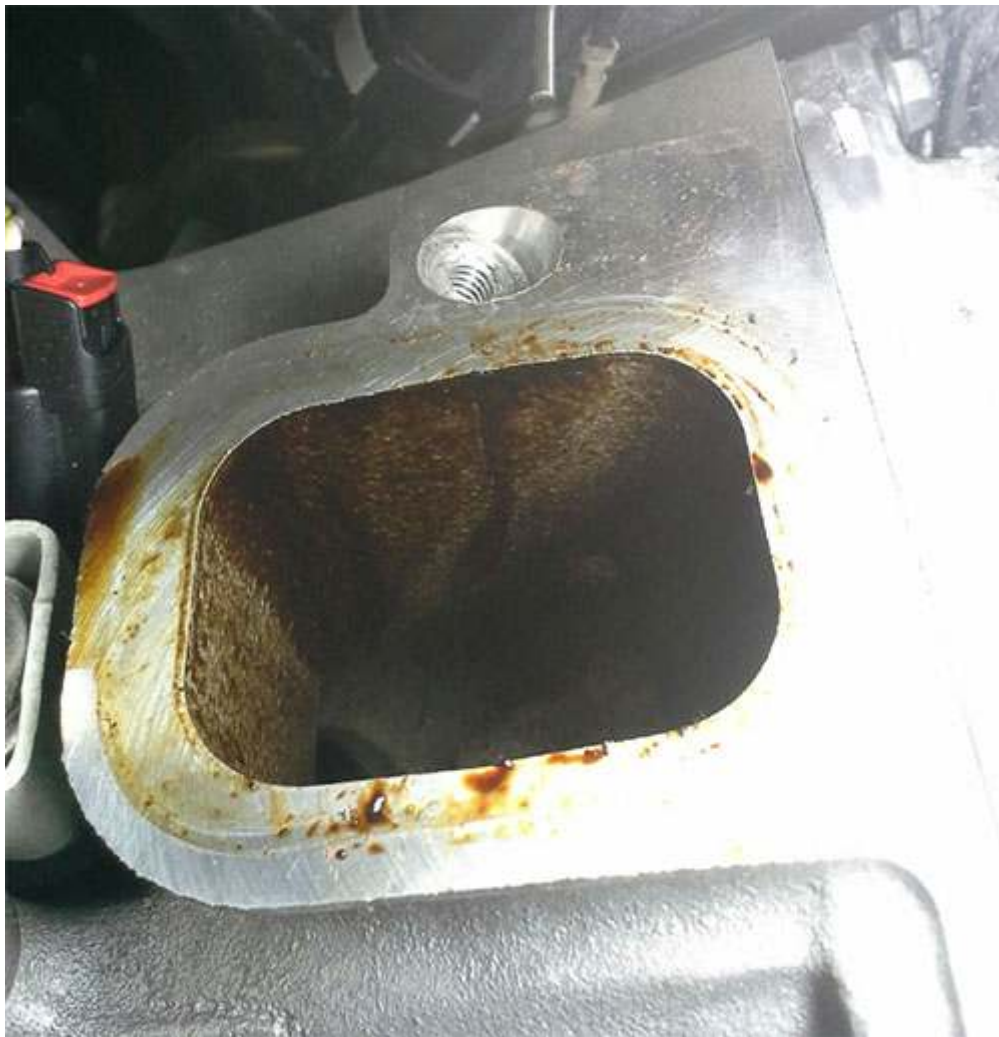
If the head casting line is the concern the intake port will be wet with a coolant oil mix.

This could be the cause of a running rough warm concern with or without codes.

The location of where the coolant is running down in the port will also look washed down.

If this is found the cylinder head will need to be replaced.
