# Preliminary Information

## PIP5335B SES Lamp With Camshaft Position Codes P0340 and/or P0341

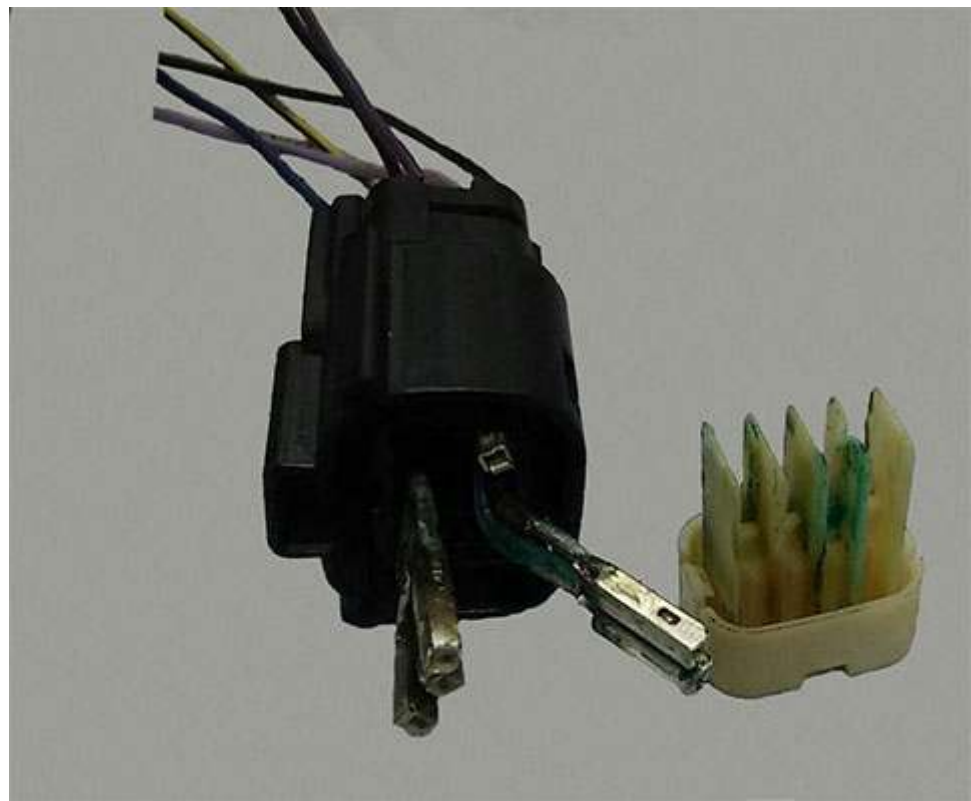
A vehicle may be setting DTC's P0340 and P0341 at times

If normal SI Diagnostics does not isolate the concern, inspect for corrosion in connector X154 or X159 (2015 only) located on the front cover next to the vacuum pump.

See the illustration below

If this condition is encountered repair as needed.

For wiring repairs covered under warranty, please refer to latest version of bulletin [10-00-89-005](#) for warranty information on wire/connector repairs.
