Preliminary Information

PIT5535C Service Front Camera / Service Lane Departure Warning / Service Lane Keep Assist Message with DTC B1008 SYM4B / IntelliBeam Headlight / Windshield Wind Rush Noise

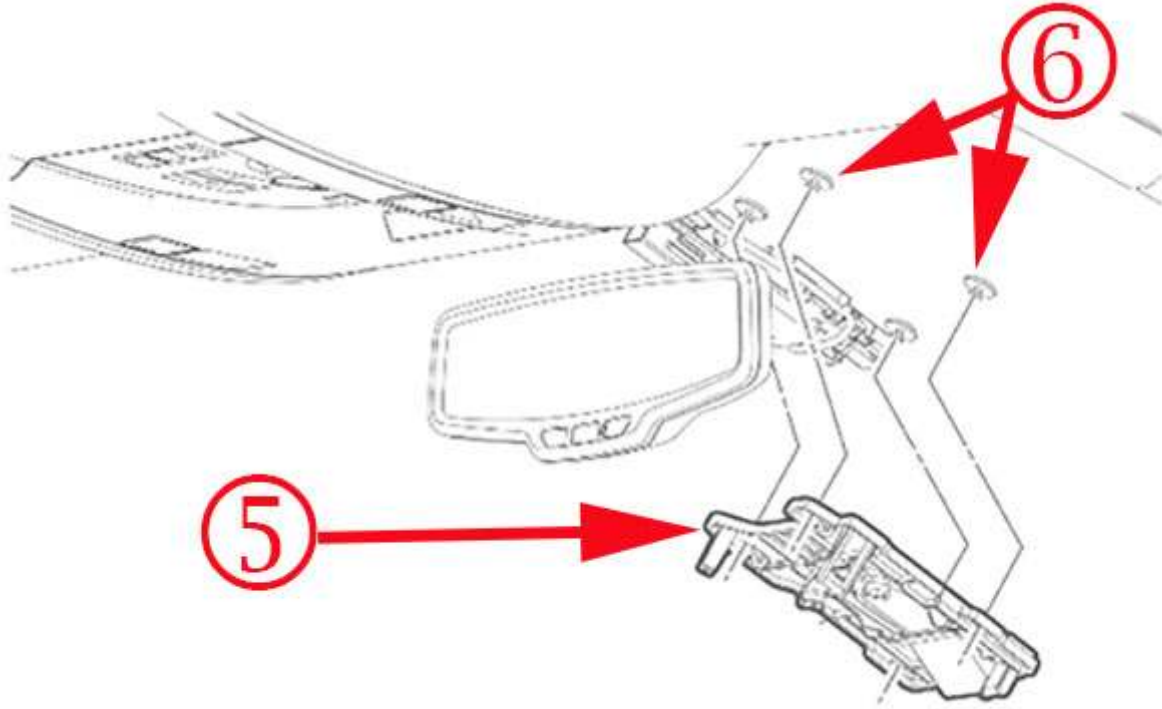
| Cause | This is caused when the front view camera module has determined that it is not properly mounted and/or there is a blockage of its view. |

- **Verify the front view camera module bracket (5) is fully seated down and secured on the windshield pins (6), shown below.**

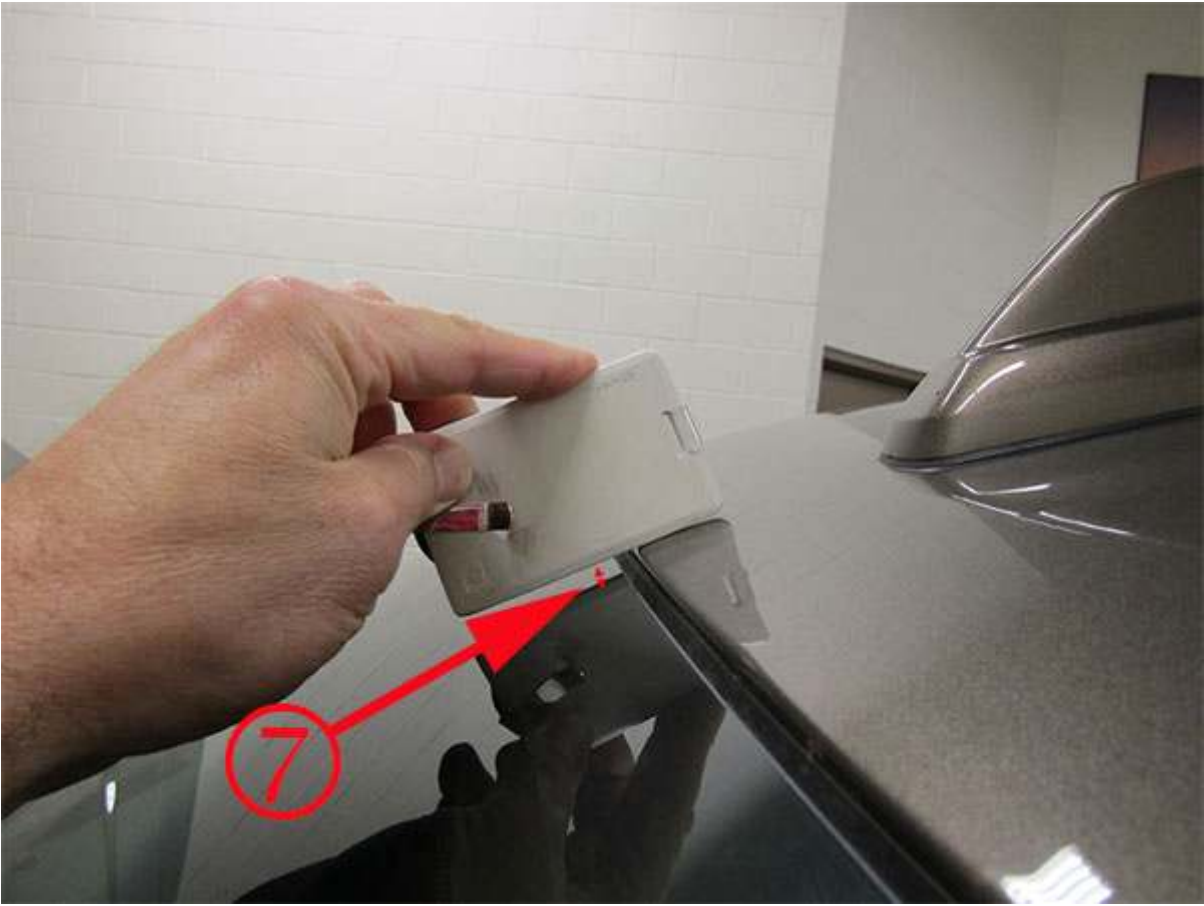
Also, inspect to make sure the windshield is sub-flush to the roof sheet metal (7), as shown below. If the windshield is proud of the roof sheet it could indicate:

- The old urethane adhesive bead was not cut low enough and left excessively thick.
- Windshield alignment/locating pin(s) are not fully in the alignment hole(s).
- During windshield installation it was not firmly pressed around the entire outside edge in order to wet-out the urethane adhesive bead.
- The urethane adhesive bead dried before the windshield was installed.

**NOTE: A windshield proud of the roof sheet metal could cause excessive wind noise.**

Either of these windshield mounting issues could cause the camera to be misaligned and

unable to complete the learn.

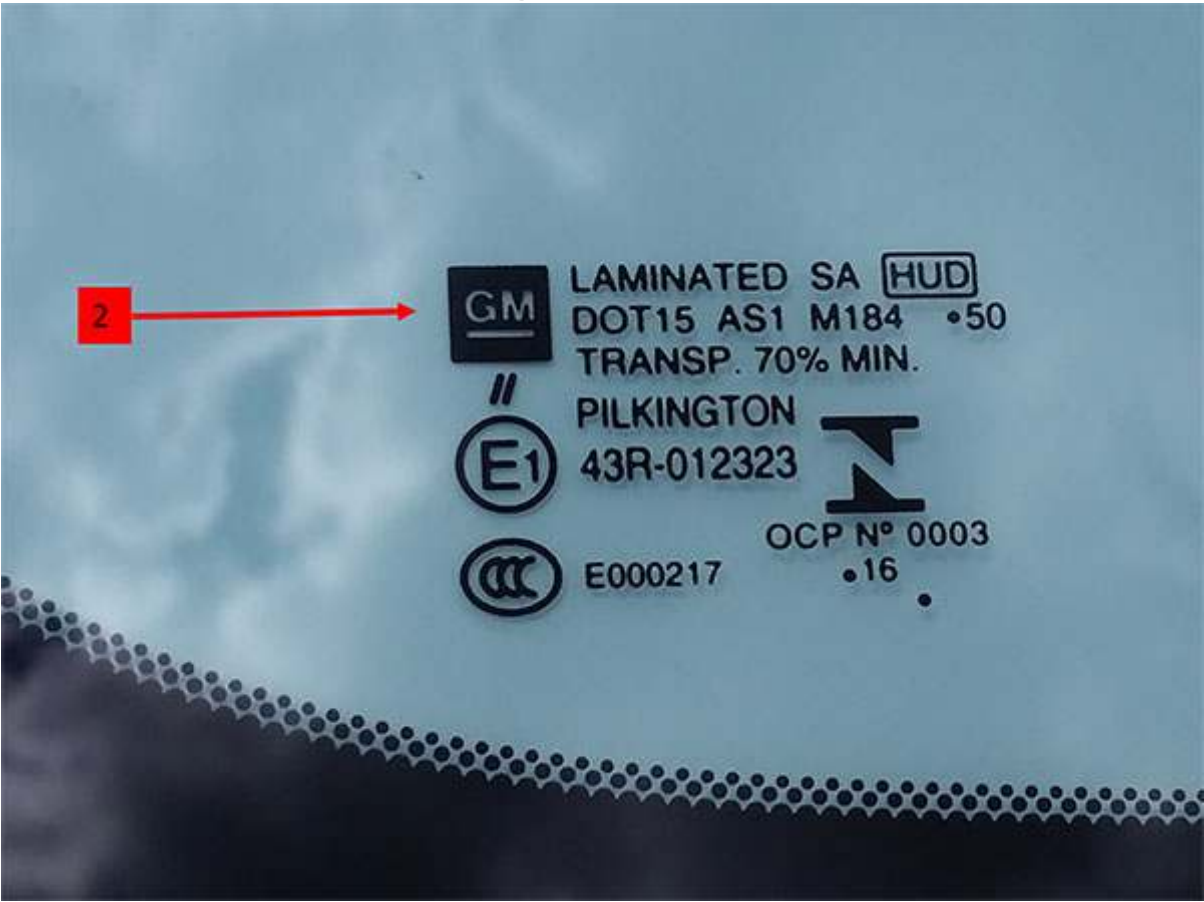
- If, after performing the checks listed above and the root cause of the camera not completing the calibration/learn is still not found, inspect for an aftermarket windshield being installed in the vehicle. To determine whether or not the windshield is an aftermarket or factory windshield, inspect for the "GM" Logo in the lower right corner of windshield, as shown below (2). If the "GM" Logo is not present, then the windshield is aftermarket.
