Preliminary Information

PIP5402D Check Engine Light MIL P015B, P1101 and /or P0101  
Reduce Engine Power

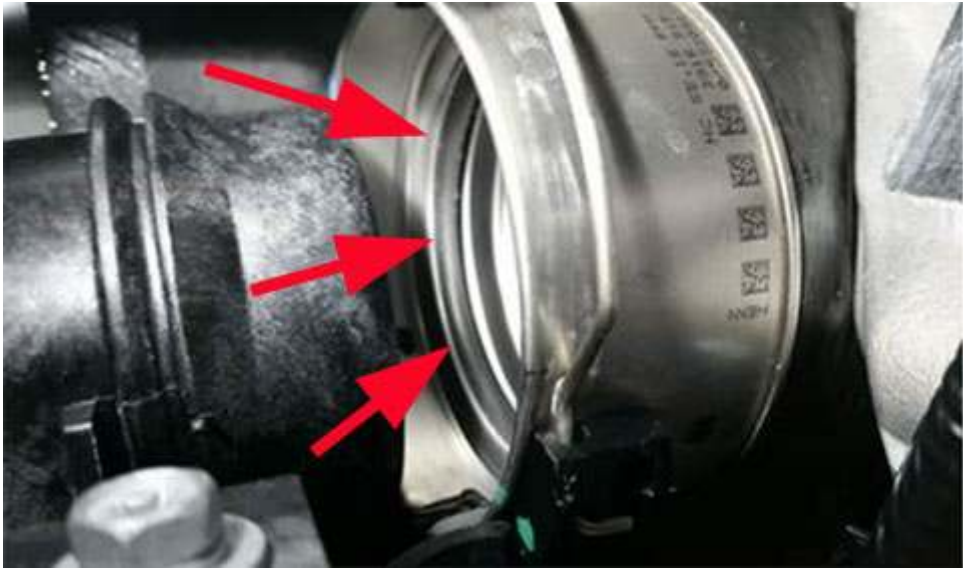
This coupler is located on the passenger side of the charge air cooler where the air duct slips into it.

The arrows in the picture below are pointing to the O-ring seal being discussed.

The picture below is from an ATS. Other models are similar.

After following normal SI diagnostics, if a solution is not found, inspect for a missing/damaged O-ring seal in the charge air cooler coupler.
