# Technical Service Bulletin

**ENGINE MISFIRE DURING ACCELERATION WITH CHECK ENGINE  
LIGHT FLASHING AND DTCs P0302:00, P0303:00 AND/OR U0401:00**

**Bulletin No.:** 01-010/18

2016-2017 CX-9 vehicles with VINs lower than JM3TC\*\*\*\*\*135222 (produced before Dec. 27, 2016)

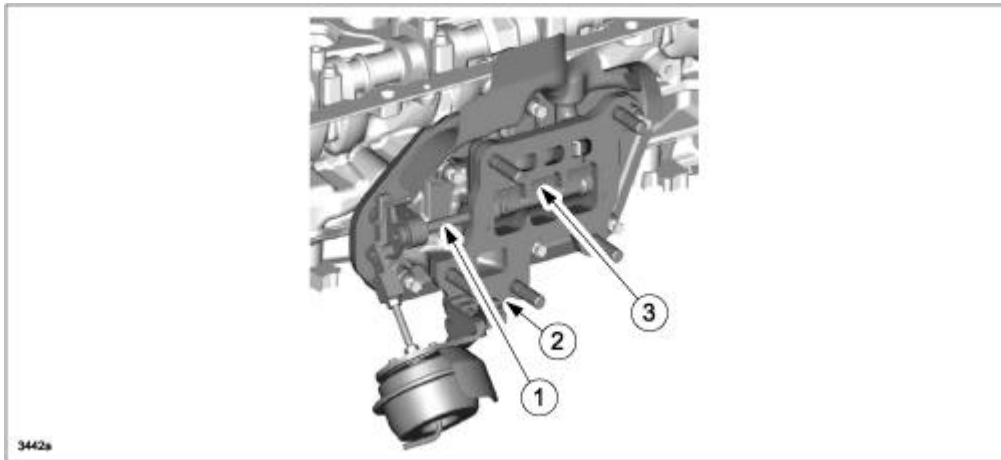
This concern may be caused if the exhaust manifold variable valve shaft (1) is out of alignment and/or the exhaust manifold variable valve housing (2) is out of shape. The exhaust manifold variable valve (3) then interferes with the housing and becomes stuck closed when the engine is hot.

To eliminate this concern in the future, the production processes and controls have been improved.

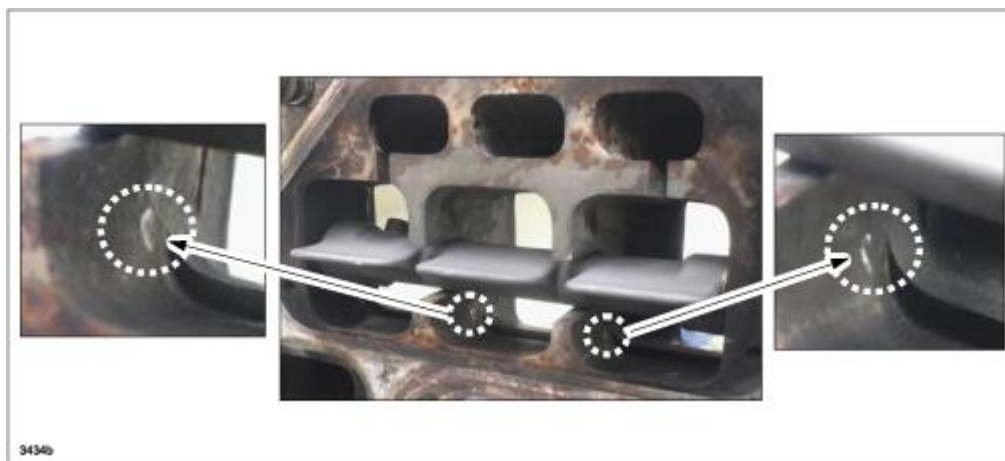
2. If one or both of the above conditions are met, remove the exhaust manifold and verify that there are contact mark(s) on the exhaust manifold variable housing caused by the variable valve, as shown below.

3. If contact mark(s) are found, replace the exhaust manifold with a modified one according to the instructions on MGSS online (EXHAUST SYSTEM REMOVAL/INSTALLATION [SKYACTIV-G 2.5T]).

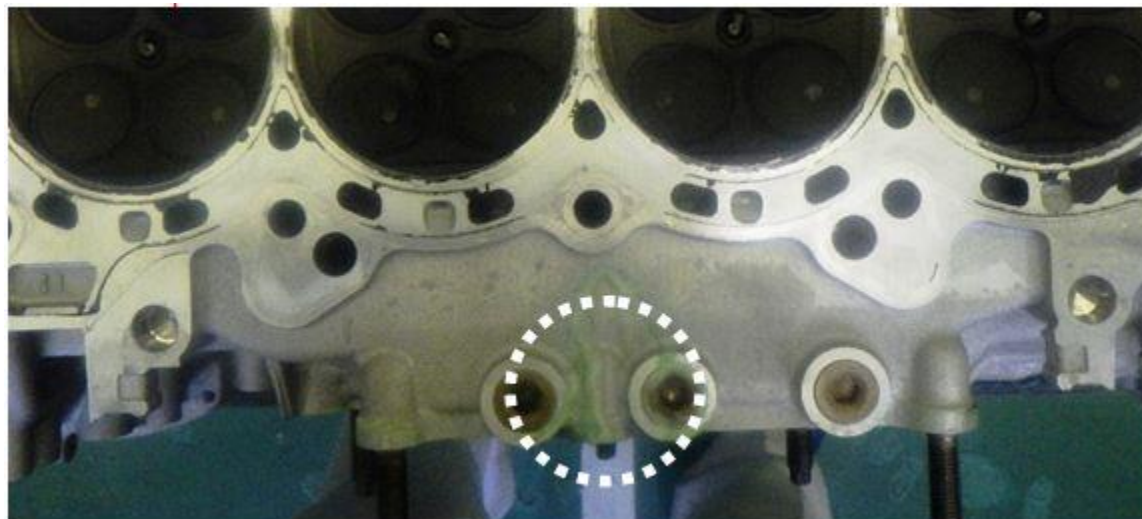
(TOP VIEW)

**CAUTION:** When tightening nuts, do not allow the stud bolt to rotate over 270 degrees, otherwise, it could cause the cylinder head to crack, as shown below. If cylinder head is cracked, replace it with a new one.

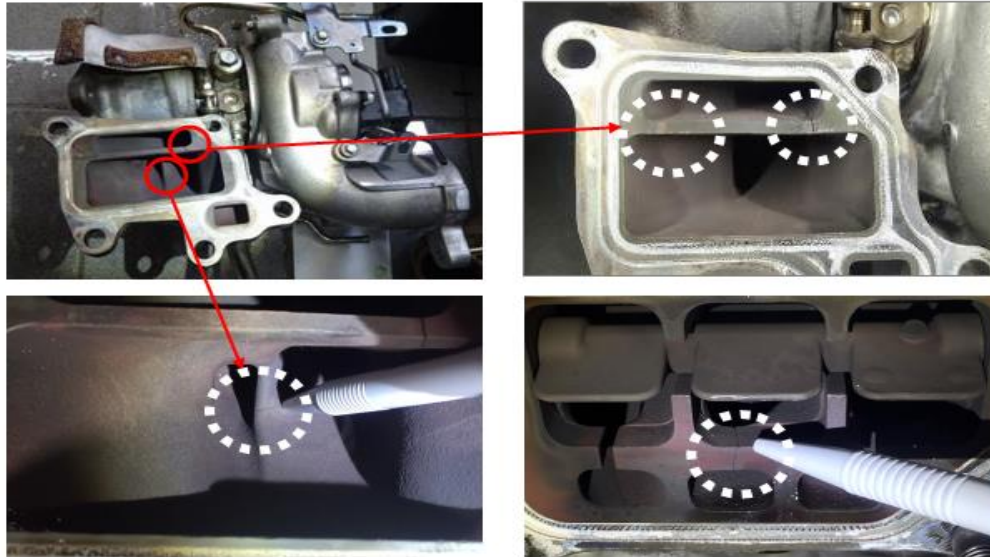
**NOTE:** There may be a crack found in the turbocharger housing and/or exhaust manifold variable housing, as shown below. These cracks do not affect engine performance, NVH or durability, so turbocharger replacement is not necessary.
