Preliminary Information

PIP5468F Check Engine Light On with Leaks in the Charge Air Cooler System.

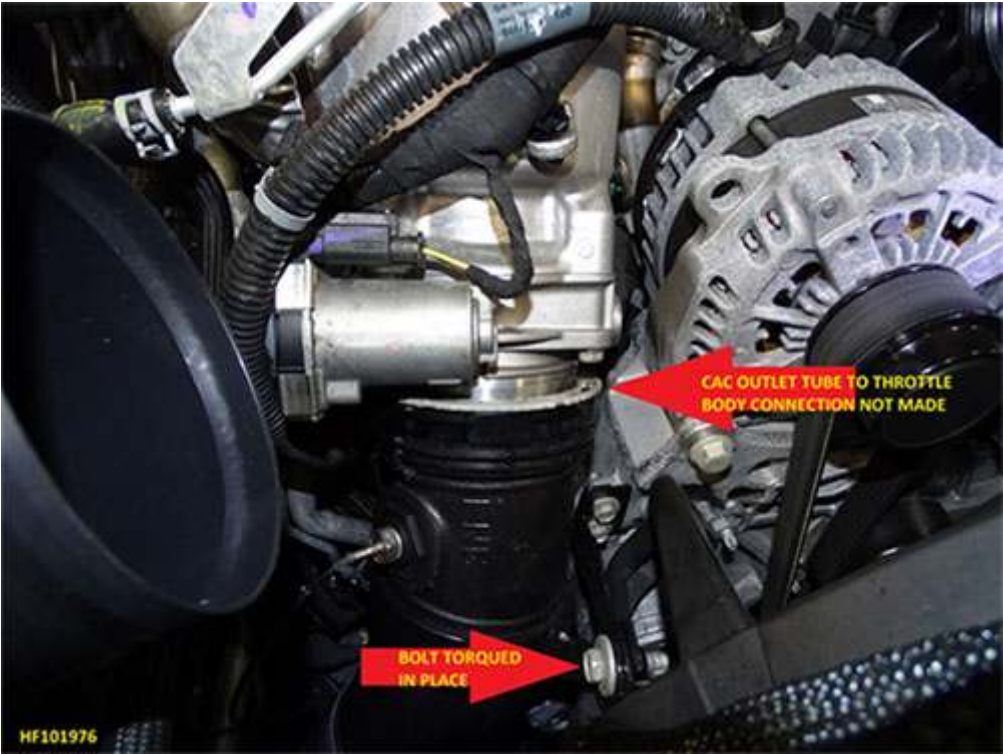
Check for non-secured connection of the charged air cooler pipe at the intake air flow valve (throttle body).  
Check for proper alignment of the charged air cooler pipe bracket and bolt hole.

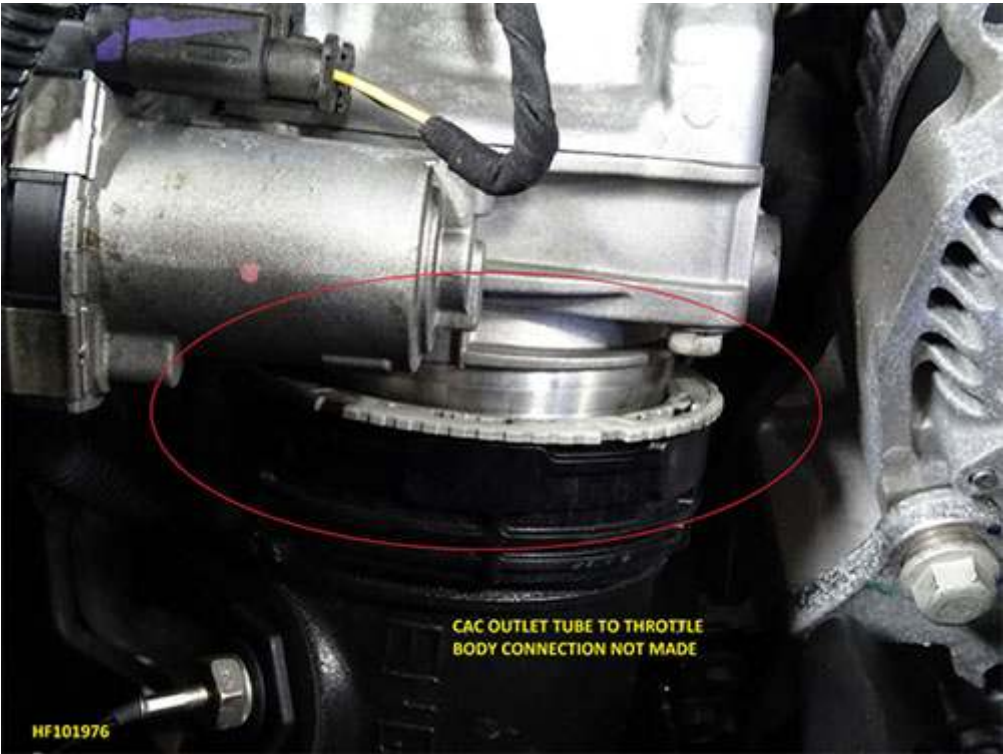
Non-secured connection.

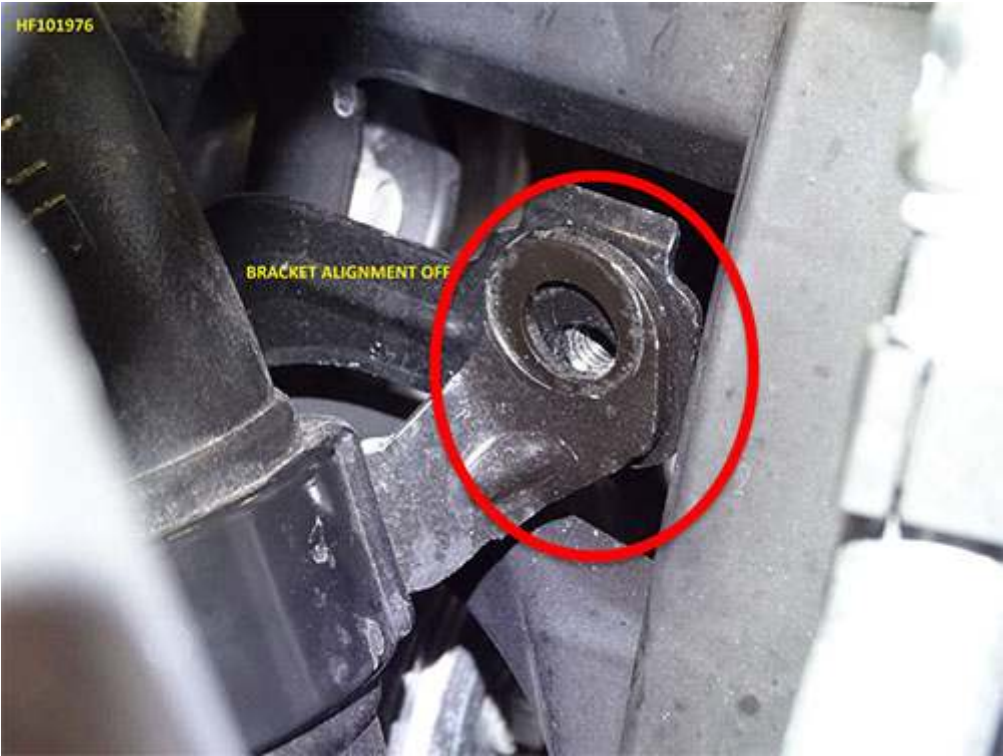
Mis-aligned charged air cooler pipe bracket and bolt hole after the charge air cooler outlet hose is connected properly to the throttle body.
