Preliminary Information

PIP3423P DTC P0016 P0017 P0018 P0019 P0008 P0009

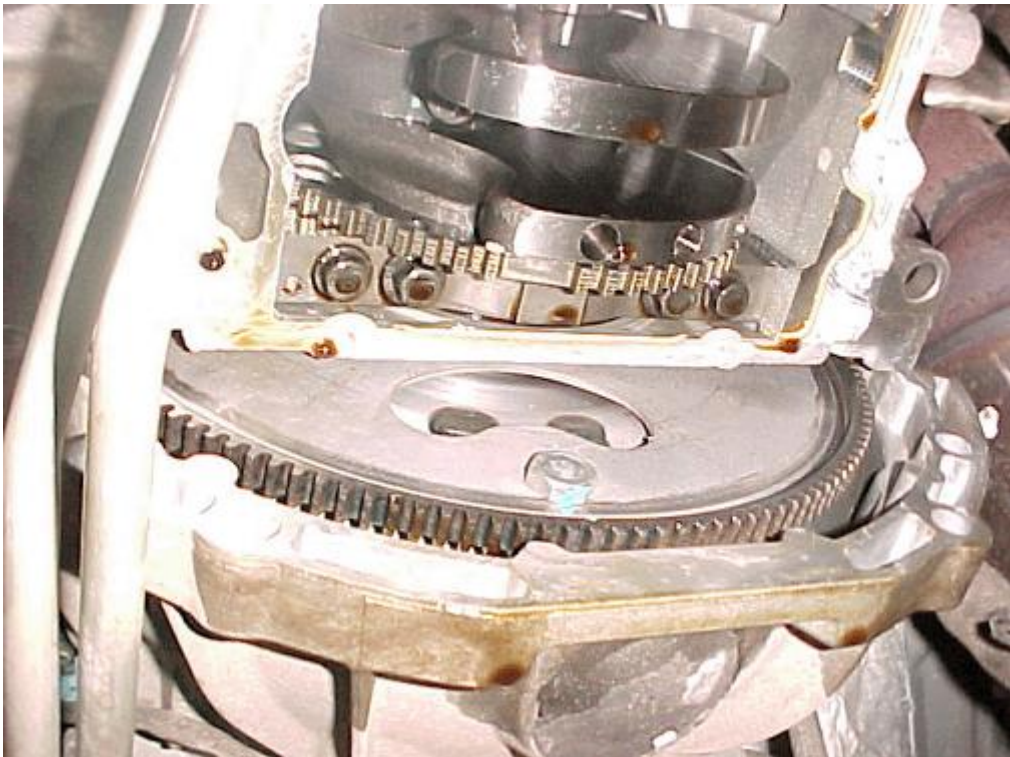
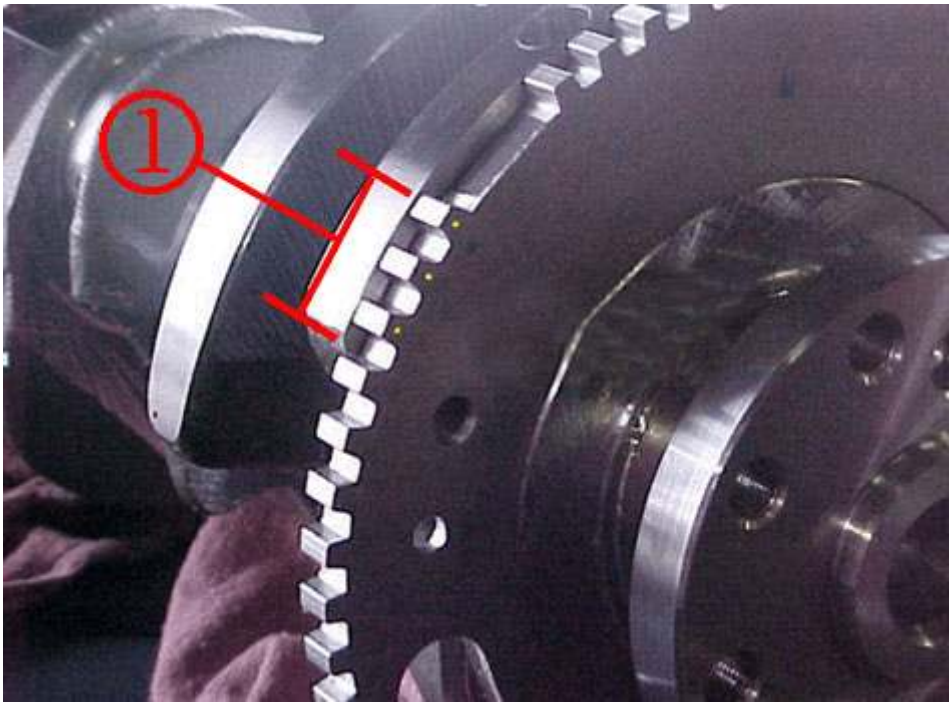
The reluctor for the crankshaft sensor pressed onto the rear of the crankshaft may have moved.

1= The actual measurement of a good Reluctor wheel.

25 to 26 mm This measurement is from the end of the machined surface of the crankshaft throw to the edge of the open space in the reluctor. (approximately 3 1/2 teeth)

If the reluctor has moved then replace crankshaft.

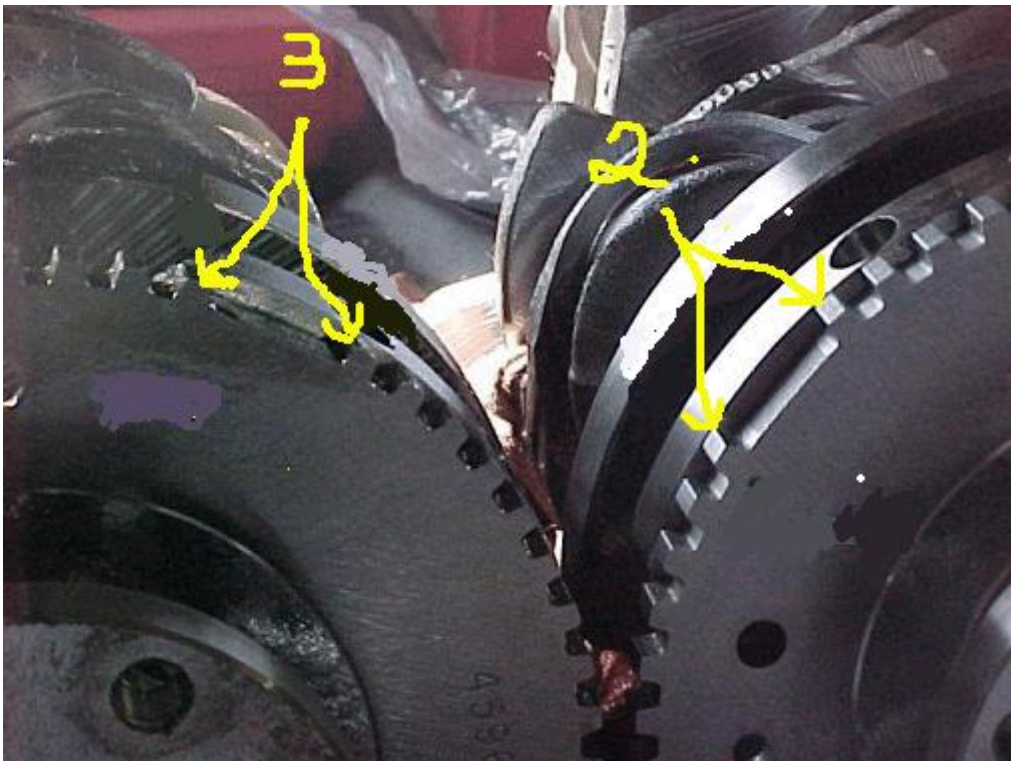
2 and 3 = Show a good reluctor next to a bad reluctor.

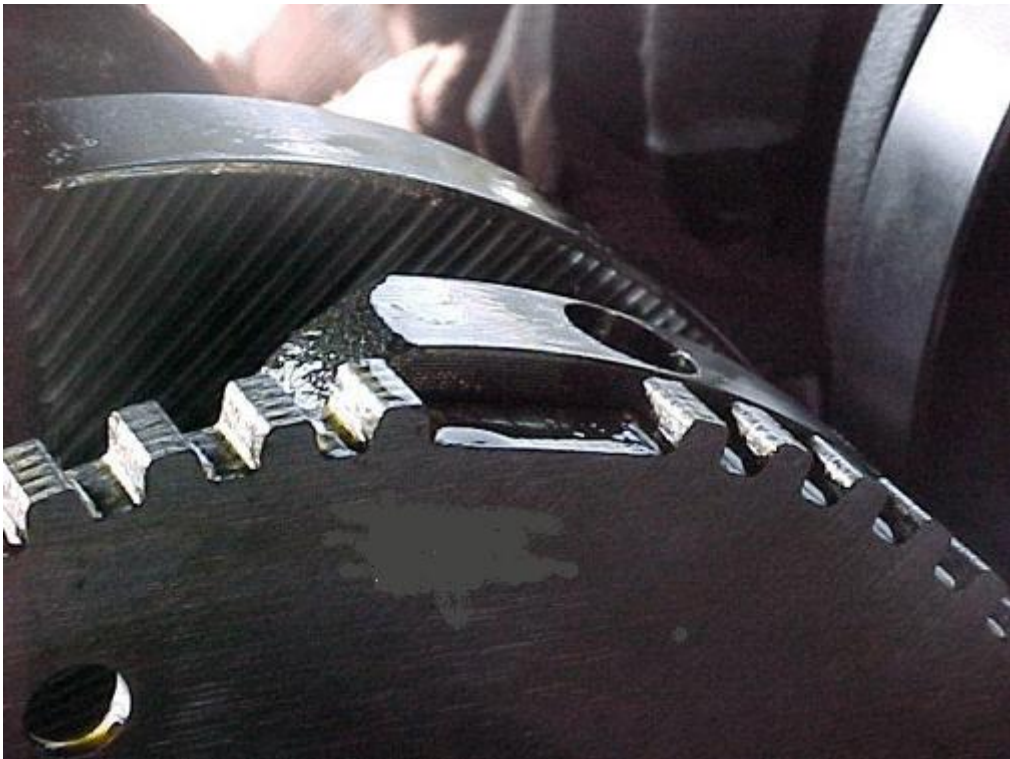
Crankshaft with bad reluctor wheel.

**NOTE:** The distance can be offset either clockwise or counter clockwise. Both will result in these codes.

**NOTE:** The balance hole does not come into play when determining if the reluctor has slipped or not.
