# Preliminary Information

## PIP5557C Intermittently Vehicle May Not Go Above 30 MPH Stuck In 2nd Gear Will Not Upshift MIL On DTC P2821 Set

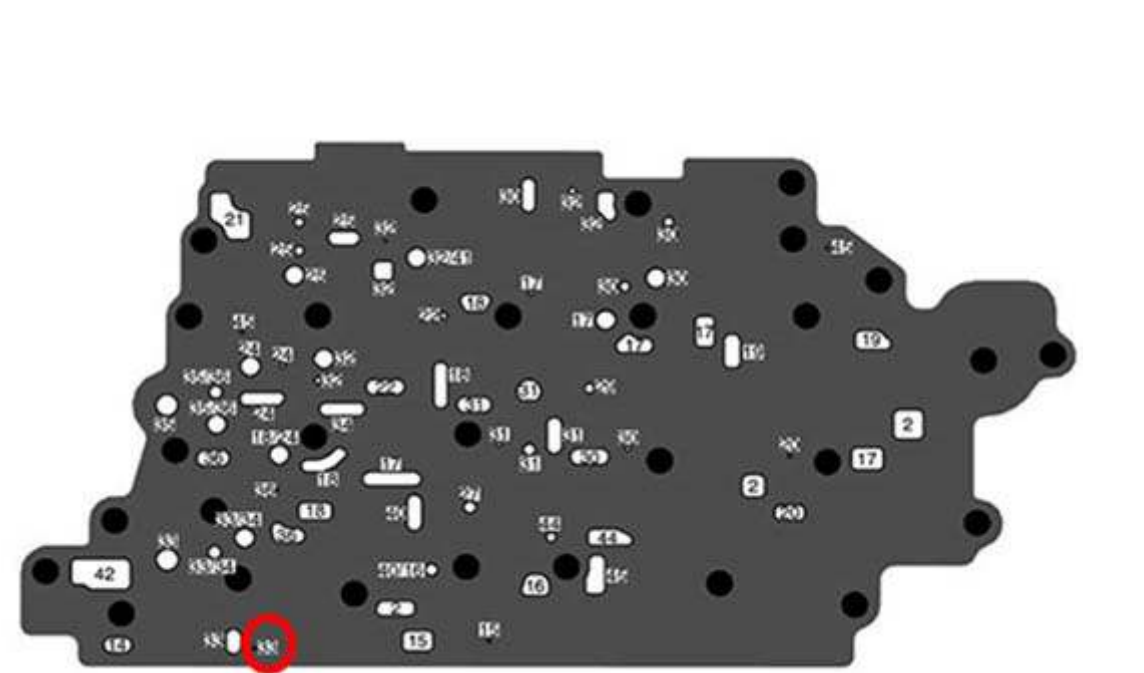
If the diagnostics procedures have found no conditions that set the codes, inspect the Control Valve Body spacer plate Orifice #33 for blockage.

**Note :** This spacer plate is between the trans assembly case and the valve body assembly, item #456, using SI #4368440.

**NOTE:** Since the hole is only 0.5 mm in diameter the best way to inspect is to shine a light

from behind the spacer plate and look for the light through the hole.

If the orifice is blocked, replace the spacer plate with a new one.

**Note :** If the spacer plate is to be replaced, refer to TSB 18-NA-121 as the spacer plate and TCM update as per the TSB must be performed at the same time.
