Preliminary Information

PIP5472E Short Duration Misfire - Rough Idle - MIL On During Cold Start - P050D

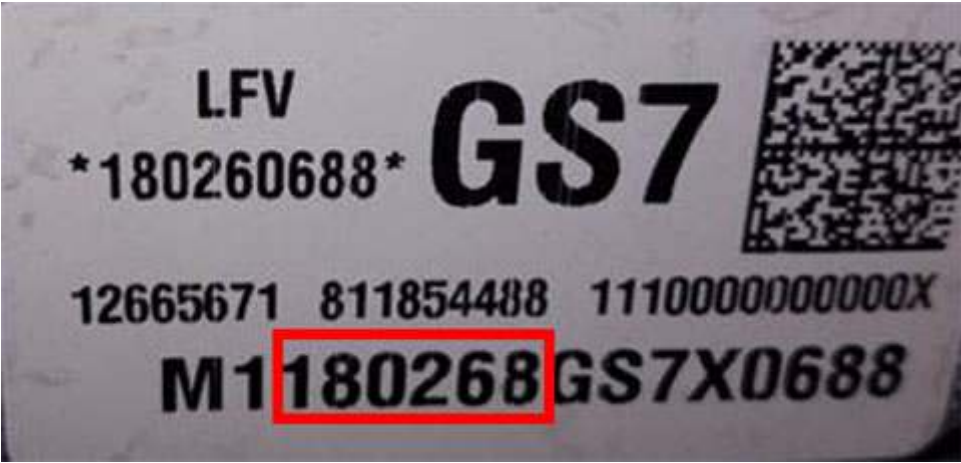
Example Engine Unit Number:

The engine Unit Number Label is located on the engine front cover.

The first digit = engine plant.

The second digit reflects the shift, in this case 1 = First Shift

The third and fourth digits reflect the model year, in this case 18 = 2018

The fourth, fifth and sixth digits reflect the day of that calendar year 026 = 26<sup>th</sup> day of 2018 calendar year (build date)

If the engine you are working on was built on or after 17135, the SHLA's (Stationary Hydraulic Lash Adjuster) should not be replaced for this concern.

If the engine you are working on was built before 17135, then replace all Exhaust SHLA's. (Stationary Hydraulic Lash Adjuster)
