# Technical Service Bulletin

## 91 SOS warning displayed in instrument cluster, DTC B191604

91 18 02 2051664/1 June 26, 2018.

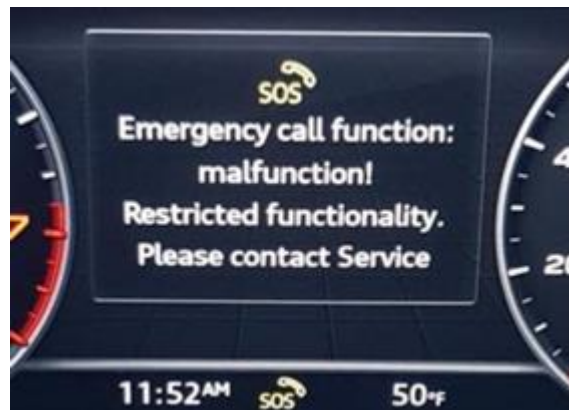
- A warning message appears on the instrument cluster. The message reads "Emergency call function: malfunction! Restricted functionality. Please contact Service" (Figure 1).

**Figure 1.** Warning message shown in instrument cluster.

- DTC B191604** (Backup battery Faulty).

Incorrect software parameter for the connected Gateway's back-up battery charge monitoring. The system must be reset by performing a manual discharge of the connected Gateway's backup-battery.

1. Perform a manual discharge of the connected gateway's back-up battery by removing constant power (KL30) and accessory power (KL15), while KL15 is switched on.

In the event that fault does not clear, and is marked as Active, then replace the connected gateway's backup battery. Consult the repair manual for instructions on replacing the connected gateway's backup battery. Consult the parts catalog for the correct part number of the connected gateway's backup battery.

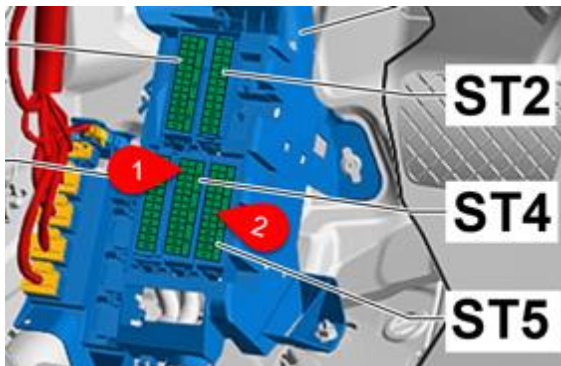
**Figure 2.** Q7 Driver's Side Footwell Fuse Box. 1: KL15 Fuse. 2: KL30 Fuse.

| Model | Fuse Number | Panel | Location | Fuse Number | Panel | Location |
|---|---|---|---|---|---|---|
| Q7 | SB7 | ST5 | Figure 2.2 | SB2 | ST4 | Figure 2.1 |

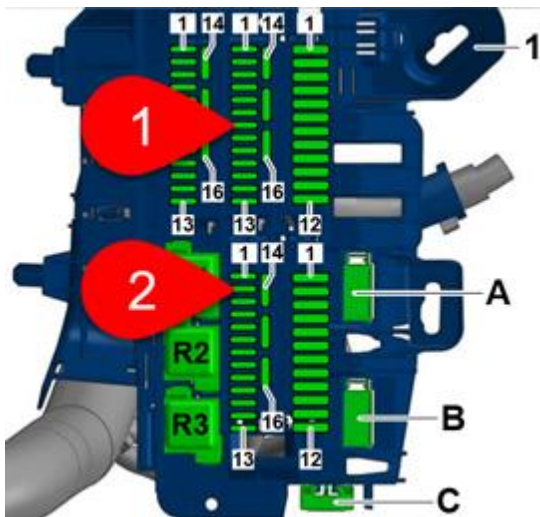
**Figure 3.** A4, A5, and Q5 Driver's Side Footwell Fuse Box. 1: KL30 Fuse. 2: KL15 Fuse.

| Model | Fuse Number | Panel | Location | Fuse Number | Panel | Location |
|---|---|---|---|---|---|---|
| Q5 | SB7 | ST2 | Figure 3.1 | SB2 | ST4 | Figure 3.2 |
| A4 | SB7 | ST2 | Figure 3.1 | SB2 | ST4 | Figure 3.2 |
| A5 | SB7 | ST2 | Figure 3.1 | SB2 | ST4 | Figure 3.2 |
