# Technical Service Bulletin

## 01 MIL on, DTC P045600 stored in the ECM; small EVAP leak

01 18 69 2044156/4 May 10, 2018. Supersedes Technical Service Bulletin Group 01 number 16-74 dated August 18, 2016 for reasons listed below.

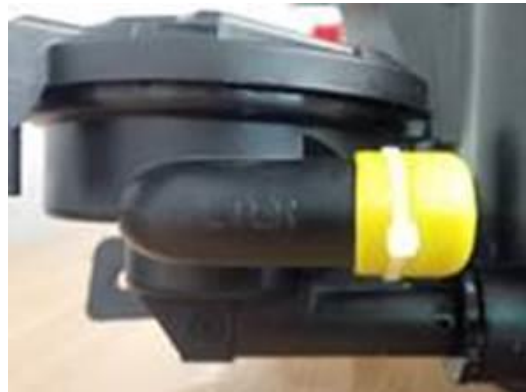
**Figure 1.** Block the filter port on the NVLD sensor.

1. Before proceeding, ensure that the gas cap was tight, and that the DTC is present.
2. Test for a leak by first calibrating tester KLI9210 to 0.02 inch port with 14 inch/water as described on the tester. Set marker on flow meter to this position and take a picture for documentation.
3. Block off the filter port on the NVLD sensor (Figure 1).

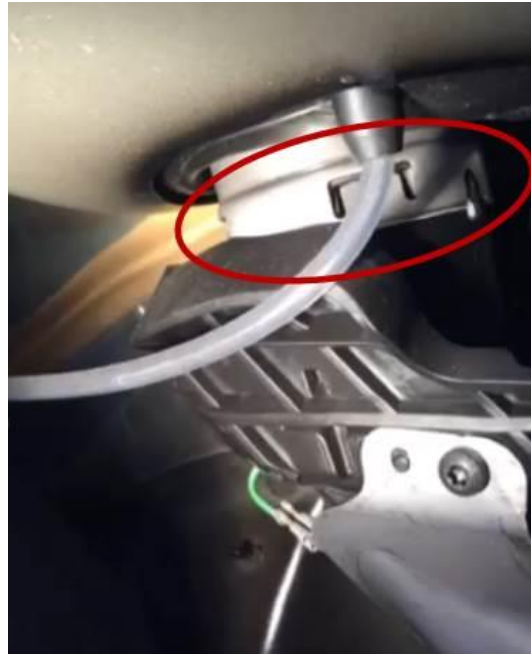
Rubber O-ring at tank filler neck is out of position.

**Figure 2.** Check for smoke escaping around the filler neck.

9. • If smoke is escaping around the filler neck of the fuel tank (wheel liner removed) replace fuel tank (Figure 2).
- If no leak can be found, contact TAC.
