## Technical product information

| <b>Topic</b> | Steering malfunction message displayed on dash, DTC 'C10AC07-Steering mechanical malfunction' stored |
| <b>Brand</b> | Bentley |
| <b>Transaction No.</b> | 2051802/1 |

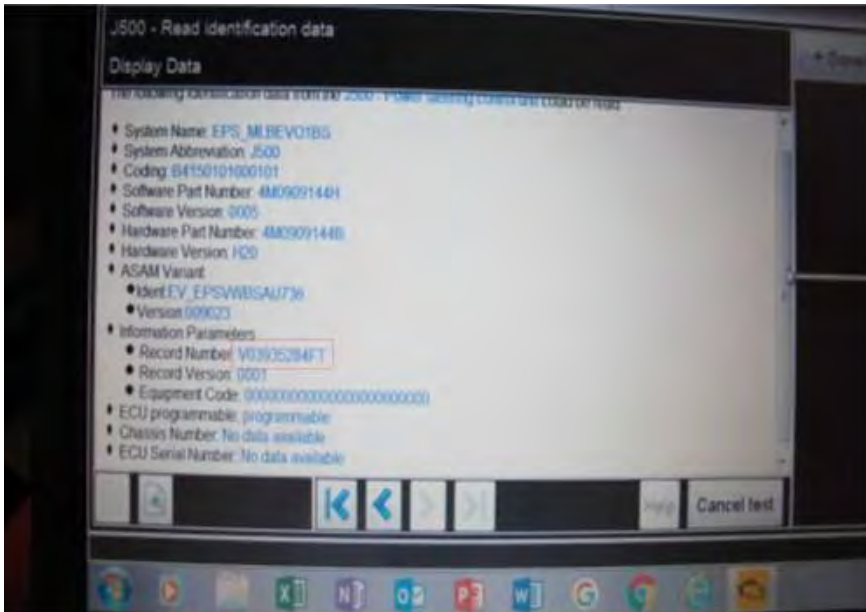
Figure 1

Under the title **Information Parameters**, the **Record Number** should end in suffix **FT**, see *Figure 1*. This confirms the procedure has been successful.
