# Technical Service Bulletin

**VARIOUS ELECTRICAL SYSTEM MALFUNCTION(S) RELATED TO C-15 CONNECTOR CORROSION**

**Bulletin No.:** 09-036/18

2013-2015 CX-5 vehicles with VINs lower than JM3KE\*\*\*\*\*554564 (produced before Nov. 24, 2014)

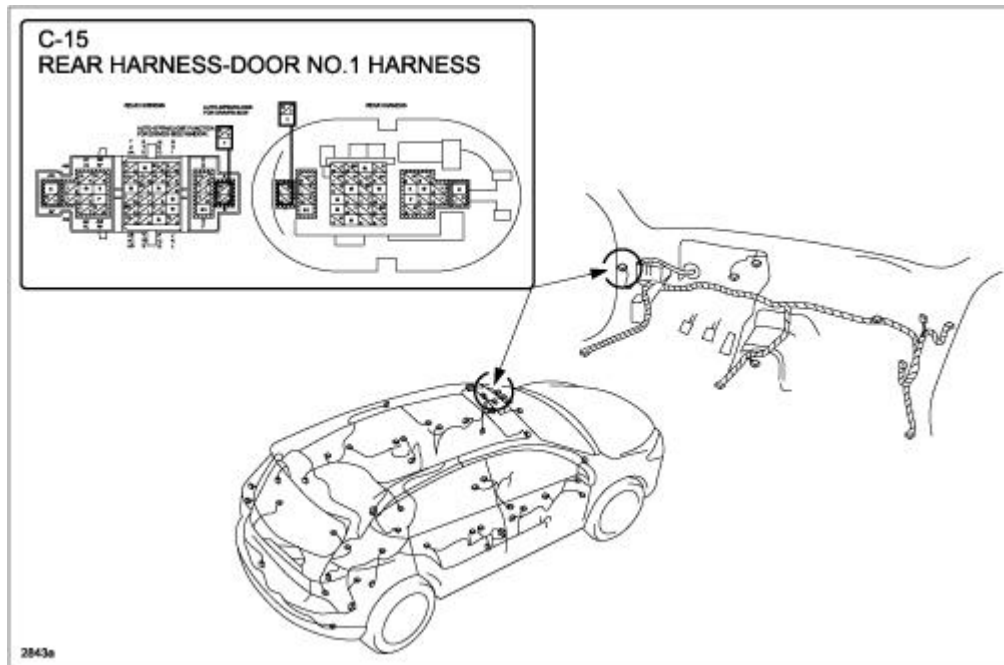
The symptoms listed above may be caused by corrosion of the C-15 connector terminals due to water intrusion through the front door. In low ambient temperatures, the door harness hardens. If the door is fully opened, it may create a gap between the door and the door harness grommet, which may allow water to enter through the gap.

- The front door harness grommet has been changed to improve sealing performance.
- Holes inside the front pillar (which are made for weight reduction), have been covered to prevent water intrusion.
- **The C-15 connector has been improved.**

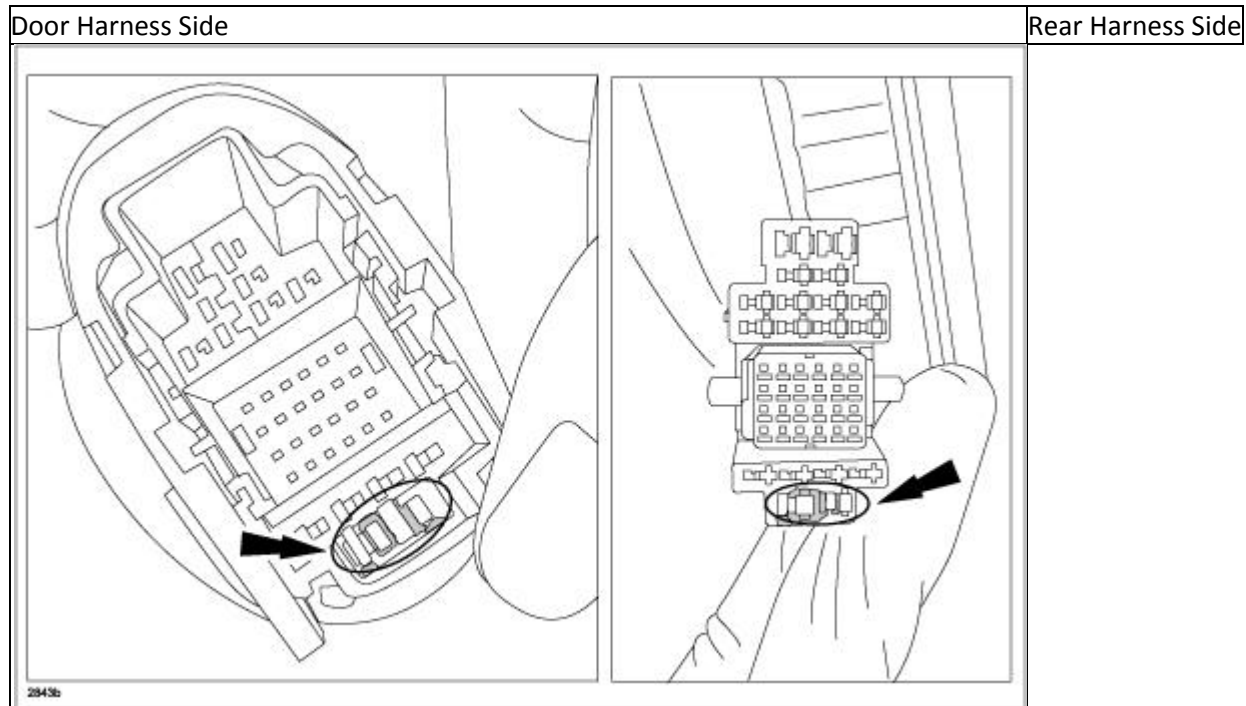
2. Record customers pre-set radio stations.
3. Slide the driver side front seat fully backwards.
4. Disconnect the negative battery cable.
5. Disconnect the C-15 connector according to the MGSS online instructions (FRONT DOOR REMOVAL/INSTALLATION).
6. Inspect for any corrosion found on the terminals shown below.

- If there is any corrosion found on the terminals, go to next step.
  - If there is no corrosion found on the terminals, this bulletin is not applicable. Troubleshoot the concern(s) according to the MGSS online instructions.
7. Remove the driver-side front side trim according to the MGSS online instructions (FRONT SIDE TRIM REMOVAL/INSTALLATION).
  8. Remove the hood release lever from the under panel according to the MGSS online instructions (HOOD LATCH AND RELEASE LEVER REMOVAL/INSTALLATION).
