# Preliminary Information

## PIP5584 Dynamic Fuel System DTC

| Brand: | Model: | Model Years: | VIN: | | Engine: | Transmissions: |
|---|---|---|---|---|---|---|
| Chevrolet | Silverado 1500 (new Model) | 2019 | All | All | 5.3L 6.2L, L84, L87 | All |
| GMC | Sierra 1500 (new Model) | 2019 | All | All | 5.3L 6.2L, L84, L87 | All |

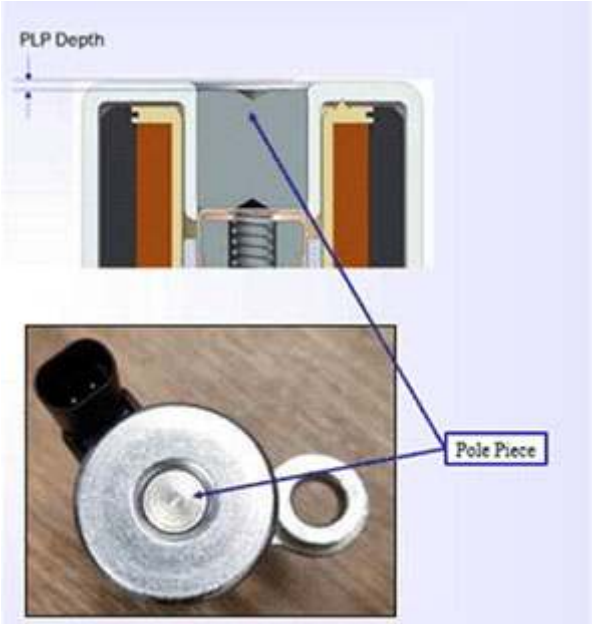
Inspect the rest of the solenoids for pole piece standing proud as seen below.

If the pole piece is sticking out (above the surface) the solenoid will also need to be replaced.

> 0.4mm = Good

< 0.4mm = NOK

Replace the OCV for the cylinder with the concern.

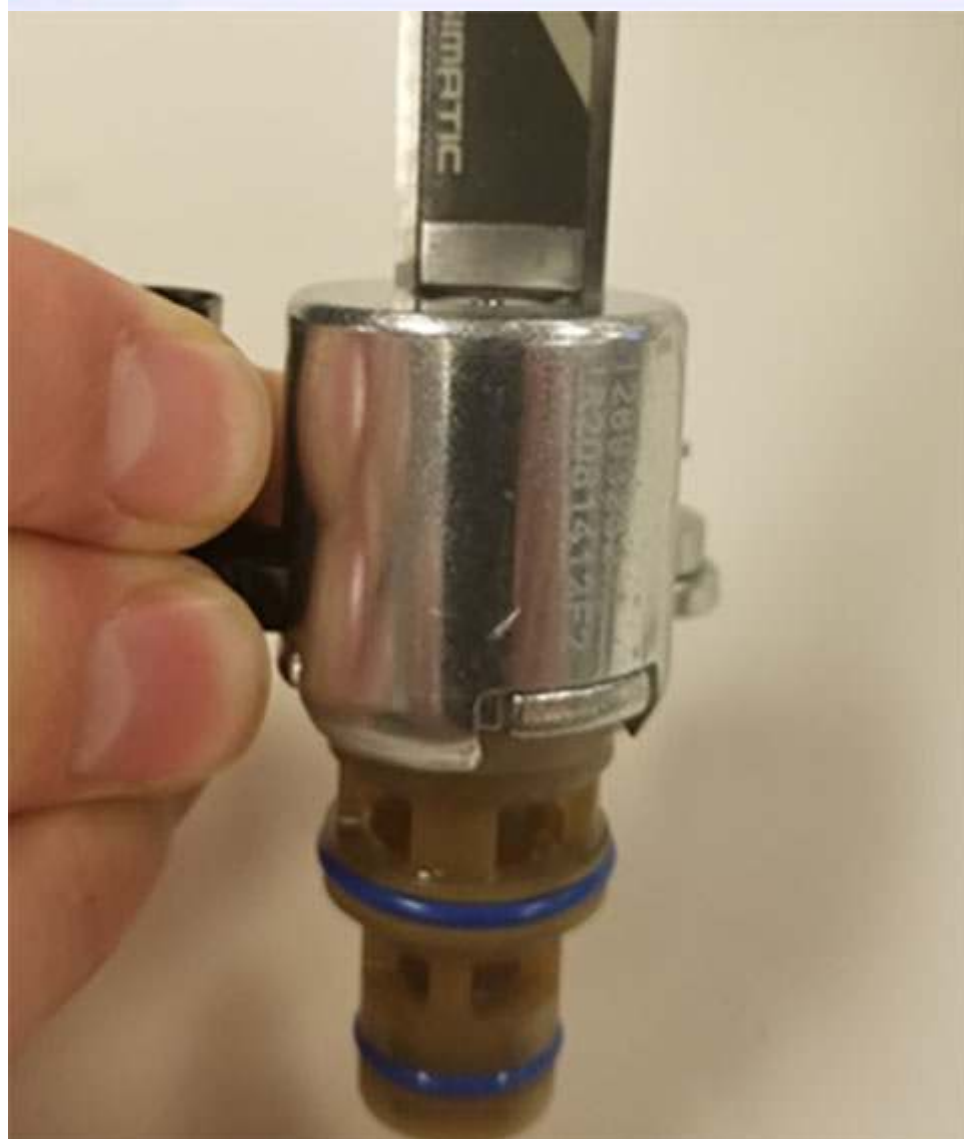
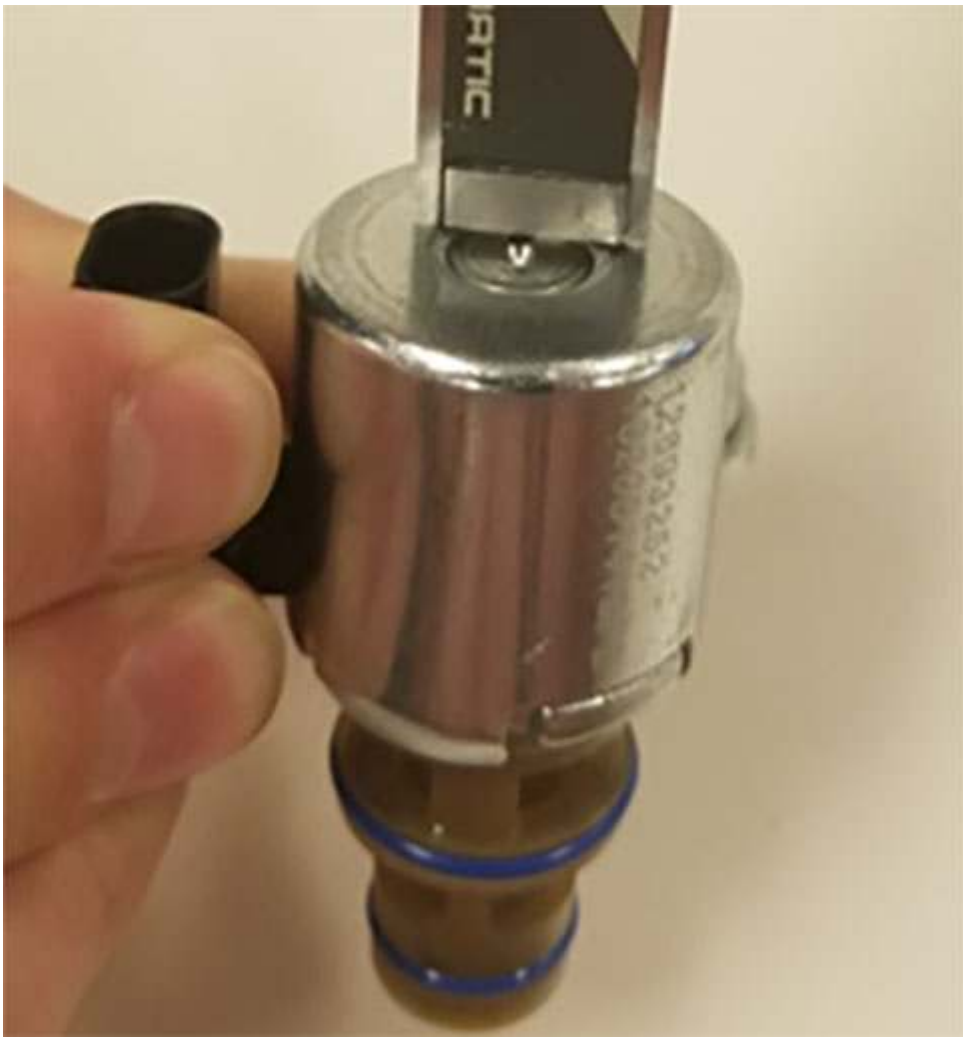
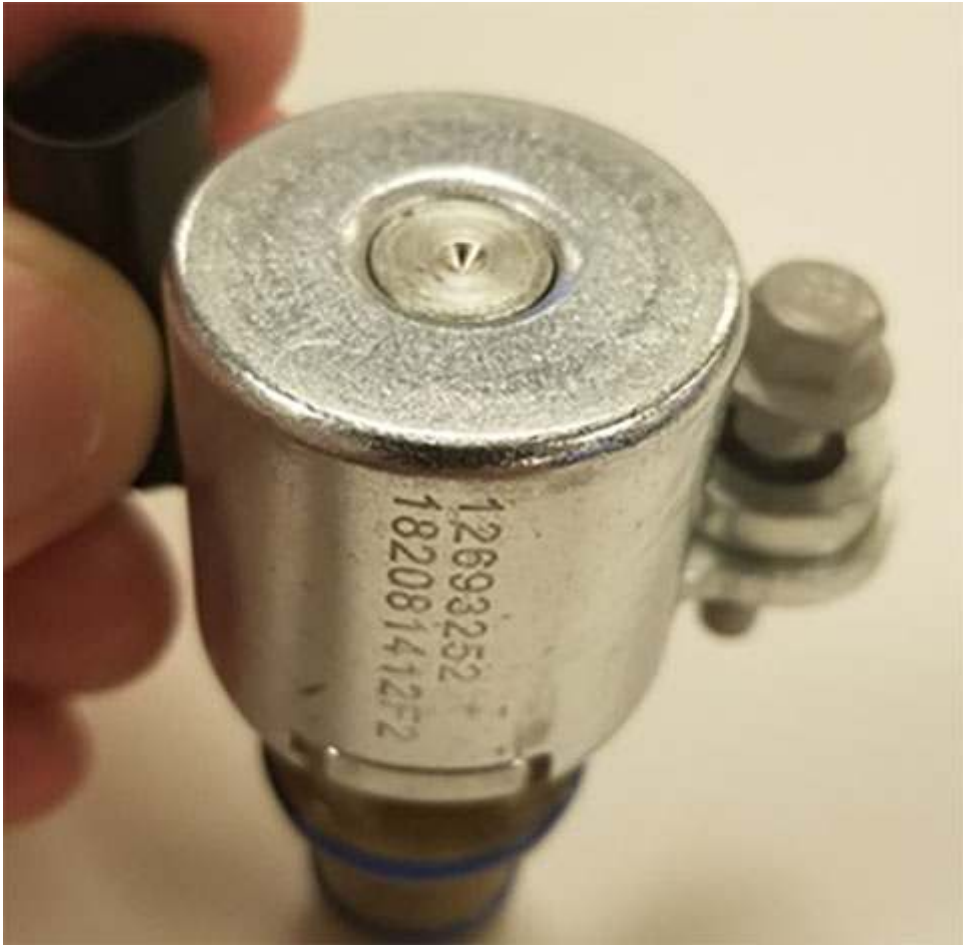
3 Images above show measuring the plunger of the OCV. (It should be checked in the vehicle)
