Preliminary Information

PIP5553A SES Lamp With Camshaft or Oil Pump System Related DTCs

Product Investigation Review Required

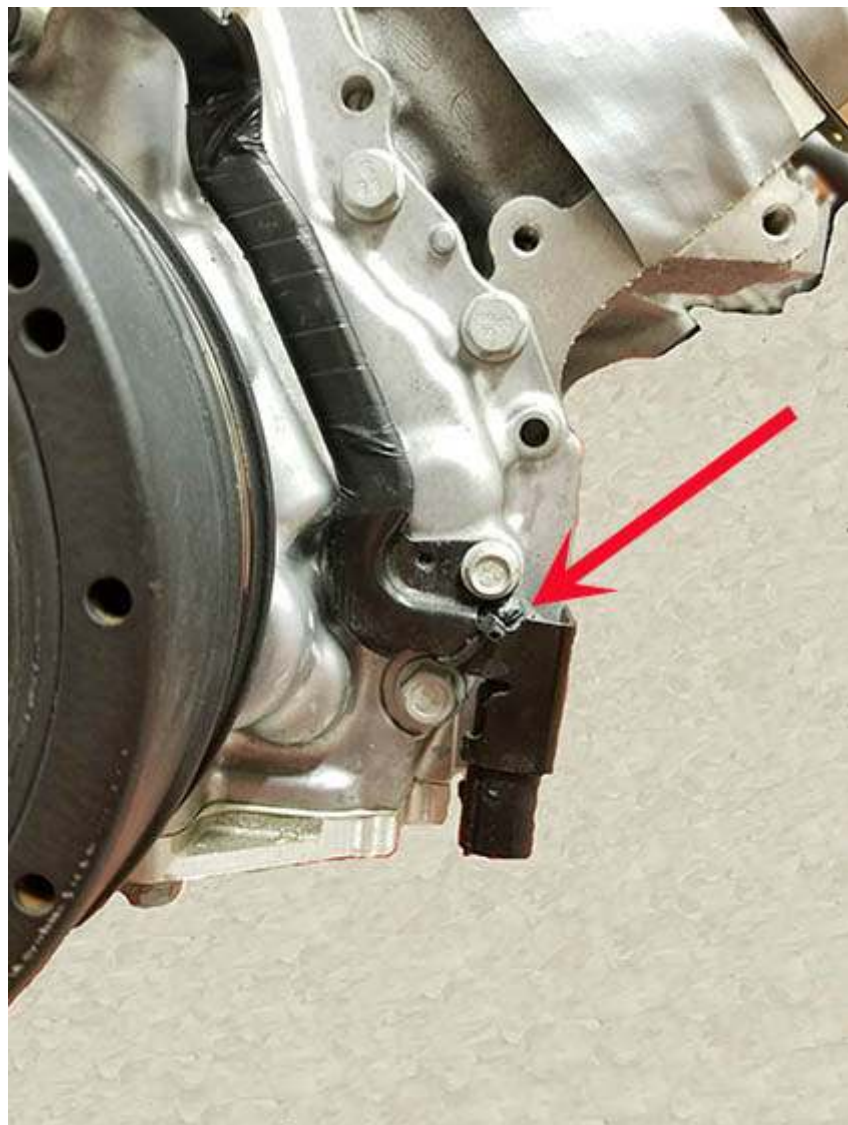
| Cause | Possible wiring jumper harness chaffed at the bolt at the X154 connector on lower left side of the engine front cover. |

Inspect for the wiring harness being chaffed or pinched under the bracket on the location below.

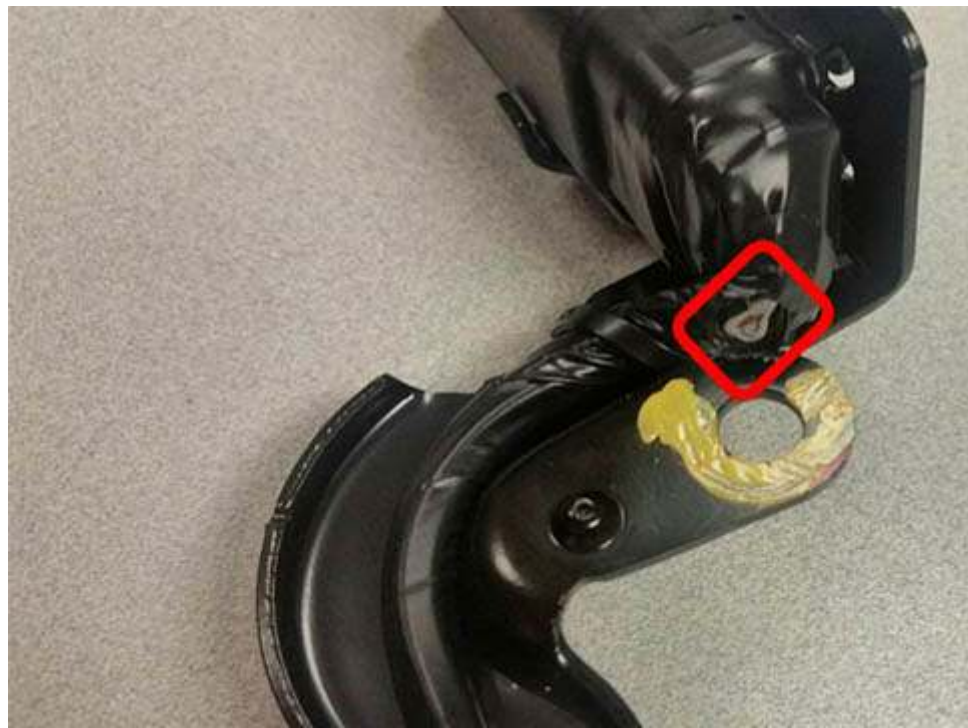
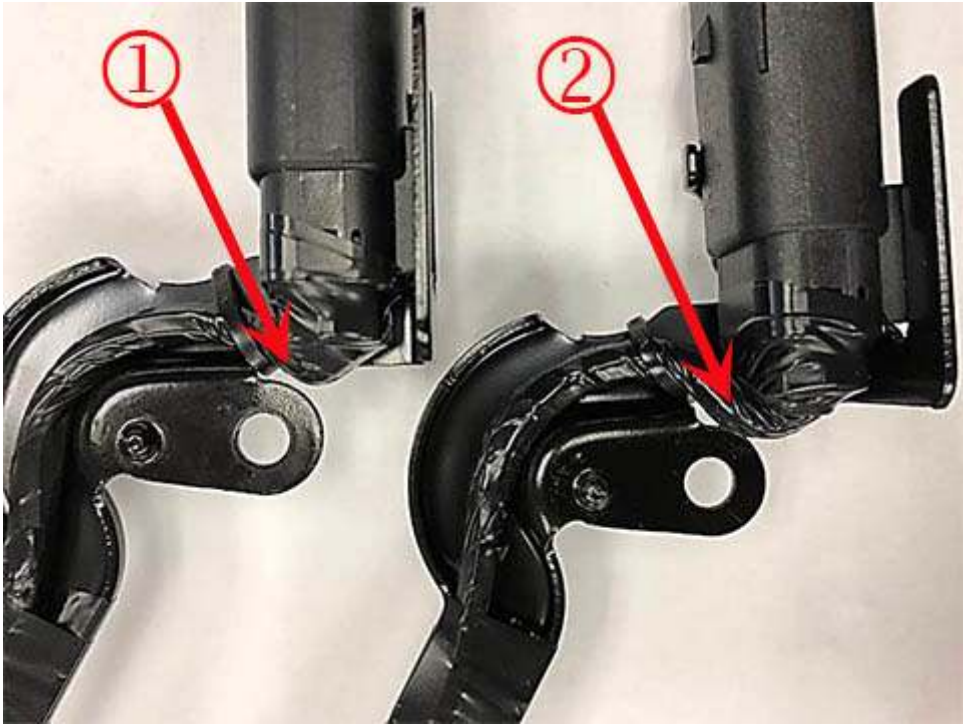
Below is what has been found

Before installing a new jumper harness be sure to inspect the wiring harness.  
As seen above 1. shows a good harness 2. shows a suspect harness.  
if the harness looks like number 2 please adjust the harness as needed.
