# Preliminary Information

## PIP5495E Check Engine Light On With P0299 Or P0234

| Cause: | Misdiagnosis Leading to Returned Turbochargers with NTF |

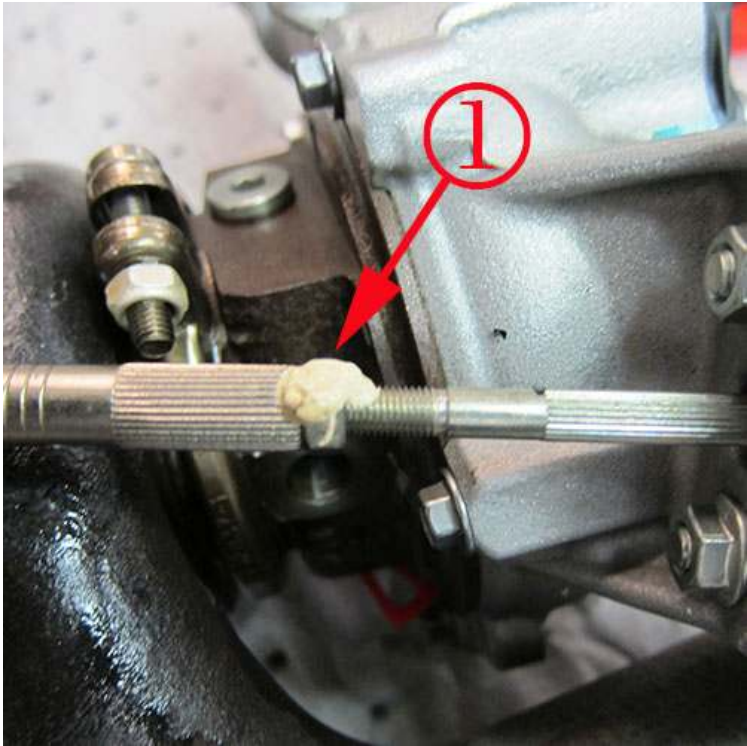
If the tamper paint seal is broken or missing, check the vehicle for any additional sign of modification to the induction, exhaust, or engine calibrations as this may indicate an attempt to adjust the wastegate arm to modify the powertrain operation.

If found, review the powertrain warranty status with your service manager prior to performing repairs.

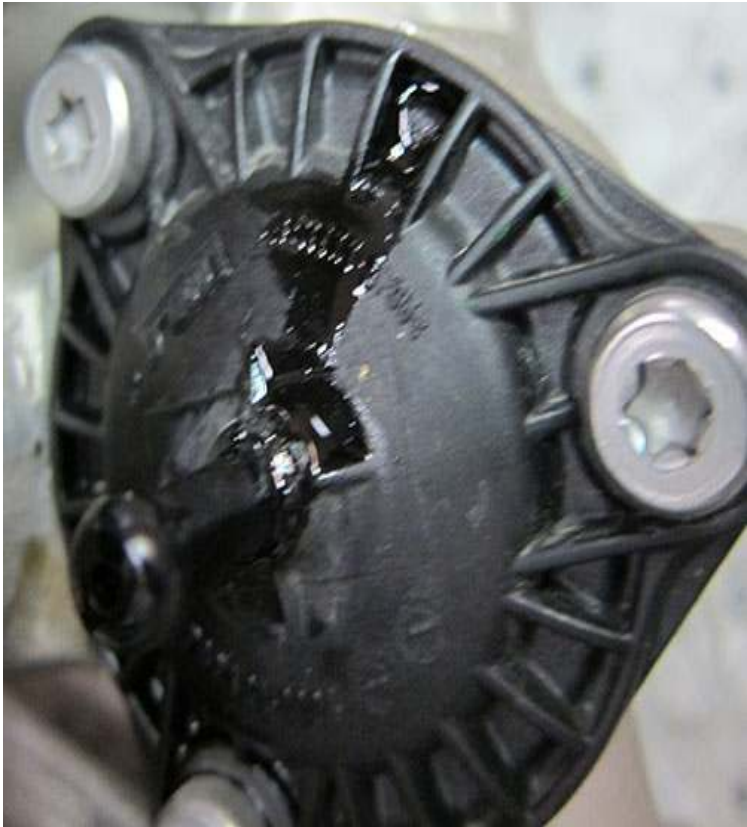
Bypass (recirculation) valve cover port broken or water/oil found inside the valve (clean the components, if necessary replace bypass (recirculation) valve assembly - released for service)

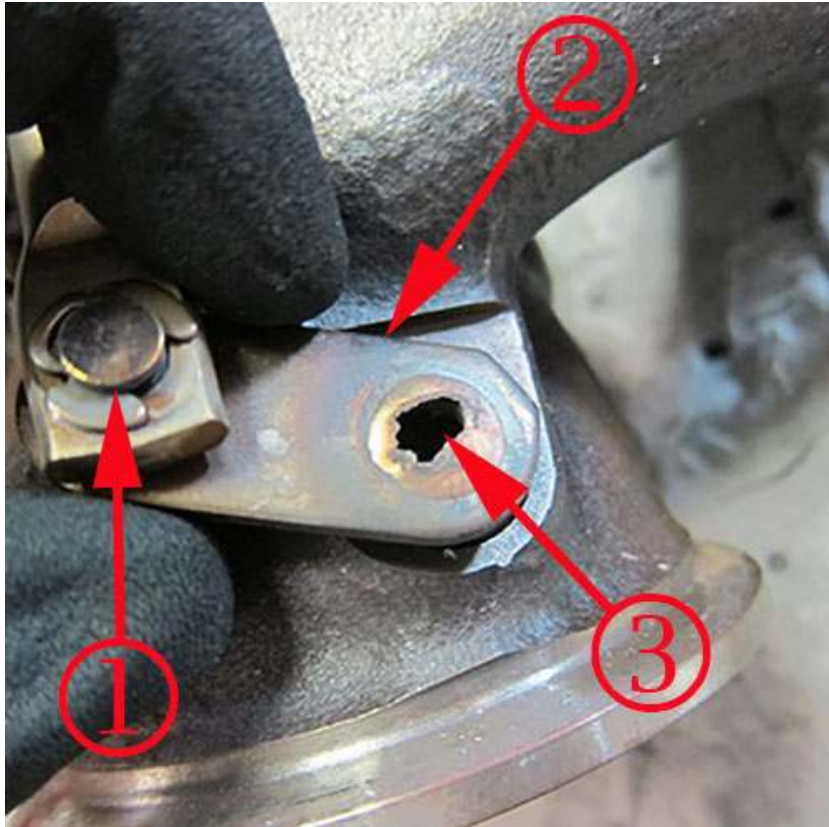
Disconnected wastegate lever arm (crank) (2) from the shaft (3).

Disconnected wastegate lever arm pin (1) from the lever arm (crank) (2).

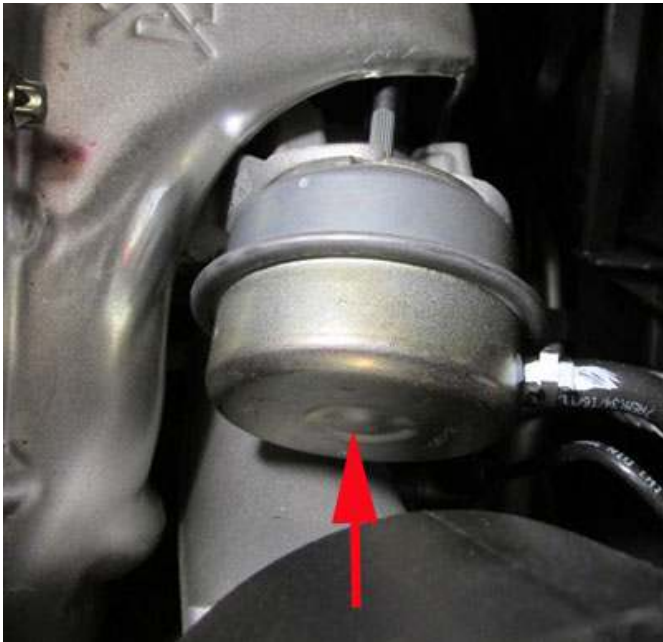
The updated design actuator shown below has a stop that is not recessed and allows 5mm more travel in the closed direction.

With this updated design, it is very unlikely that an insufficient preload issue exists.

Updated design.
