## SERVICE BULLETIN

BR10-009a

September 10, 2018

### 2009 MURANO; ABS / VDC LIGHT ON WITH DTC C1161 / C1162

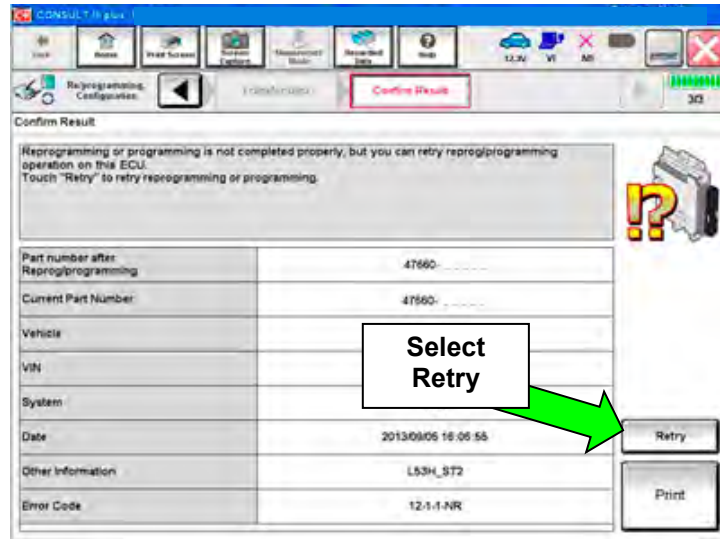
Figure 19

If reprogramming does not complete and the “!?” icon displays as shown in Figure 19:

- Check battery voltage (12.0–15.5 V).
- Ignition is ON, engine OFF.
- External Bluetooth® devices are OFF.
- All electrical loads are OFF.
- **Select retry and follow the on screen instructions.**
- “Retry” may not go through on the first attempt and can be selected more than once.

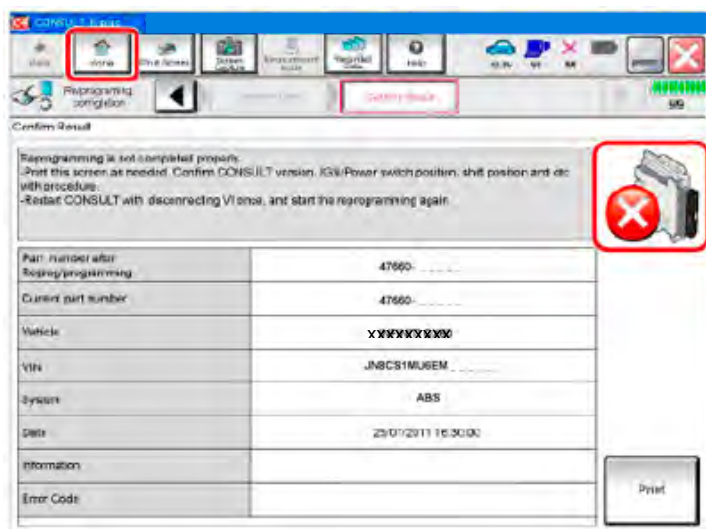
Figure 20

If reprogramming does not complete and the “X” icon displays as shown in Figure 20:

- Check battery voltage (12.0 – 15.5 V).
- CONSULT A/C adapter is plugged in.
- Ignition is ON, engine OFF.
- Transmission is in Park.
- All C-III plus / VI cables are securely connected.
- All C-III plus updates are installed.
- **Select Home, and restart the reprogram procedure from the beginning.**
