# Technical Service Bulletin

## 01 MIL on, DTC P20E900 or P20FE00 stored in ECM

01 18 80 2034359/4 July 30, 2018. Supersedes Technical Service Bulletin Group 01 number 18-66 dated April 19, 2018 for reasons listed below.

| Model(s) | Year | VIN Range | Vehicle-Specific Equipment |
|---|---|---|---|
| Q7 | 2012 - 2015 | All | TDI |

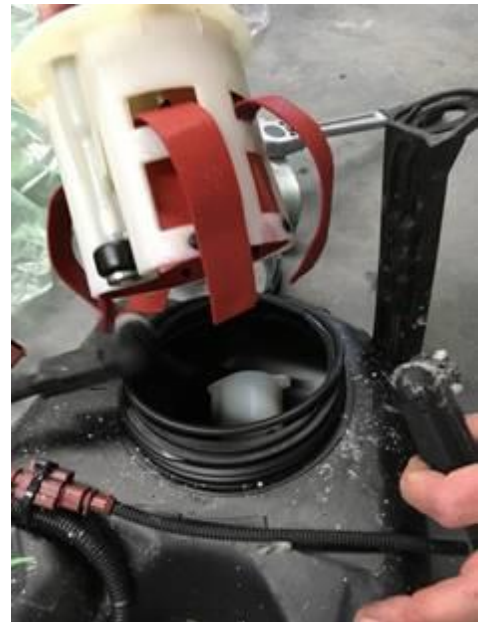
In vehicles produced during a certain period, the AdBlue filter seal within the level sensor module may have been damaged during the assembly process or the AdBlue filter housing may come loose over time. This can allow unfiltered AdBlue to be drawn into the delivery system, subsequently damaging the pressure sensor and reducing agent pump V437.

*Figure 1. Filter element housing loose inside tank.*

1. In cases with the above fault codes, remove the active tank according to instructions in the Elsa Repair Manual.
2. Remove the G684 Reducing Agent Tank level sensor.
3. Inspect the reducing agent filter housing which should be clipped to the G684 level sensor module. If the filter housing is loose (see Figure 1 and Figure 2), **then the G684 level sensor AND the V437 reducing agent pump must be replaced.**

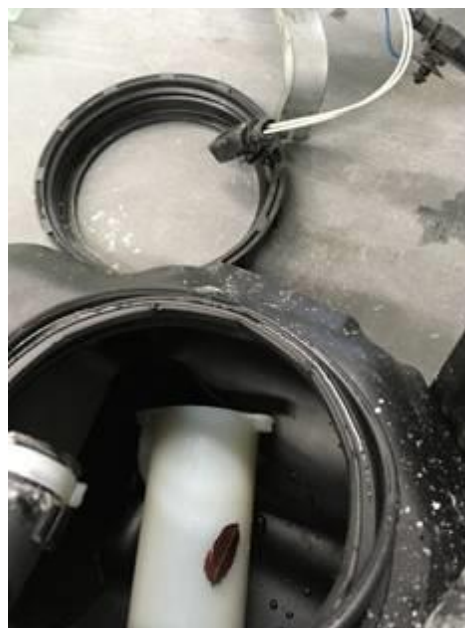
**Figure 2.** Filter element housing loose inside tank.
