# Technical Service Bulletin

## 94 Rear lights do not switch from bumper to hatchgate after closing

94 18 00 2050234/2 July 17, 2018. Supersedes Technical Service Bulletin Group 94 number 18-96 dated January 30, 2018 for reasons listed below.

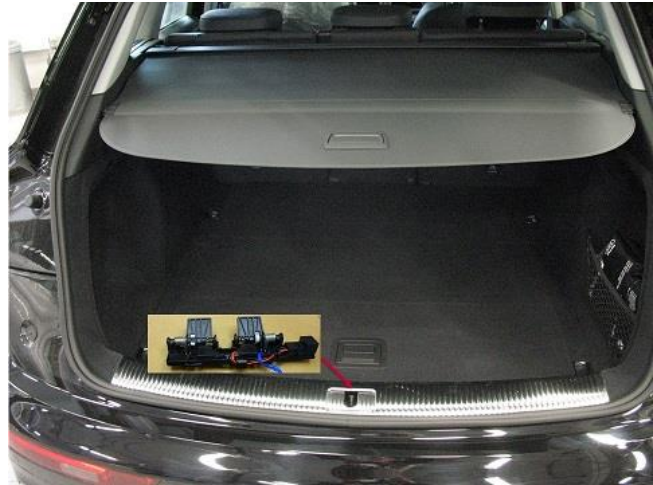
1. The paddle on the micro switch was broken due to adjustment of the rear hatch or the striker in production.
2. Dirt can block one/both paddles on the micro switch, which is fastened on the striker of the rear lid.

**Figure 1.** Rear lid closed sensor.

1. Replace the rear lid closed sensor if found broken (Figure 1).
2. Blow out any debris that might be causing an obstruction with compressed air (Figure 2).

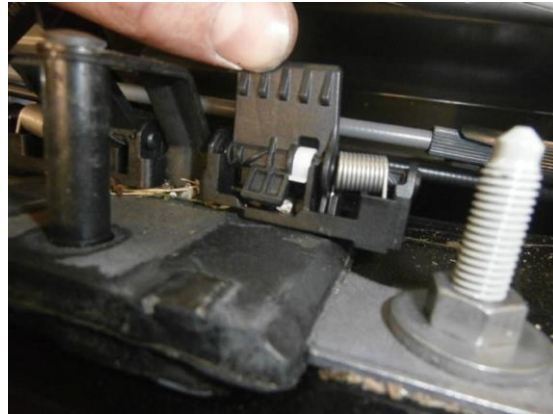
**Figure 2.** Debris trapped in the rear lid closed sensor.
