LTB01156NAS2

# TECHNICAL BULLETIN

303-01: Engine

Engine MIL Illuminated With DTC P132B-77 Stored

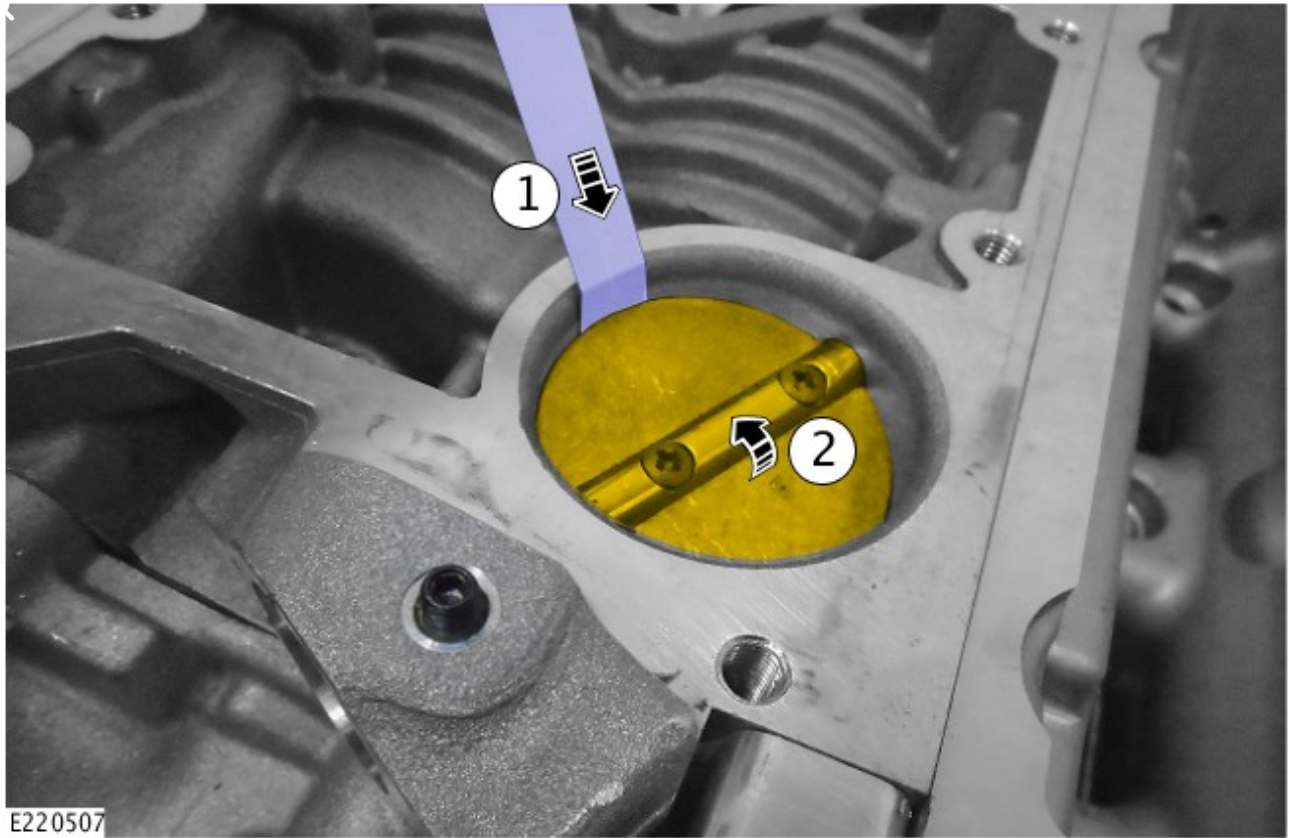
With the bypass valve in an open position, insert a feeler gauge **(1)** of 0.102 mm (0.004 in) into the valve body and close the valve **(2)**.

- If the bypass valve is **NOT** set to a gap of 0.102 mm (0.004 in), **go to Step 3**.
- If the bypass valve is set to a gap of 0.102 mm (0.004 in), **refer to TOPIx Workshop Manual section 303-14A-E [depending on model]: Electronic Engine Controls - Diagnosis and Testing and continue with diagnosis of DTC P132B-77 as a separate claim.**
