## Technical Service Bulletin (TSB)

### Umbrella Valve Seal Missing From Cylinder Head Cover

| REFERENCE: | TSB: 09-023-26<br>GROUP: 09 - Engine | Date: | September 25, 2026 | REVISION: | 09-020-26<br>09-017-26 REV A |
| VEHICLES AFFECTED: | 2026 - 2027 (WL) Jeep Grand Cherokee / Grand Cherokee L<br>This bulletin applies to vehicles built on or before **August 21, 2026 (MDH 0811XX)** equipped with a 2.0L Hurricane 4 Turbo W/ESS (Sales Code EC7). | | | MARKET APPLICABILITY:<br><div><input checked="" type="checkbox"/> NA<input checked="" type="checkbox"/> MEA<br/><input checked="" type="checkbox"/> EE<input checked="" type="checkbox"/> IAP<br/><input checked="" type="checkbox"/> SA<input type="checkbox"/> CH</div><br>NOTE: This bulletin applies to North and South America, Enlarged Europe, Middle East & Africa, and India & Asia Pacific markets. | |

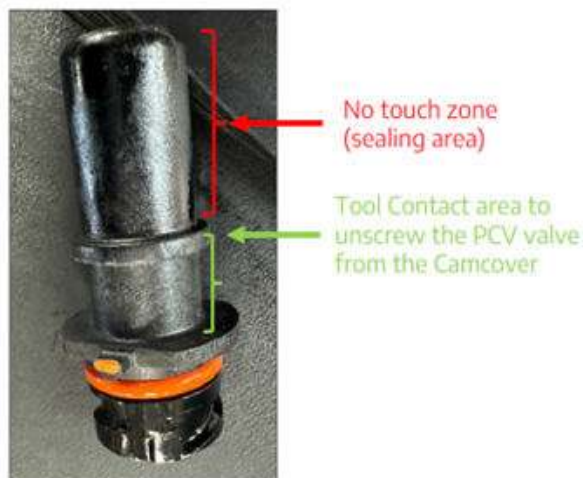
**Fig. 1**  
PCV Valve During Removal

**NOTE:** Be sure to follow warnings regarding location on the PCV valve where tool contact should be avoided [Fig. 1](#).

1. Remove the Positive Crankcase Ventilation (PCV) valve. Refer to the detailed service procedures available in DealerCONNECT/Service Library under: Service Info> 25 - Emissions Control / Crankcase Ventilation / Valve, Positive Crankcase Ventilation (PCV) / Removal and Installation.

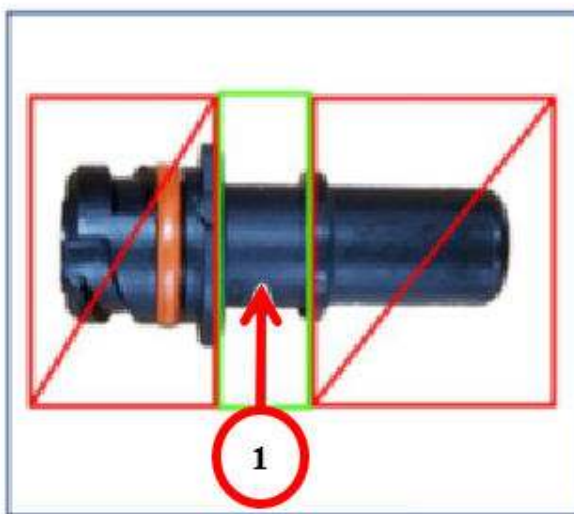
**Fig. 2**  
Approved Zone - PCV Valve Removal

**NOTE:** Use a pair of thin nosed pliers inserted into the approved zone on the PCV valve for removal [Fig. 2](#).

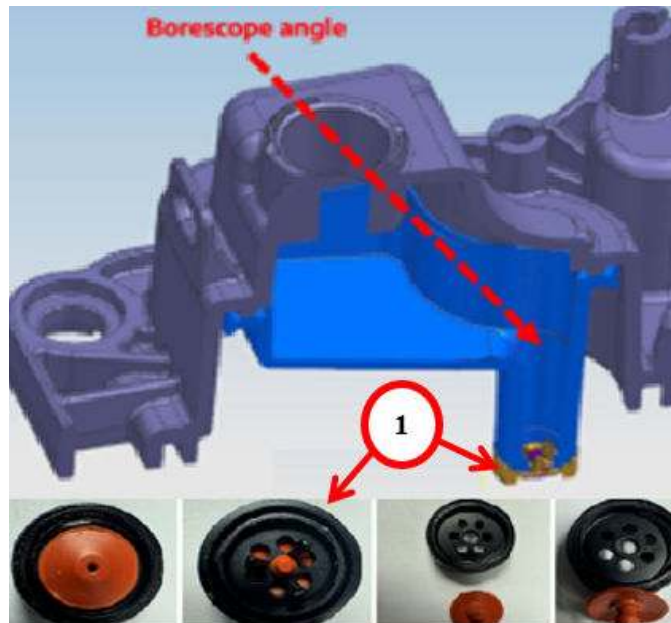
**Fig. 3**  
Borescope to PCV Valve Opening

2. **With the PCV valve removed**, insert a borescope into the PCV valve opening [Fig. 3](#) to inspect if the umbrella valve is missing or present [Fig. 4](#) [Fig. 5](#) [Fig. 6](#).

1 - Umbrella Valve Seal

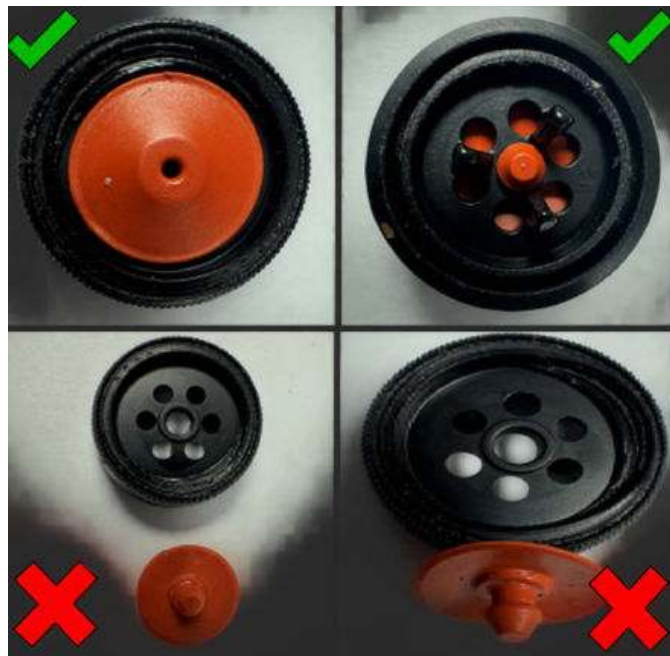
**Fig. 4**  
**\*\*Umbrella Seals - Present and Missing\*\***

| CAUSE: | Cover Cylinder Head Umbrella valve seal missing | | | | |

Green Check Mark - Umbrella Valve Seals - Present

Red X Mark - Umbrella Valve Seals Not Seated or Missing

3. Is the umbrella valve seal missing [Fig. 4](#)?
  - YES>>> Replace the cylinder head cover assembly. Refer to the detailed service procedures available in DealerCONNECT/Service Library under: Service Info> 09 - Engine, 2.0L / Cylinder Head / Cover(s), Cylinder Head / Removal and Installation and then proceed to [Step 4](#).
  - NO>>> This bulletin has been completed. Use Inspection LOP (09-35-20-98) to close the active RSU.
4. Ensure that the engine oil level is to proper specification.
5. Using wiTECH, perform the PCM Reset ECU routine. Navigate to **Guided Diagnostics > Reset ECU**, select **PCM**, and follow the on-screen instructions to complete the procedure.
6. Clear DTCs.
