| <b>Subject:</b><br><br><b>"TCU MALFUNCTION. HAVE THE VEHICLE INSPECTED."<br/>MESSAGE AND DTC B1252:87 OR U0198:00 STORED</b> | <b>Service Alert No.: SA-012/26</b> |
| | <b>Last Issued : 09/17/2026</b> |

2024-2026 Mazda3  
2024-2026 CX-30  
2024-2027 CX-90 (All)  
2025-2026 CX-70 (All)  
2025-2027 CX-50 (All)

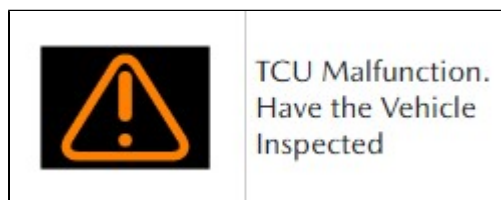
Some customers may experience a message "TCU Malfunction. Have the Vehicle Inspected" in the instrument cluster.
