# Service Alert

INFOTAINMENT CENTER DISPLAY AND CONNECTED VEHICLE  
IMPROPER OPERATION

Service Alert No.: SA-015/26

2026 CX-5

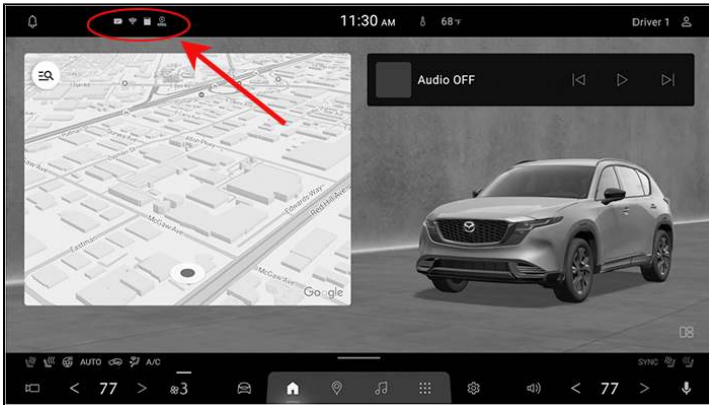
1. Intermittent Globe with a slash icon for longer then 90 seconds.

- If communication between the CDC and DCM does not complete within 90 seconds, refer to [SSPE2](#) and [MSP67](#).
- **Did SSPE2 and MSP67 repair the customer's concern?**
  - **YES:** Repair complete.
  - **NO:** Proceed with standard MGSS troubleshooting.

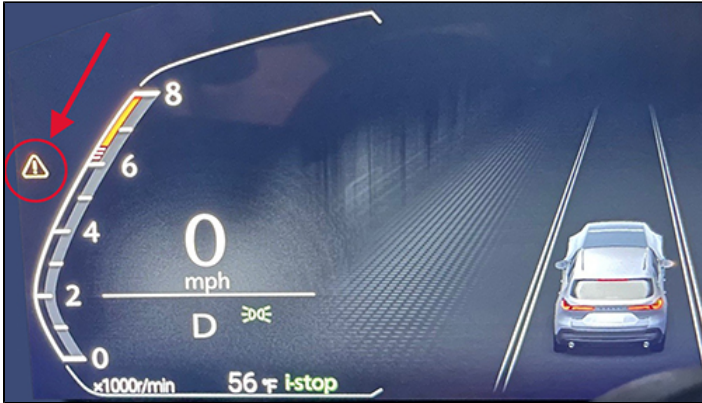
3. Instrument Cluster Master Warning Light may be illuminated.

- Emergency Call Unit Malfunction Notification.
  - Center Display Home screen --> All Apps --> Maintenance --> Notifications
- This condition is related to Item 1 above. Advise the customer that Mazda is aware of the condition and is currently working on a resolution. As soon as a resolution becomes available, this Service Alert will be promptly updated and re-released.

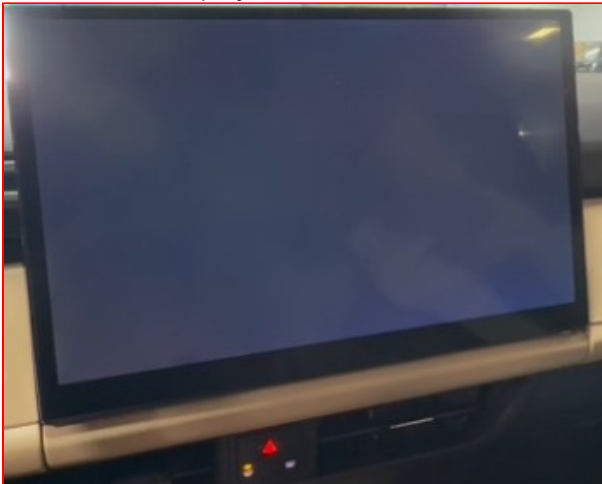
4. The center display screen is blank.

- This condition is related to Item 1 above. Refer to [SSPE2](#) and [MSP67](#).
- **Did SSPE2 and MSP67 repair the customer's concern?**
  - **YES:** Repair complete.
  - **NO:** Proceed with standard MGSS troubleshooting.

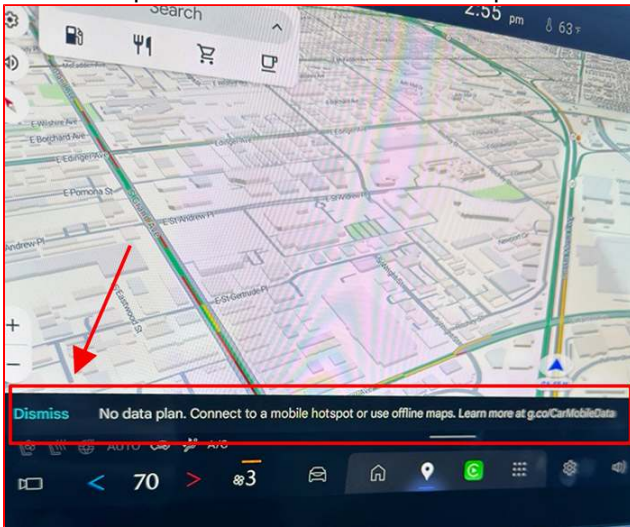
5. No data plan. Connect to a mobile hotspot or use offline maps. Learn more at [g.co/CarMobileData](https://g.co/CarMobileData) message.

- This message is incorrect.
- It does not affect system operation.
- Dismissing the message may temporarily clear it.
- Please ignore this message at this time.
- This condition is related to Item 1 above. Advise the customer that Mazda is aware of the condition and is currently working on a resolution. As soon as a resolution becomes available, this Service Alert will be promptly updated and re-released.

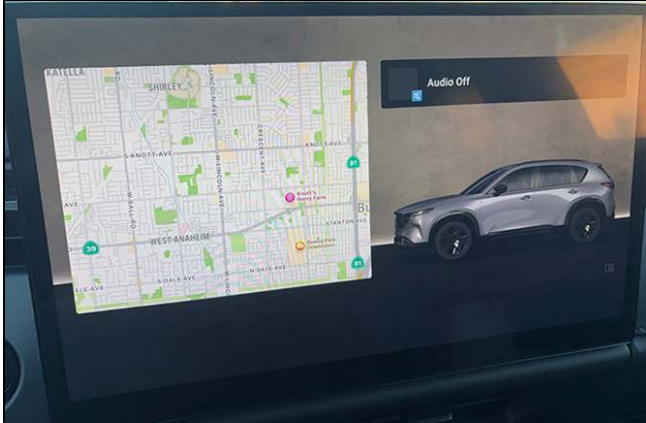
## 8. Infotainment Center Display Home Screen Partial Boot Up.

- Top icons are not displayed.
- Bottom climate controls are not displayed.
- Google Voice is inoperative.

Confirm that the Cockpit Domain Controller (CDC) is updated to the latest software version.

Navigate to MGSS → Mazda Connect/Connected Vehicle → MAZDA CONNECT Updates → [MAZDA CONNECT 3](#).

- Software update is available: Update the software, then confirm the repair.
- Software update is not available: Proceed with standard MGSS troubleshooting.

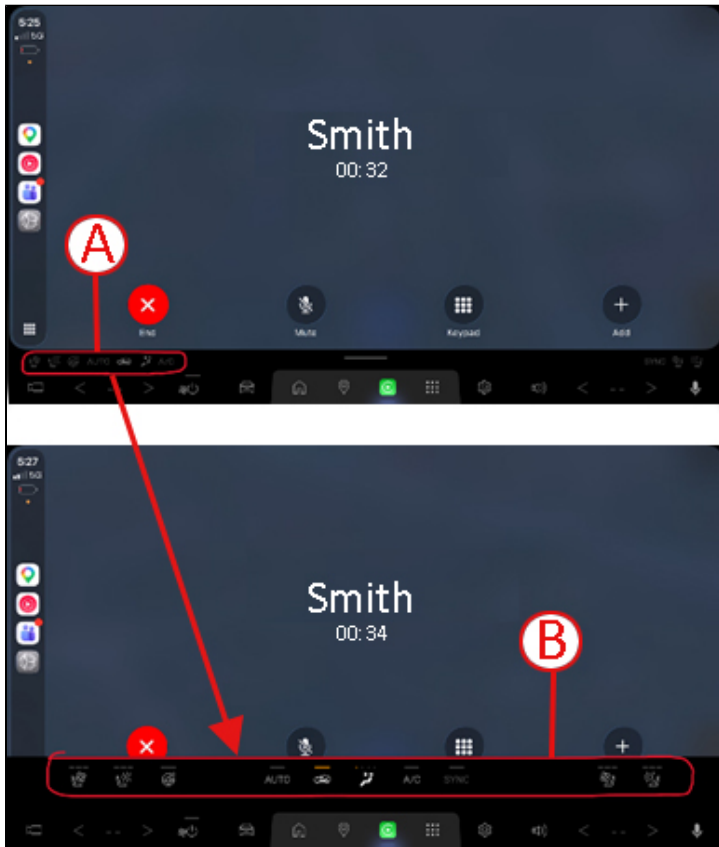
11. During an Apple CarPlay phone call, the Climate Control full-screen menu cannot be accessed. This is normal system operation.

- The Climate Control is available during a Apple Carplay phone call by selecting the area above the menu bar (A), then the Climate Control quick menu (B) will be displayed.

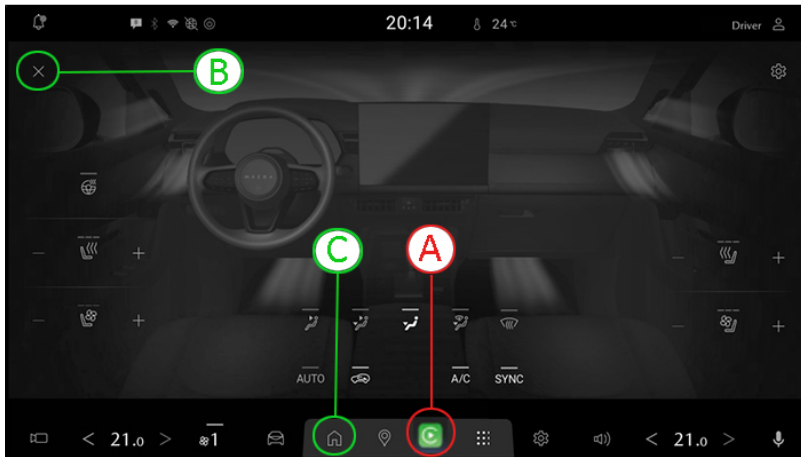
12. While the Climate Control screen is displayed in full screen, tapping the Apple CarPlay icon (A) does not launch Apple CarPlay.

- Because the screen priority is set to "Climate Control screen," it is not possible to switch directly to the CarPlay screen from the navigation bar.
- Use one of the following methods to return to the CarPlay screen:
  - Tap the "x" button (B) in the upper-left corner of the screen.
  - Tap the HOME button (C) on the navigation bar, then tap the CarPlay button on the navigation bar.
