# Service Alert

**ELECTRICAL CONCERN AND/OR MULTIPLE DTC'S DUE TO  
AFTERMARKET DEVICE**

**Service Alert No.: SA-041/26**

**Last Issued : 09/10/2026**

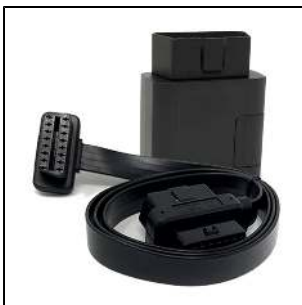
**NOTE:** Some aftermarket devices may include a pig-tail connector or passthrough attached to the OBD-II port. Be sure to check for any extensions, splitters, or other port adapters (see example image below).

- If an aftermarket device is found connected to DLC-2, take a photo and attach it to the RO. Advise the customer to remove it.
- If you determine that no aftermarket devices have been installed, continue with normal MGSS diagnosis.

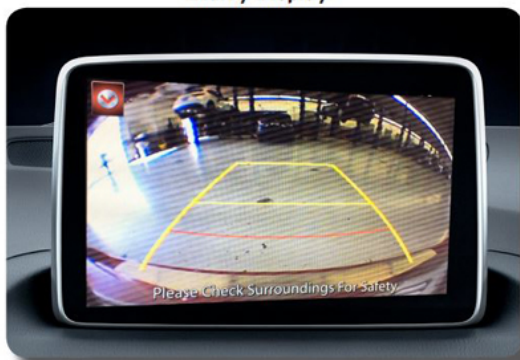
Blurry Display

With aftermarket cell  
phone charger connected  
to 12V outlet

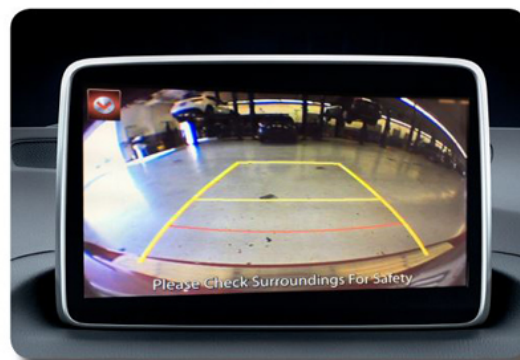
OK

Without aftermarket cell  
phone charger

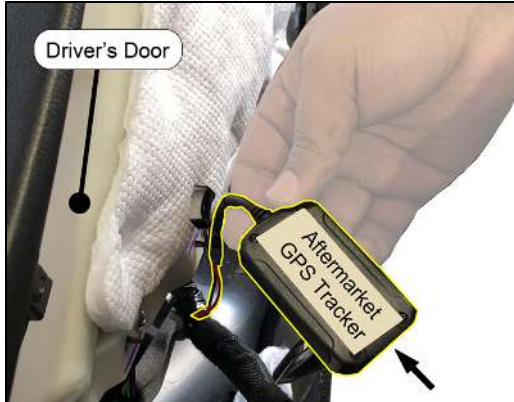
Below are examples of concerns due to an aftermarket GPS tracking device wired to the power window main switch:

- Engine no start
- Battery discharge
- Main relay buzzing

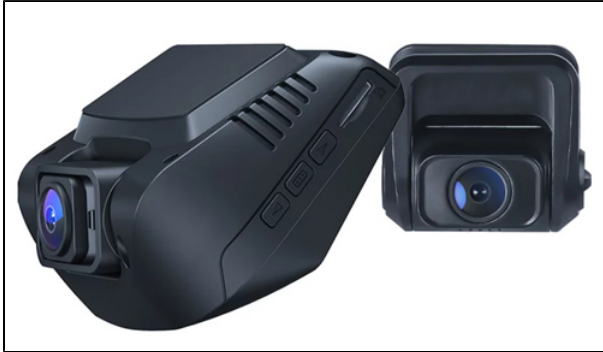
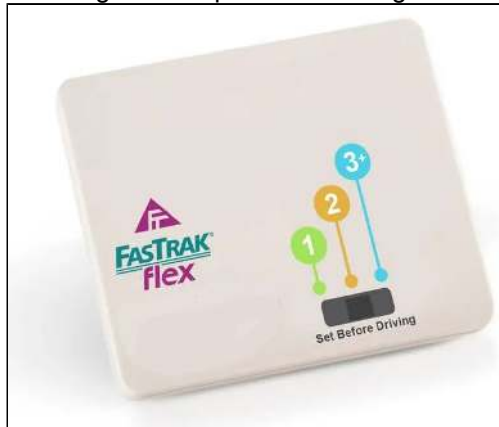
DTC B119F:01 (TEL antenna No.1 malfunction) stored. This may be caused by an aftermarket dash cam, radar detector and/or FasTrak device.

The aftermarket device may cause electrical noise disturbing the reception of GPS signals.

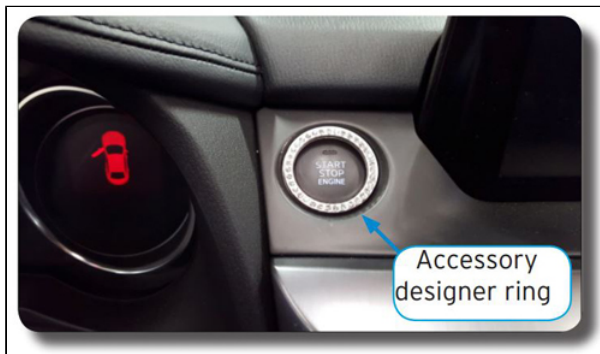
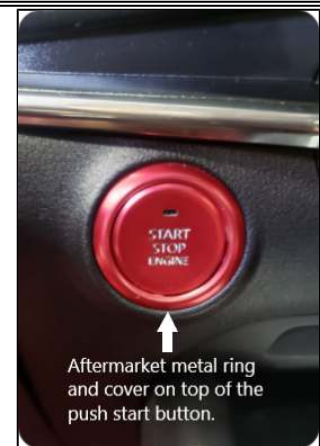
When programming a key or installing a Genuine Mazda Accessory Remote Engine Start system, you may encounter programming difficulty. This may be caused by a customer installed aftermarket decorative trim and/or cover on the START/STOP ENGINE button. The aftermarket accessory may create electrical interference, which may interfere with programming.
