# Service Bulletin

**Subject:** Diagnostic Tip - P0016 Setting As A Hard Fault

**Models:** 2014 Chevrolet Silverado 1500  
2014 GMC Sierra 1500  
Engine RPO LV3 4.3L

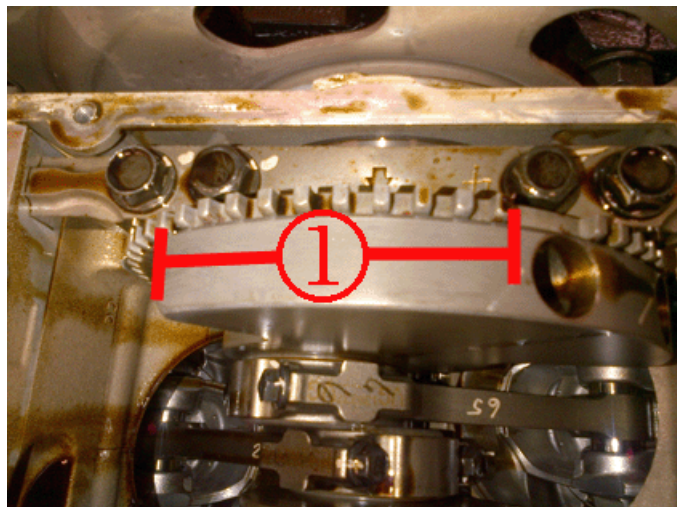
If no trouble is found, verify crankshaft reluctor wheel is properly indexed on the crankshaft, by referring to the picture to determine the reluctor wheel has 11 teeth from the trigger window to the end of the crankshaft throw.

Replace the crankshaft if the crankshaft reluctor wheel is not properly indexed.
