# Service Bulletin

**Subject:** Rough Running / Idle Surge / CEL On Or CMP Actuator Codes After Installation Of Reman HVV6

**Models:** 2007 Buick Rendezvous, Terraza  
2007 Saturn VUE  
2007 Chevrolet Monte Carlo  
2007 Chevrolet Uplander  
2007-2011 Chevrolet Impala  
2007-2010 Chevrolet Malibu  
2007-2009 Pontiac G6  
2007-2008 Saturn Aura  
2009-2011 Buick Lucerne  
With 3.5L Engine (RPO LZE or LZ4)  
or 3.9L Engine (RPO LZ8, LZ9, LZG or LGD)

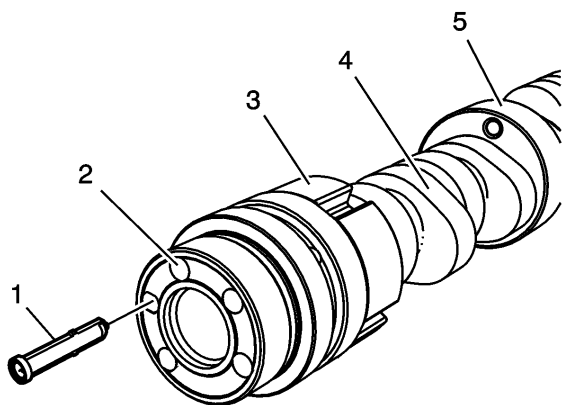
A technician may encounter any of the following concerns after installing a Reman HVV6 engine: rough running, idle surge, misfire on one or both banks of the engine with a P0300, CEL or CMP actuator DTC P0011 and / or P0016.

If oil pressure is within the specifications above, perform all testing listed in PIP4345A including a visual inspection of the camshaft position actuator filter (see picture below) and repair or replace as necessary.
