# Preliminary Information

PIT5457B Service ABS / TCS / Power Steering and/or Suspension Message DTC U0077 U0121 U0126 U0131 U0139 U0151 U0401 U0415 U0428 (Circuit 5986 High Resistance)

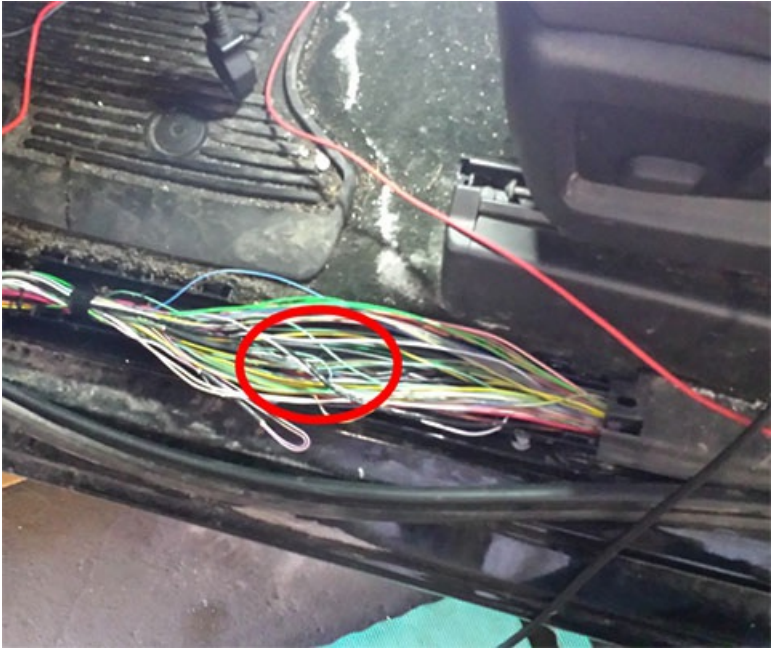
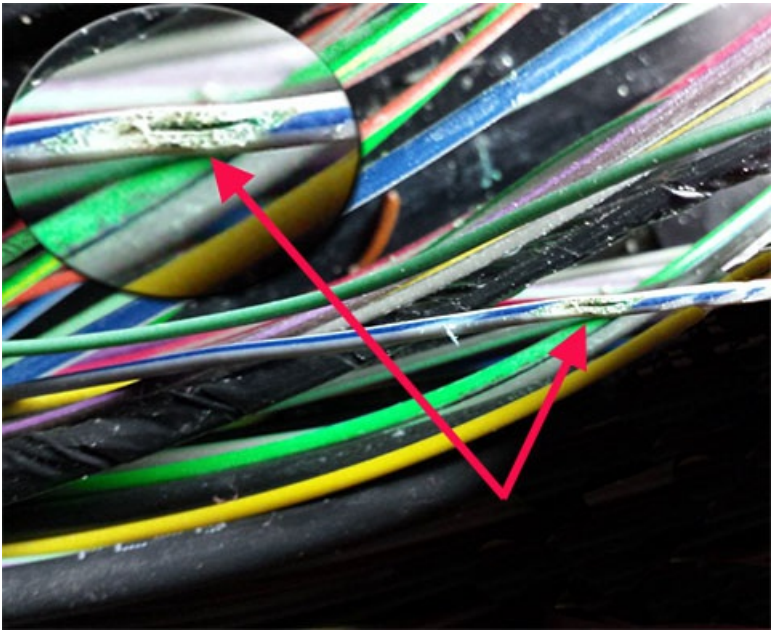
These concerns could be caused by high resistance/open in the Communication Enable circuit 5986. The BCM activates this circuit when the ignition key is in ACC, ON, and START positions (There will be voltage present in the OFF position only for a short time until the BCM goes to sleep). The communication enable circuit wakes up the module for serial data bus communication. Circuit 5986 will have approximately 12 volts and should light a test light, but is not designed to handle heavier electrical loads like a headlight bulb. Below are three known areas where circuit 5986 has been found to be open/shorted/high resistance:

1. On short wheel base utilities (Escalade, Tahoe and Yukon), the chassis harness cut/pinched/shorted between the body and spare tire crossmember, see latest version of PIT5556 for more details.
2. Under the driver's sill plate, shown below.

Monitor the voltage on the communication enable circuit 5986 at any of the modules affected, example EBCM, PSCM, SWPS, SDM, HMI, PTO, and/or SCM. If low voltage or no voltage is present when the concern occurs, inspect for open/high resistance/shorts on circuit 5986. Repair any opens/high resistance/shorts in the circuit.

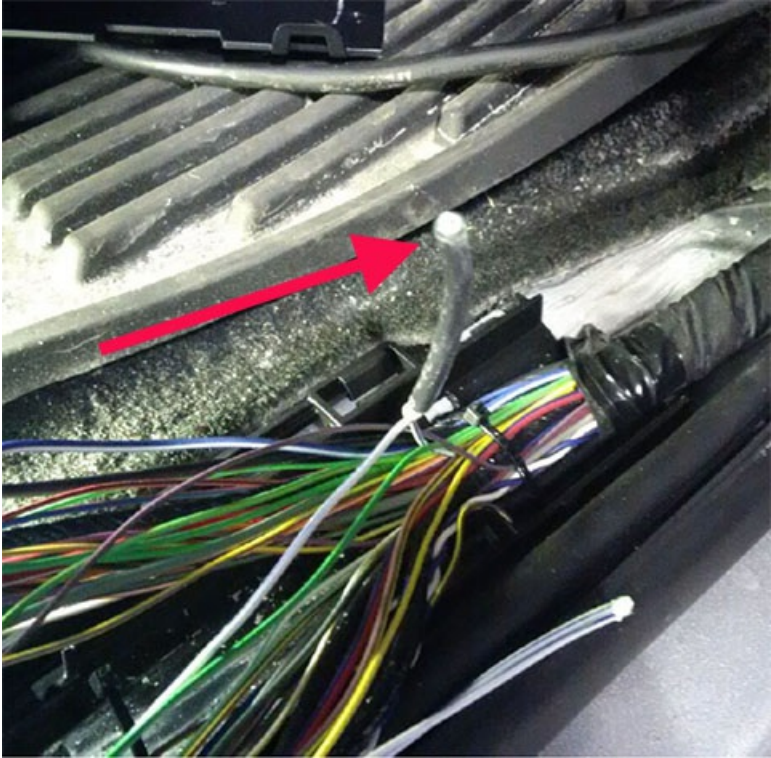
3. Splice J365 located under the passenger front sill plate, shown below.
