# Service Bulletin

**Subject:** No Crank / Start Then Immediate Stall / SES MIL / Service 4WD / Relay Clicking / DTC (Inspect Ignition 1 voltage)

**Models:** 2015-2016 Cadillac Escalade Models  
2014 Chevrolet Silverado 1500  
2015-2016 Chevrolet Silverado, Suburban, Tahoe  
2014 GMC Sierra 1500  
2015-2016 GMC Sierra, Yukon Models

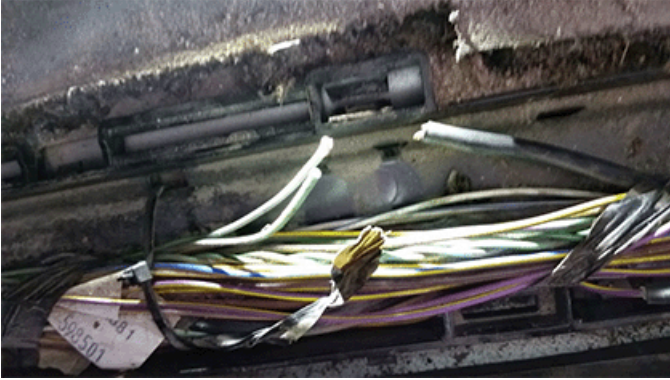
3. Circuit 5199 under the driver's sill plate for being damaged/corroded, as shown below.

Repair any wiring / terminal issues using the appropriate SI wiring repair documentation.
